St. Clair River Shoreline Restoration Assessment and Design of Restorative Works

Report to Great Lakes Sustainability Fund and Project Partners

St. Clair Region Conservation Authority
April 2006

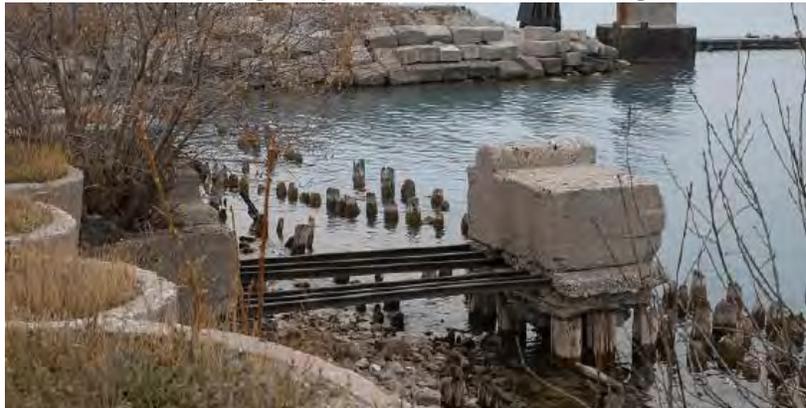
- The north end of the platform is hinged on a concrete foundation
- The foundation is protected with a Gobimat which is in poor condition
- South of the ramp, five additional docking dolphins are located along the west side of the approach

- Three of these are timber pile dolphins with steel bollards
- Two are steel pile bollards with a concrete block
- No obvious damage was observed when viewed from the shore

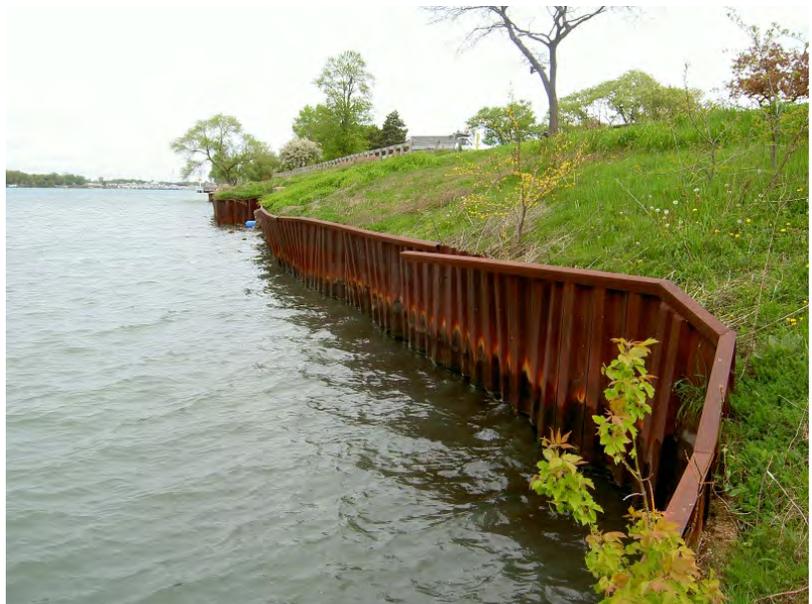
Property 12

- The steel sheet pile wall is showing signs of extreme stress and failure
- Repairs have been undertaken at several locations with very limited success
- The top of the wall is marginally low and the light gauge wall rusted through at several locations
- Anchor rods are poorly attached and anchors appear to be too close to the wall to be effective

- Due to its poor condition and the resulting necessity for repairs, there are significant opportunities for improving habitat at this site
- As a result it has been reviewed and draft designs for new protection undertaken as a part of this study

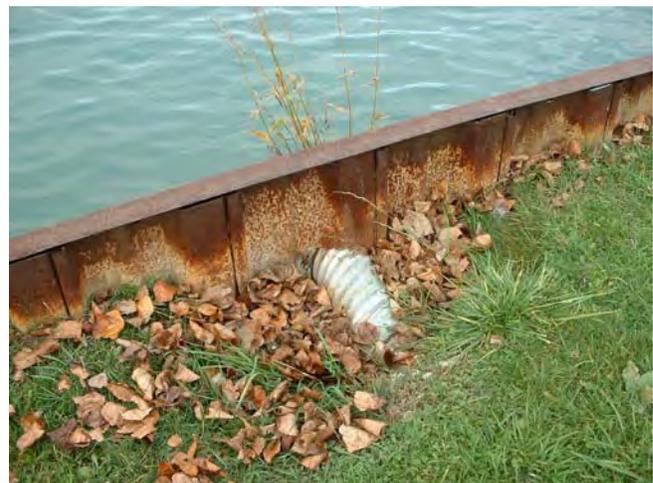
- The retaining wall and cap surfaces are in fair condition, exhibiting signs of structural instability at certain locations
- Depressions are noted in the soil behind the retaining wall at every tie rod

- The depressions are occurring directly above the nuts and washers used to secure the tie rods into the wall and it is for this reason that is felt that the problem can be attributed to the potential failure of the tie backs

- Also, the locations of the tie rods are areas where the retaining wall is experiencing bowing and again can be related to the failure of the tie rods

- At the west end of the wall there is an exposed outfall
- The soil surrounding the outfall has been lost as the outfall has corroded through

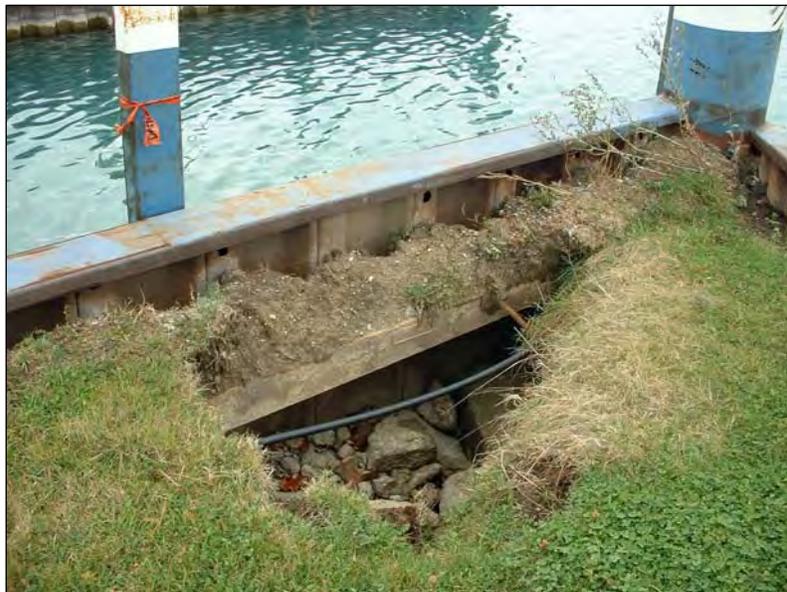
- The northern portion of the property has very steep slopes and at one location there is evidence of bank failure
- At the toe of the slope, in a five foot section, there is the debris from the failure

- The boat slip is in good condition
- The steel wall and cap are in also in very good condition
- However, due to a flaw in the design of the sheet pile wall, massive soil loss has occurred

- At the corners of each wall section, major failure has occurred behind the walls
- Depressions greater than a metre cubed have occurred at each corner

- Some of the corners have been filled with poured concrete
- Moving south, there are large voids between the broken concrete and sections of the bank are experiencing loss of material

- There are some safety concerns with regard to the large voids and exposed rebar

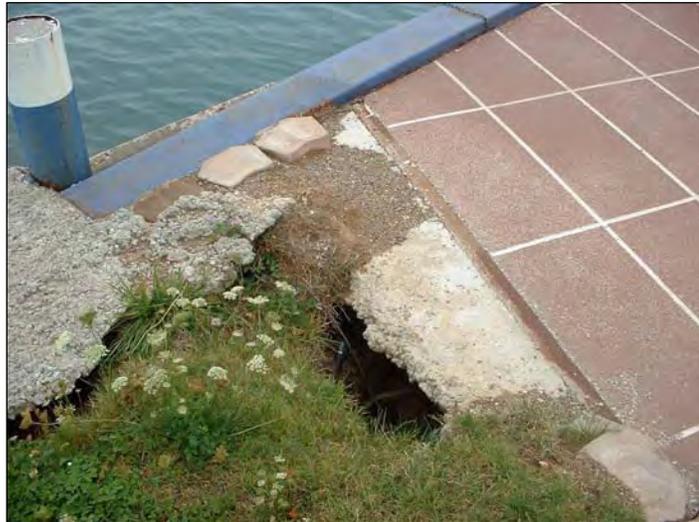
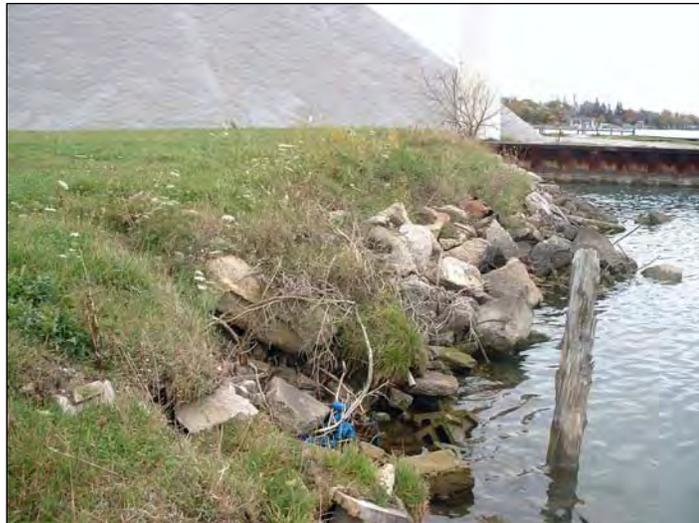
- Around the gravel dock, the retaining wall does not appear to be vertically straight at all locations thus indicating areas of slippage behind wall
- The top of the wall appears to be leaning toward the water
- A possible explanation for this slippage may be attributed to the significant amount of weight that is being placed on the underlying substrate from the gravel storage
- The cap of this wall is cracked
- This is further evidence of stress on the wall and of movement

- At the north end of the site it is recommended that the existing wall be replaced with a wall that is anchored into the bed of the river so that no undercutting behind the wall is possible
- An armourstone wall / revetment would provide the necessary support as well as provide a significantly more friendly environment
- The option does exist to contour the wall to provide further opportunities
- The discarded concrete rip rap should be replaced with suitable erosion control in the form of rock rip rap or armourstone
- In the longer term, the wall around the gravel docks could be replaced with a armourstone wall

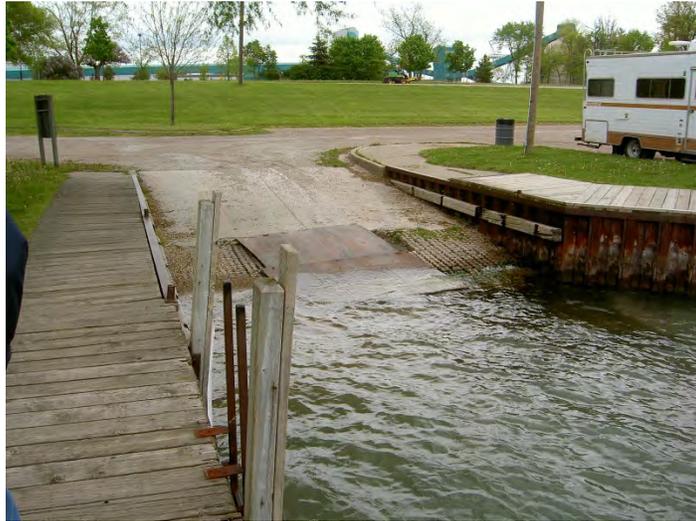
- The boat launch is in poor condition
- The steel sheet pile walls are rusted through and the floor of the launch is rutted
- The timbers of the fishing platform are also a concern as they are undersized for the span
- The beach and the rip rap / cobble revetment of are in fair to good condition and will only be of concern in the short term at higher lake levels

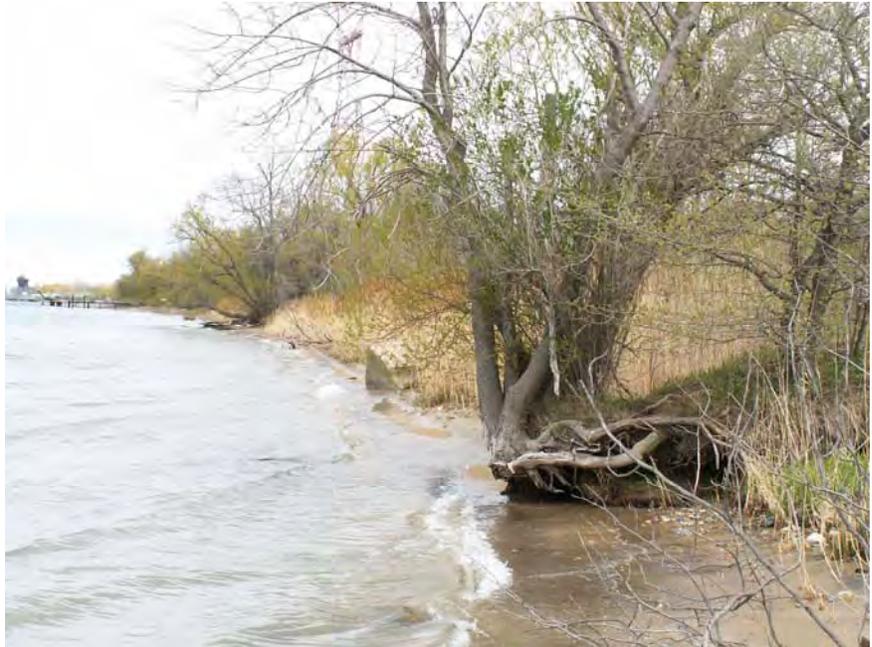
- The gabion baskets at the north end of the site are breaking down and are rolling toward the river
- Cobble beach is providing some added protection at lower water levels
- Further south erosion is more obvious as a narrow sand beach fronts the toe of an eroding slope
- The degree of toe erosion varies from section to section
- In addition some erosion has been caused by overland drainage and still further erosion is evident at some of the multiple outlets within the reach

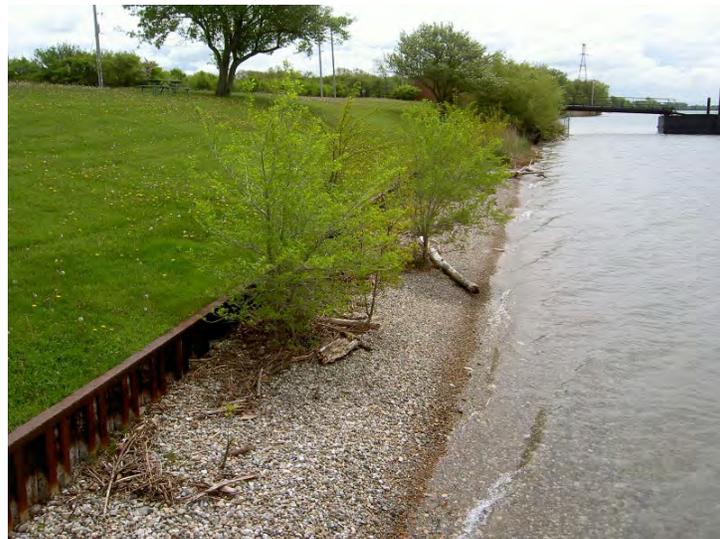
- In the beach cell areas there are signs of minor misalignment, however on the whole the wall is in good condition
- Minor backfill losses behind the wall and boardwalk in some locations
- Some of the boardwalk timbers are broken

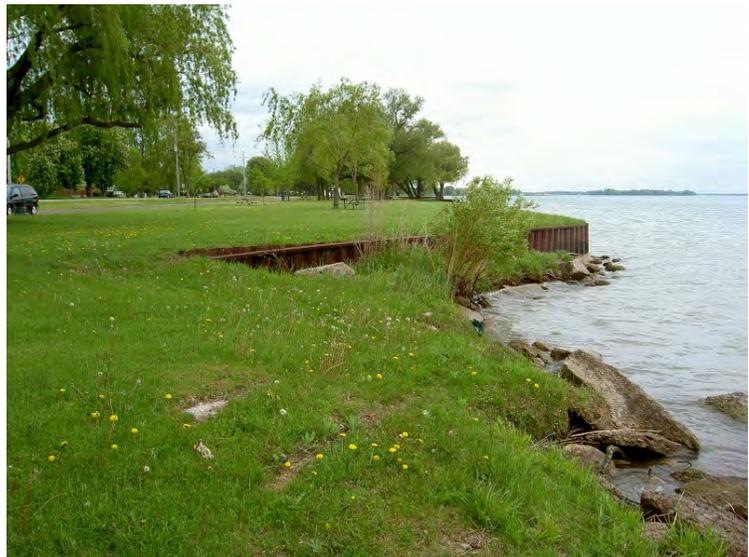
- Steel sheet pile walls in the north end of the site and south of the ramp exhibit signs of moderate instability (horizontal and vertical misalignment)
- North wall of boat launch appears stable
- Unprotected extreme north end of the site is experiencing erosion
- A minor indent from ice observed at several locations
