Blue Point Recession Study 2004

St. Clair Region Conservation Authority

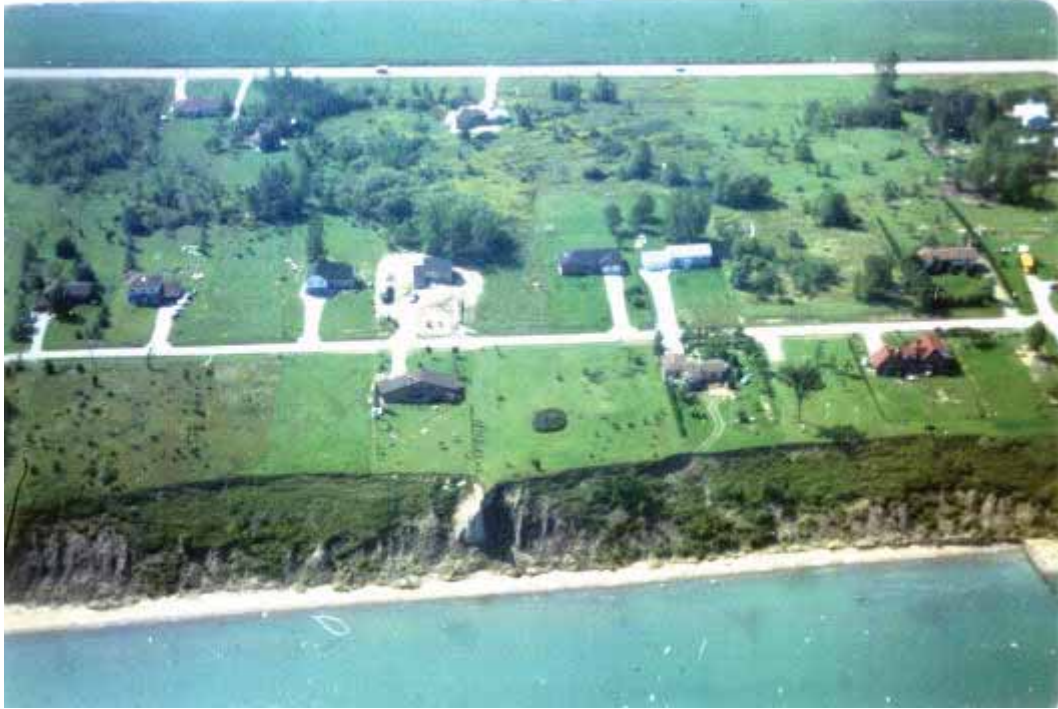
Figure B - Blue Point Subdivision 1990 –St. Clair Region Conservation Authority

The shoreline in this area consists of newer and established residences (both cottages and permanent homes). There are shoreline protection structures (groynes and seawalls) throughout the study area.

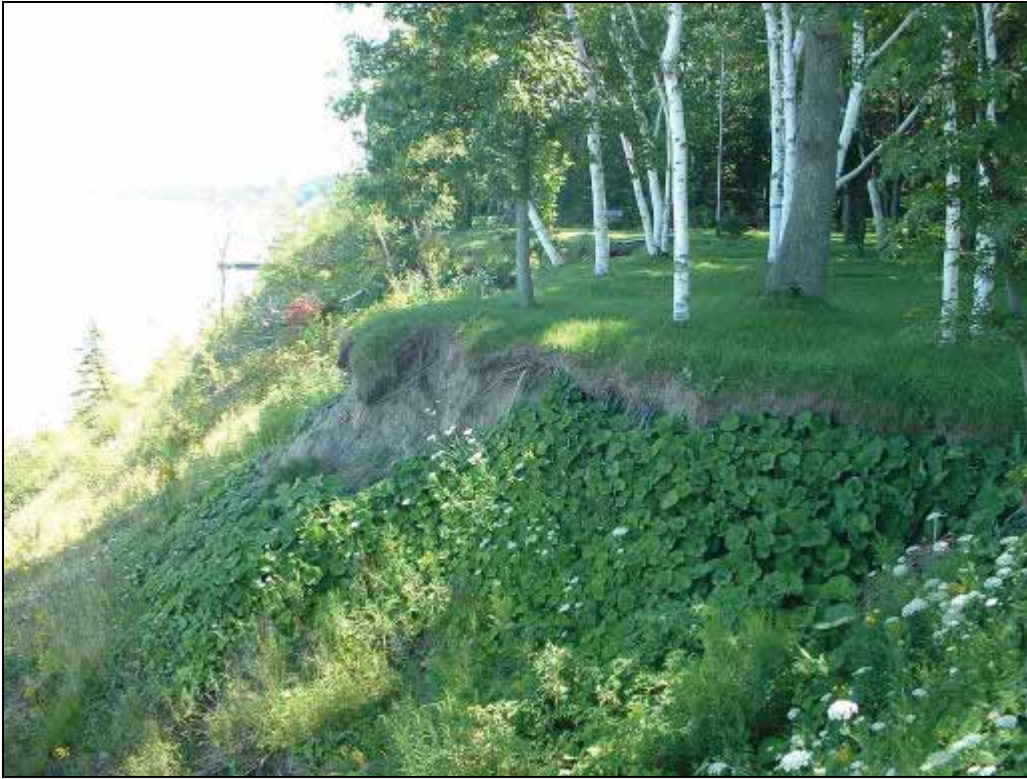
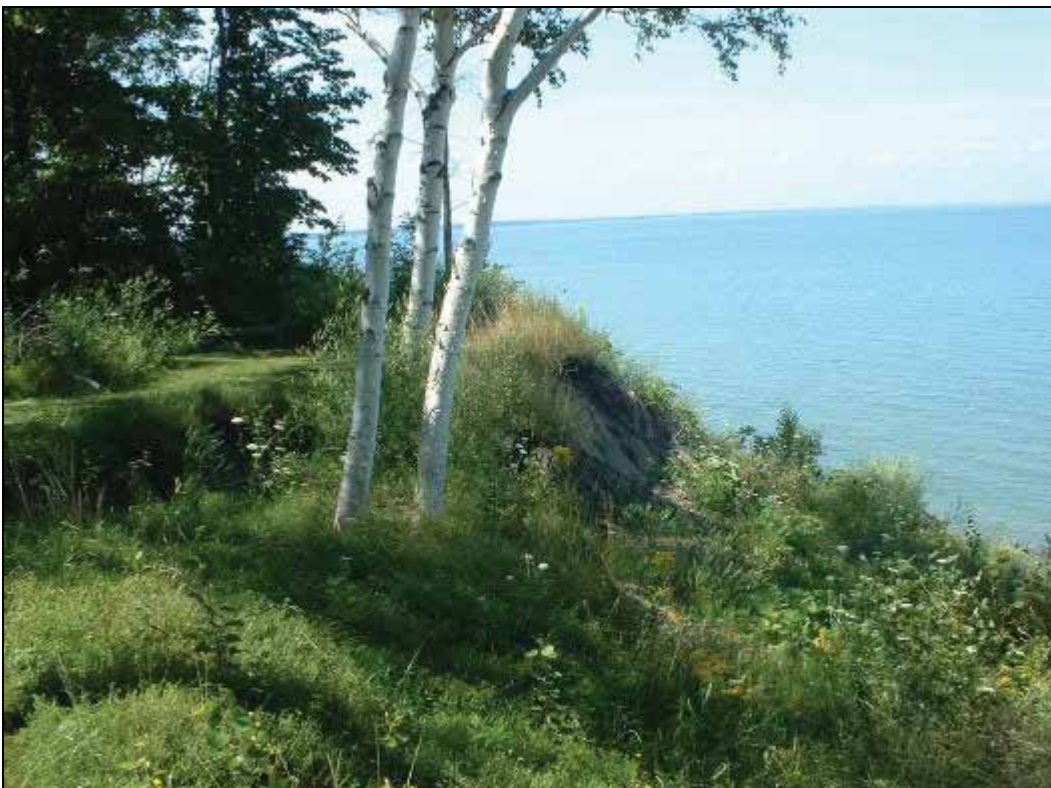
Figure C- Bank slumping in Block 1 (transects 583-586) Personal communication with landowners revealed that a 2004 rain event caused extensive top of slope sloughing 2004- St. Clair Region Conservation Authority

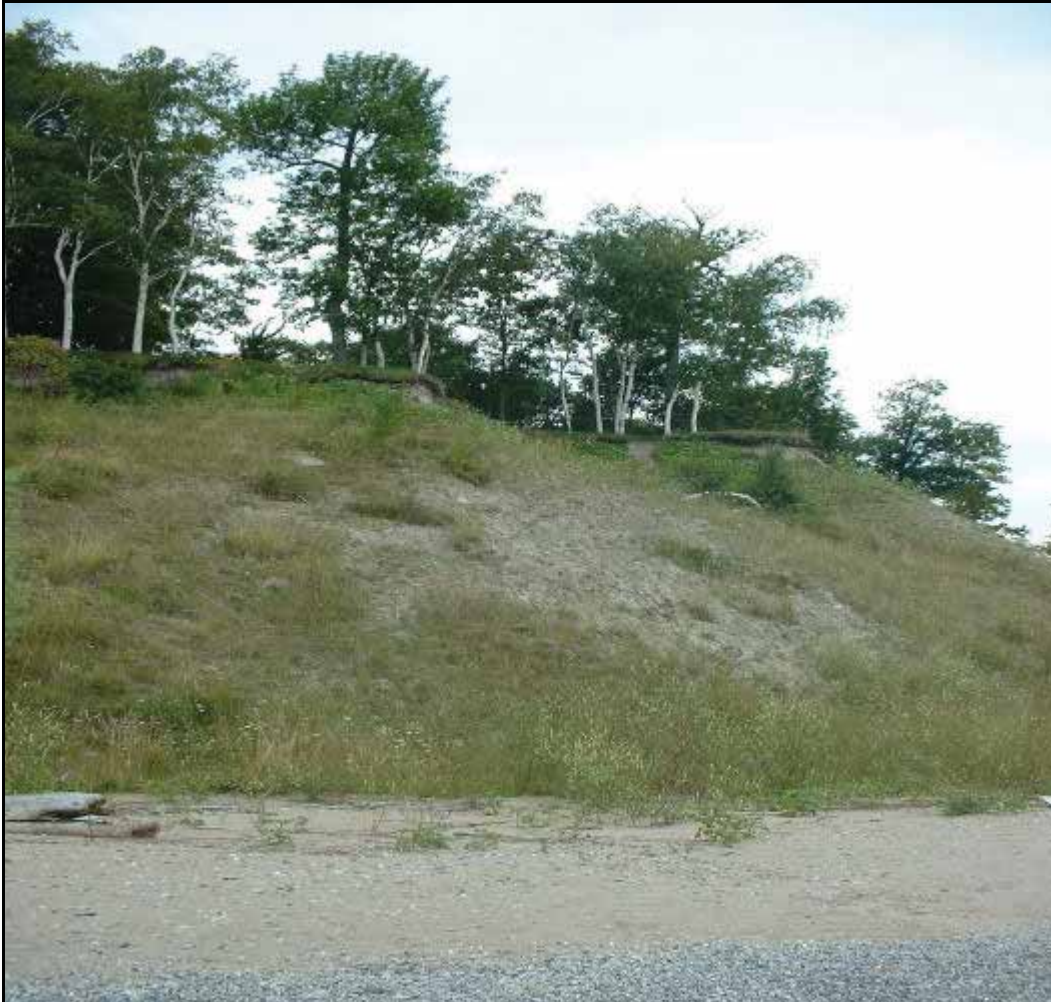
Figure D- An example of a property located within Block 2 where the toe recession was found to be the highest in the study area. Exposed slope, channeling and undercuts at the top of bluff are visible. St. Clair Region Conservation Authority- September 2004

Overall the toe of bluff in this portion of the shoreline continues to recede. There were only two transect locations where the measurements of bluff change showed accretion- transects 584 and 597. This trend of receding bluff base was also observed in the Reinders/Geomatics study. They found an average overall recession of 28 meters for reach 574 and 7 meters for reach 575. The current study found the toe of bluff erosion to be lowest in block 1 (transects 583-586) and highest directly east of the point (transects 587-590) in block 2. By far the greatest toe recession was found to be in the vicinity of transect 587 with a recorded recession distance of 8.25 meters. This significantly high recession record influences the recession average of block 2. Table 7 outlines the toe of bluff recession trend revealed in both studies and the lower recession rate in the last 11 years.

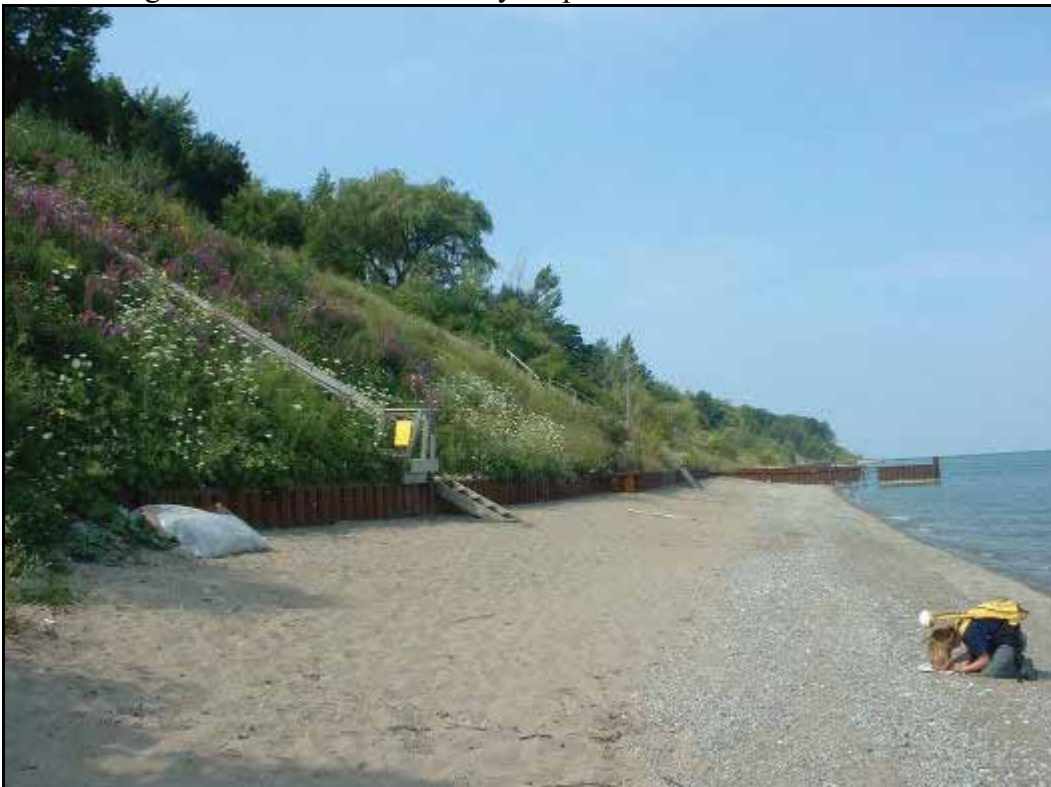
Figure E - An Example of a well vegetated bluff face
St Clair Region Conservation Authority- September 2004

Notes were taken on vegetation growing on the bluff face. There are portions of the bluff face that are well vegetated with complete vegetation cover over the face of the bluff including grasses, shrubs and trees. Other areas of the bluff are poorly vegetated and have visible rutting and toe erosion. There is no discernible trend between well vegetated slope face and lower recession rates. However the literature confirms that vegetation on the slope face will help to protect the bluff from erosion and retards the natural process of shoreline erosion. The following pictures are examples well vegetated slopes in the summer of 2004.

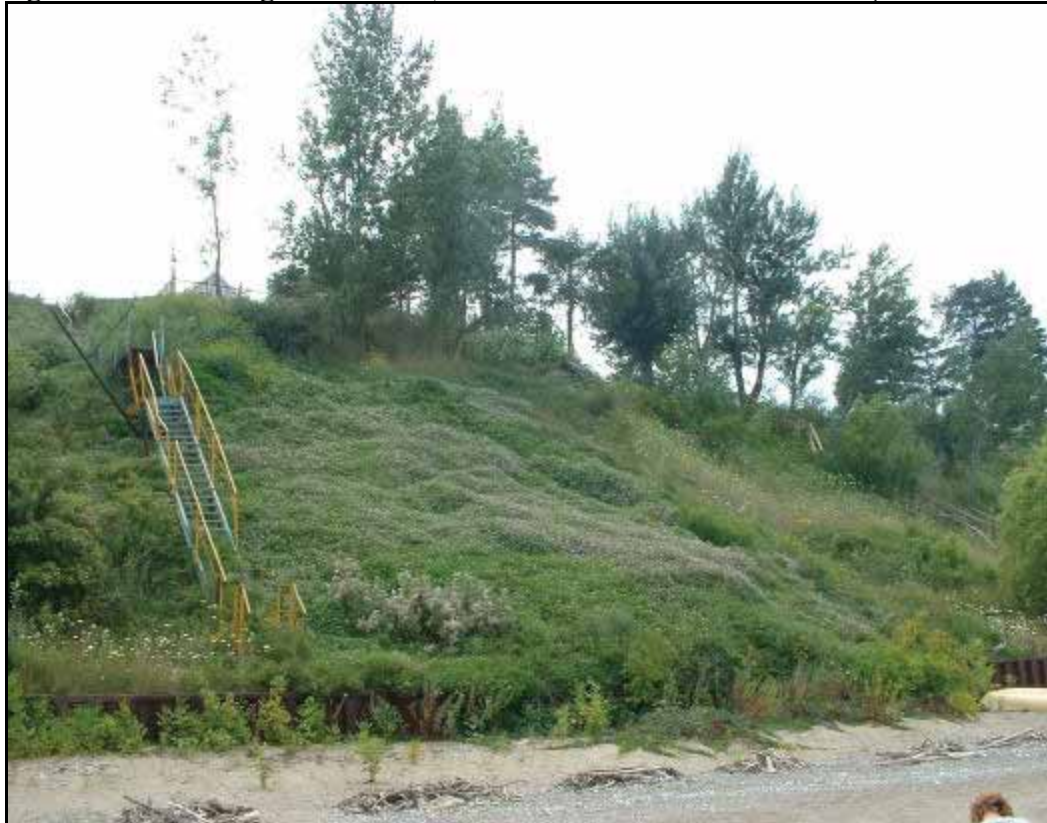
Figure F -A well vegetated bluff, established with Crown Vetch (*Coronilla varia*).

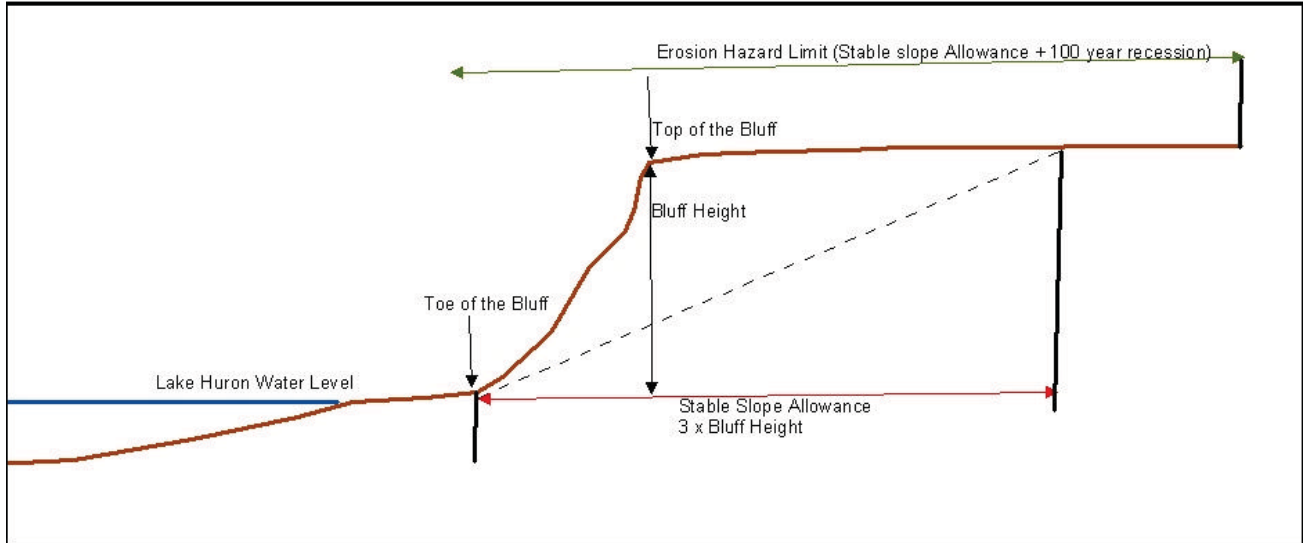
Shoreline Features -Schematic diagram showing the Shoreline Features and Hazard Zones
