Executive Summary

2.4 Implementation of Protection Works Recommendations

3.4.1 HAZARDOUS LANDS DELINEATION

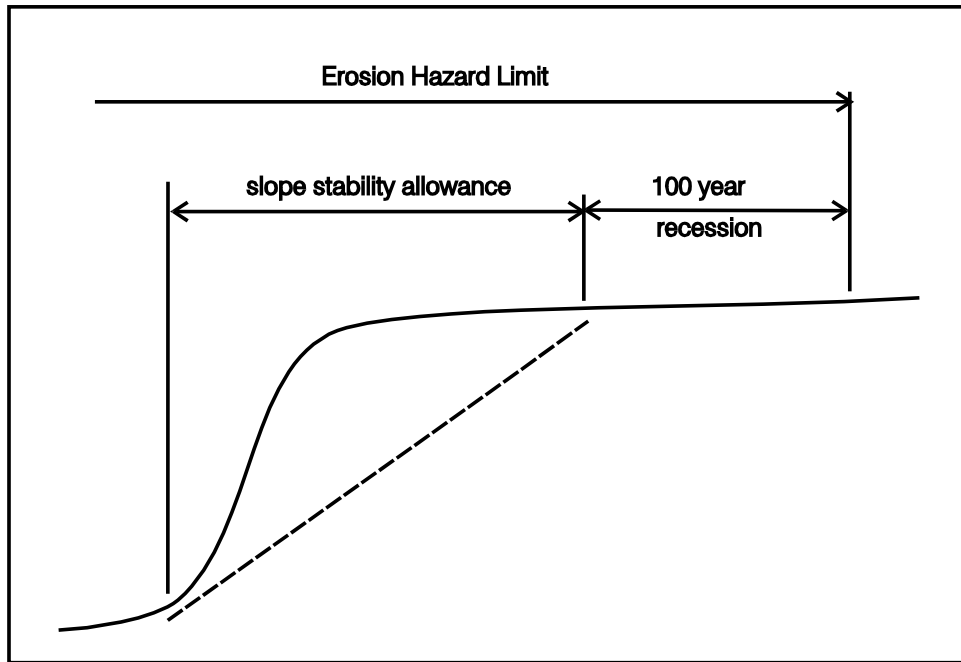
Figure 3

Erosion Hazard Limit - The standard used to define the erosion hazard limit is the sum of the slope stability allowance plus 100 times the average annual recession rate measured landward from the toe of the bluff or a 30 metre erosion allowance measured landward from the top of the bluff (WHICHEVER IS GREATER).

Erosion Hazard Limit

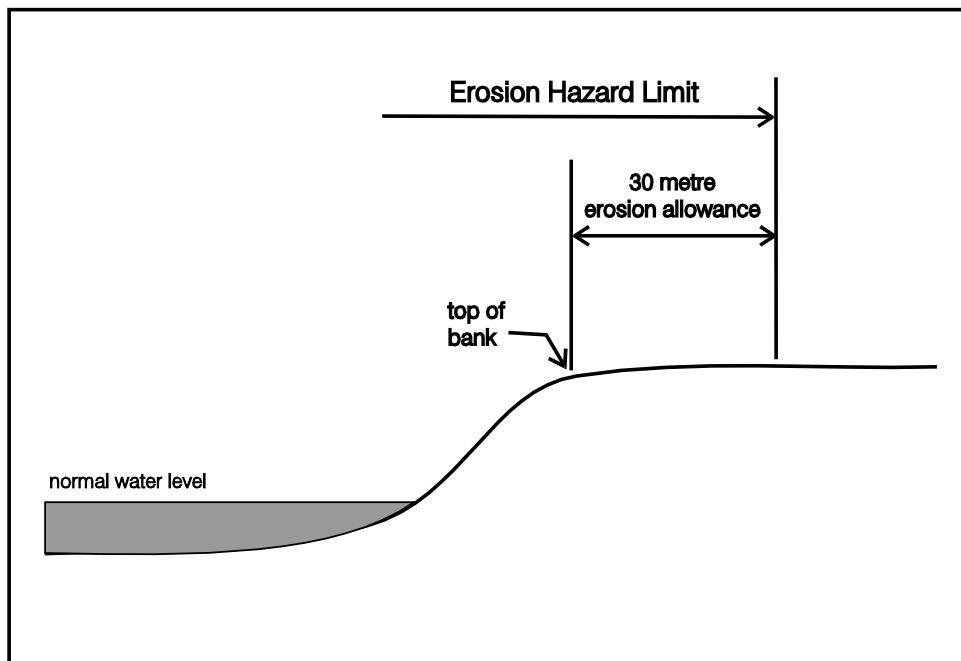
Figure 4

Erosion Hazard Limit

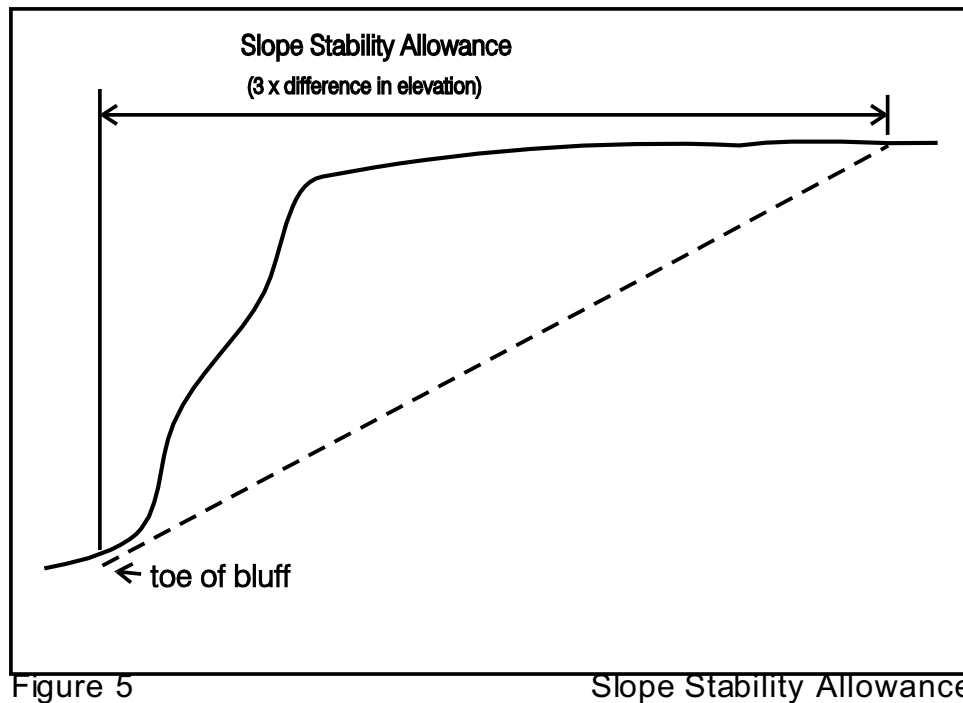
Figure 5

Slope Stability Allowance - The stable slope allowance appropriate for the study area is a horizontal setback measured landward from the toe of the bluff equivalent to 3.0 times the difference in elevation between the first lakeward break in slope and the toe of the bluff.

Slope Stability Allowance

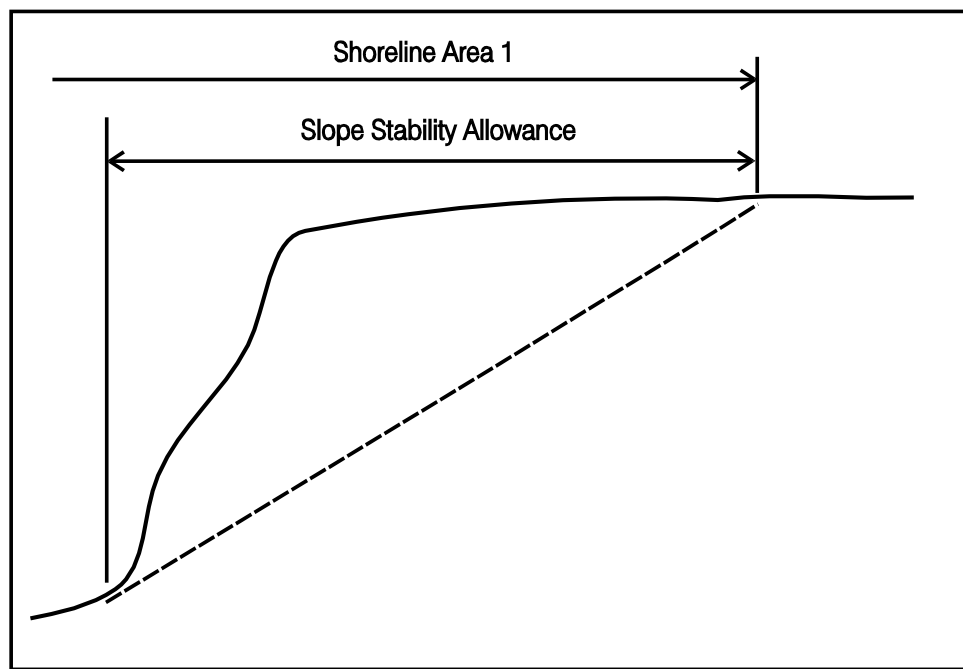
Figure 6

Shoreline Area 1 - That area of the shoreline between the water's edge and a line defined by the stable slope allowance including the beach, the face of the bluff and the table land extending from the top of the bluff to the limit of the slope stability allowance.

High Bluff Areas
Shoreline Area 1

Bluff movement can occur over a relatively short period of time and often with little warning. Where existing dwellings become at risk or are damaged by bluff instability, movement of these structures becomes an emergency operation. Access to properties with buildings damaged by bluff movement can be restricted due to additional equipment loading and proximity to top of bluff. These factors increase the emergency cost of moving the structure.

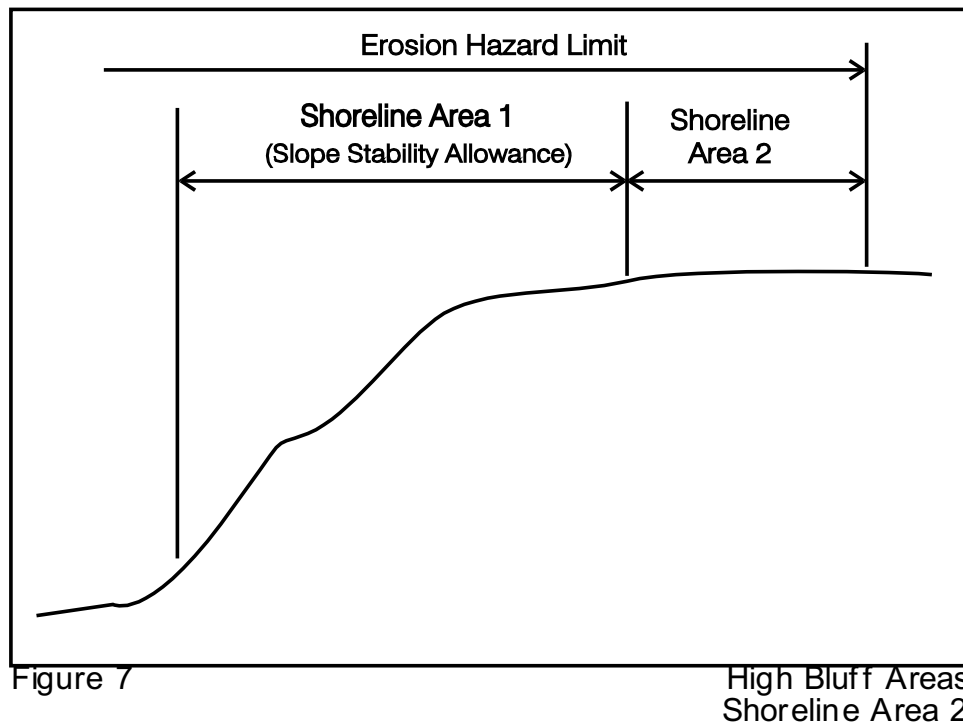
Figure 7

Shoreline Area 2 - That area of the shoreline between Shoreline Area 1 and a line defined by the slope stability allowance plus the distance that the shoreline is estimated to recede over a 100 year period or, a 30 metre erosion allowance measured landward from the top of the bluff (erosion hazard limit).

High Bluff Areas
Shoreline Area 2

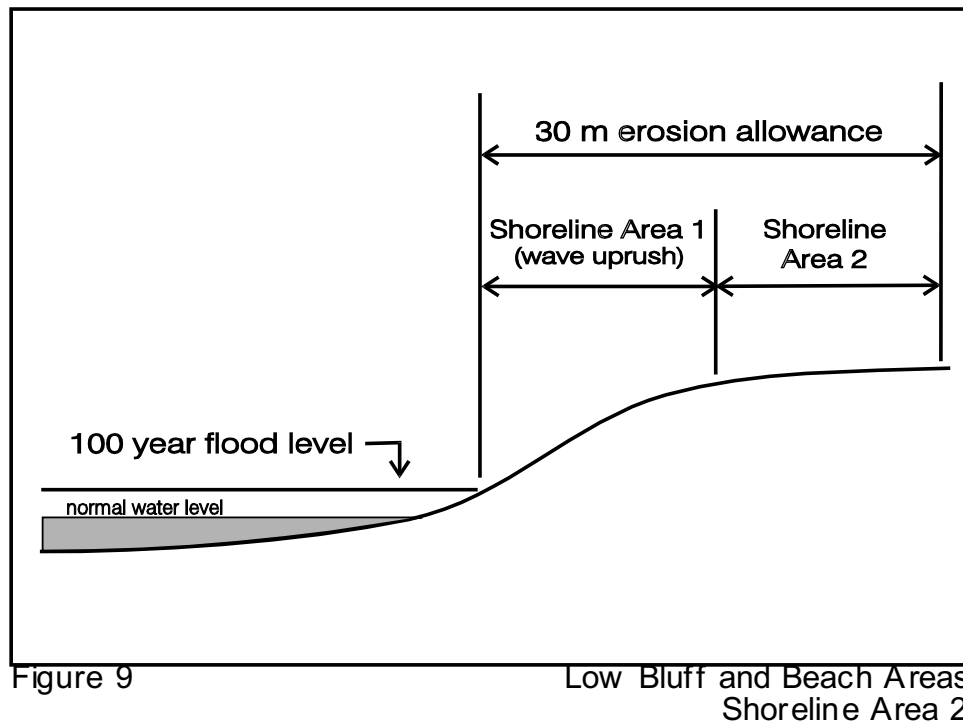
Shoreline Area 2 - That area of the shoreline between Shoreline Area 1 and a line defined by the 100 year flood level plus a 30 metre erosion allowance.

Shoreline Area 2 addresses long term recession resulting from beach and bluff erosion. The 30 metre erosion allowance recognizes uncertainties associated with natural shoreline processes and the performance of protection works. Concerns regarding protection works relate to design life, maintenance, and condition of adjacent structures. Dwellings constructed landward of Shoreline Area 2 will not rely on protection works to prevent erosion and damage to the building.
