Lake Huron Shoreline Management Plan Update - 2011

St. Clair Region Conservation Authority

December 5, 2011

W.F. Baird & Associates Coastal Engineers Ltd.

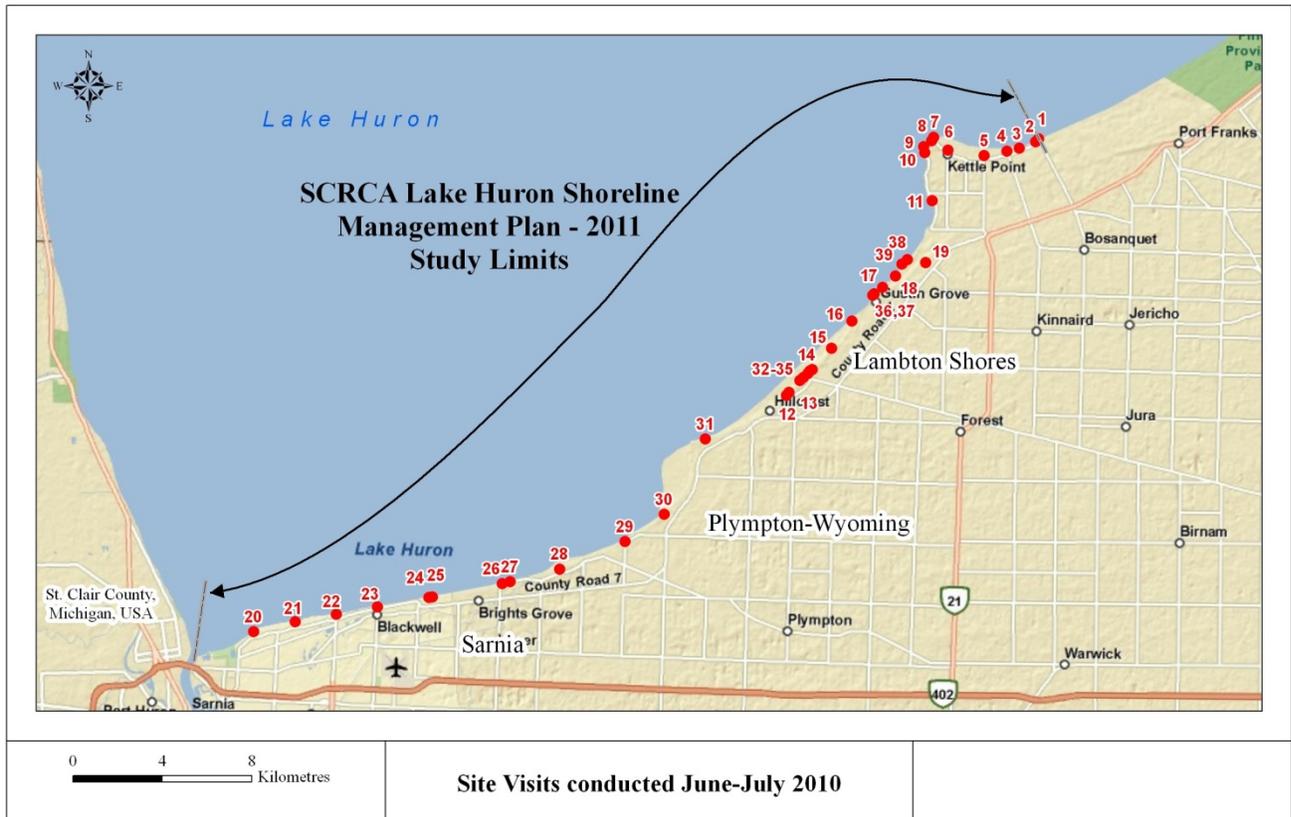
Figure 2.1 Locations of Site Visits (June and July, 2010)

A shoreline reconnaissance was undertaken and 39 sites were visited. Sites 1 through 23 were visited on June 1, 2010, Sites 24 through 31 on June 2, 2010 and Sites 32 through 39 on July 7, 2010. The site visit locations are shown in Figure 2.1. The sites were chosen as representative of the various shoreline conditions encountered within the study area, including eroding bluffs, low shores, beaches and various erosion protection structures (see Figure 2.2).

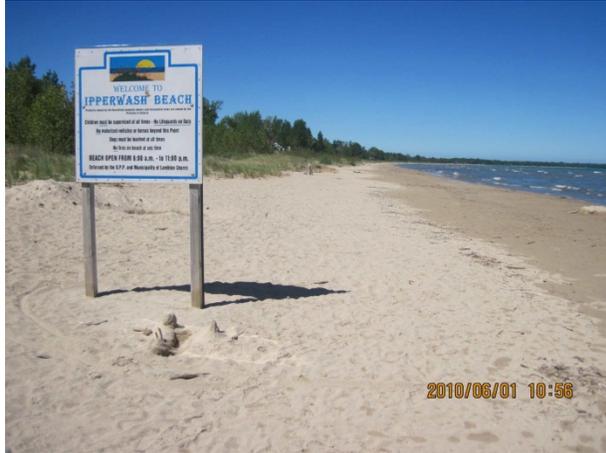
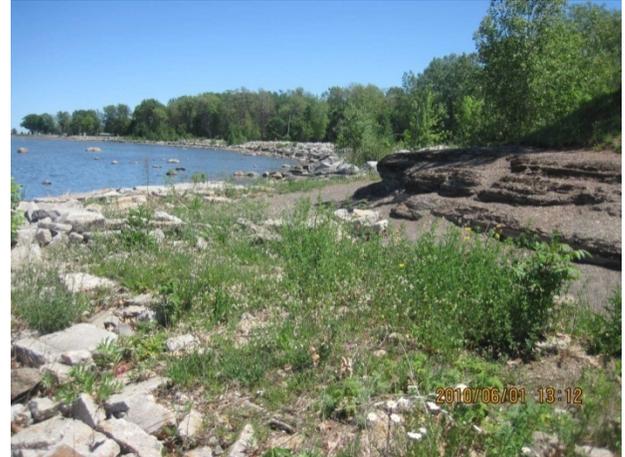
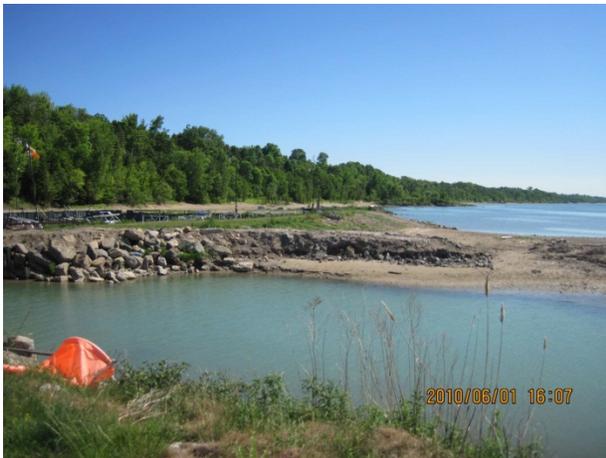
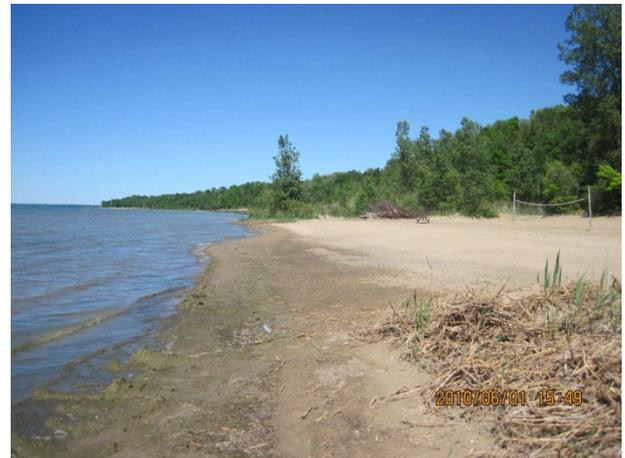
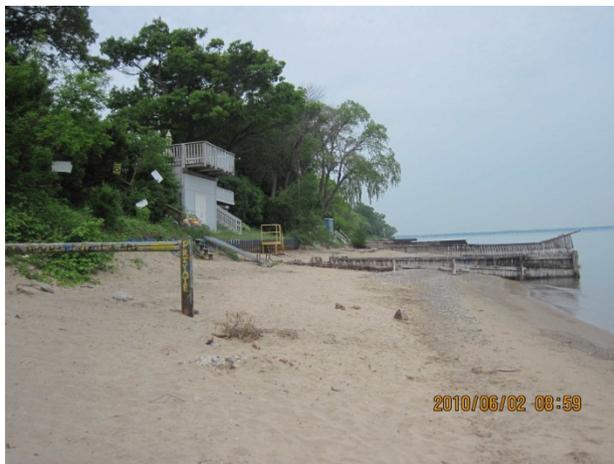
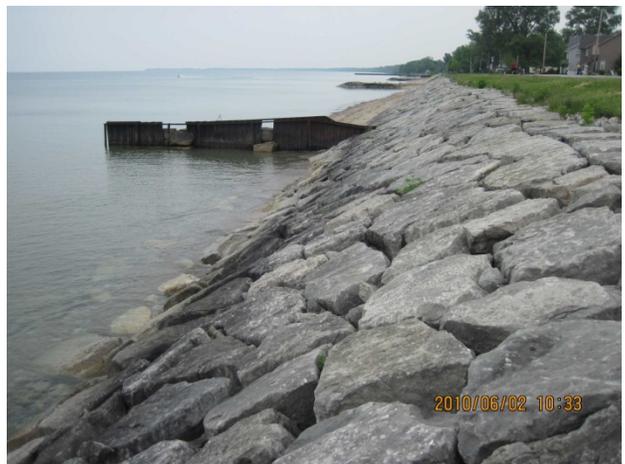
Dynamic Beach – Site 1 Reach 38

Ad Hoc Protection - Site 9 First Nations

Marina at Base of Bluff - Site 16 Reach 31

Beach at Base of Bluff - Site 15 Reach 30

Timber Groynes Retaining Beach - Site 21 Reach 4

Armourstone Revetment, SSP Groynes - Site 26 Reach 11

Figure 2.2 Examples of Shoreline Conditions from Site Visits (June and July, 2010)

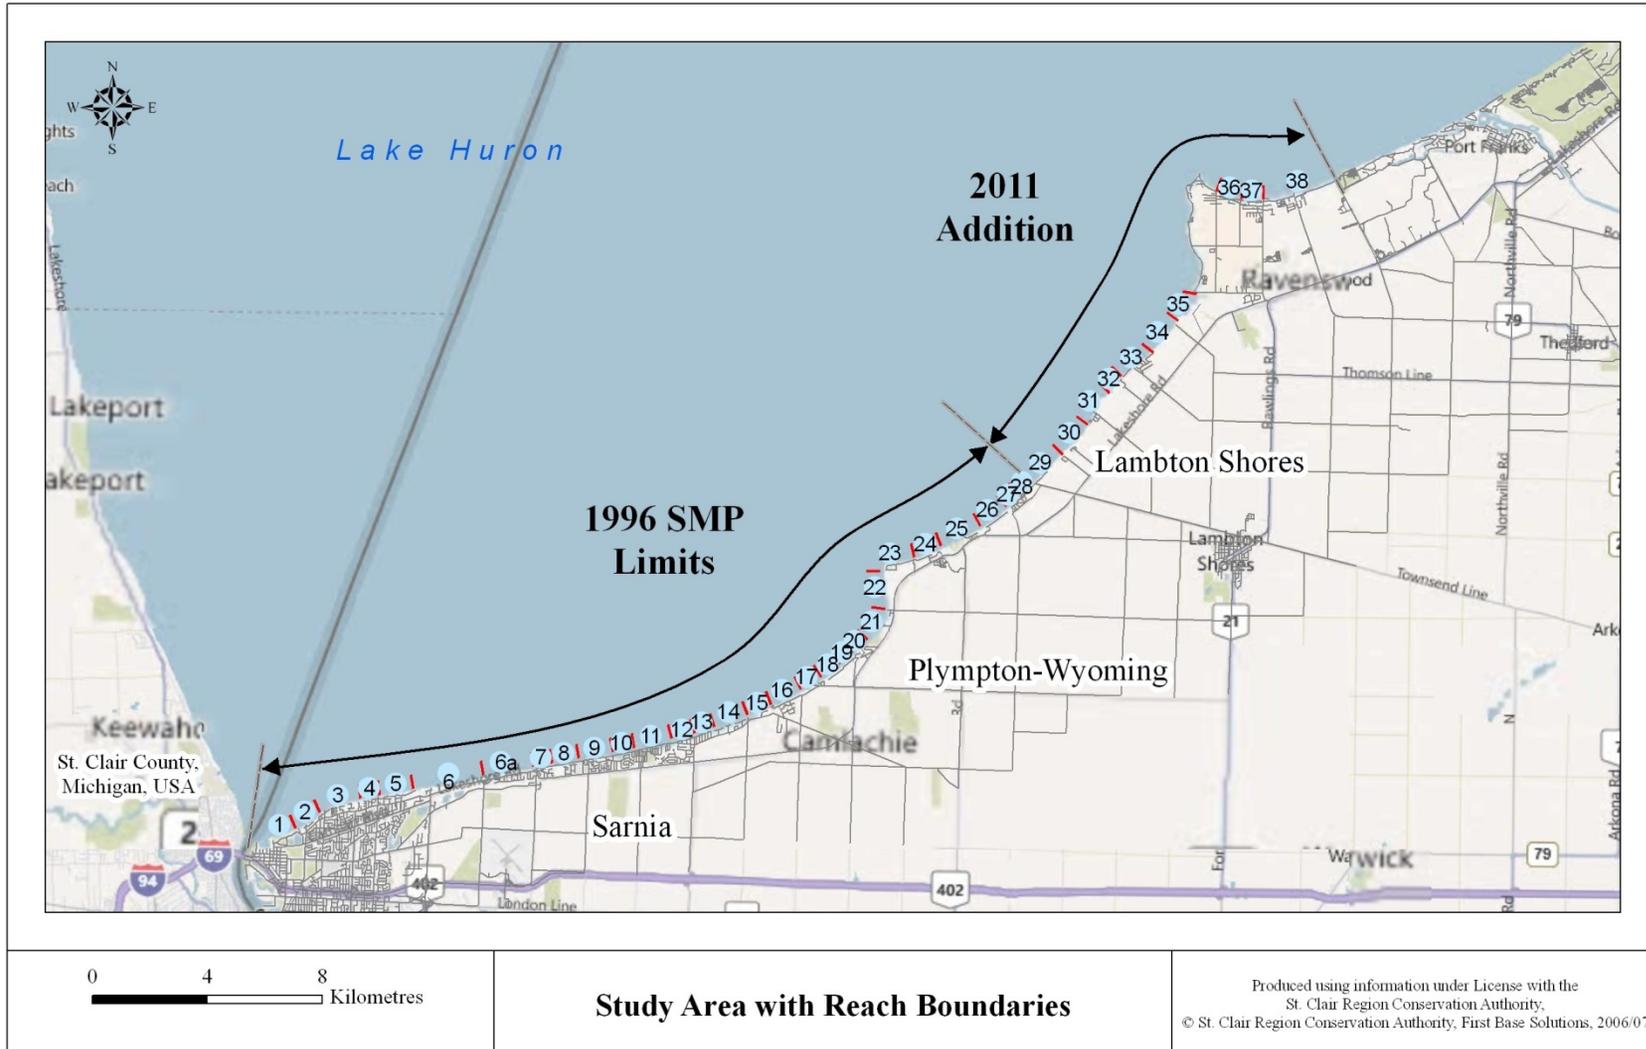
Figure 3.1 Shoreline Reach Boundaries

The reaches extend from Reach 1, at the western limit of the study area to Reach 38 at the eastern limit as shown in Figure 3.1. The geographic boundaries of the reaches are listed in Table 3.1 and descriptions of each of the reaches are provided in Appendix B.

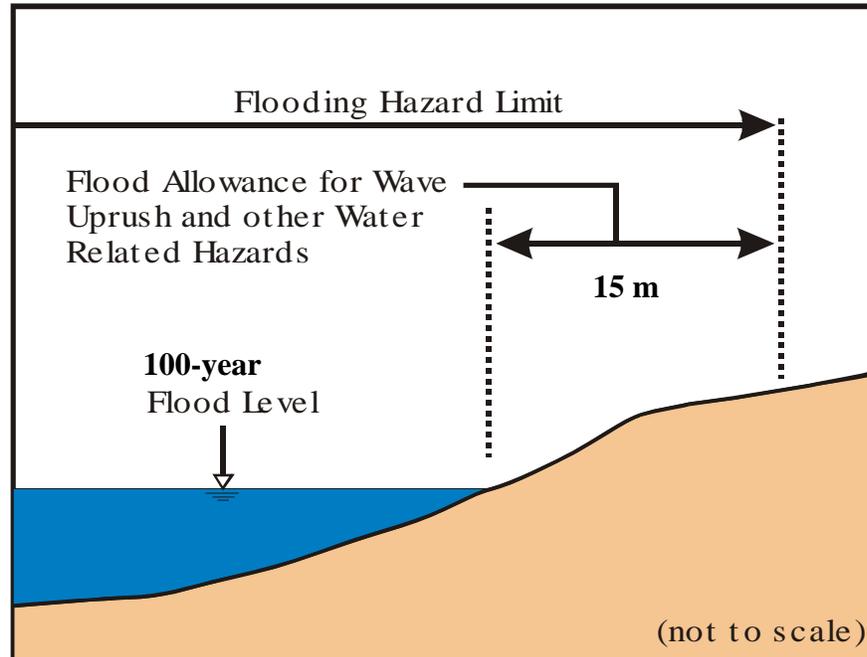
The flooding hazard is defined by the combination of "flood level" and the "flood allowance for wave uprush and other water related hazards" (see Figure 4.1). The *Technical Guide* (MNR, 2001a) requires a flooding allowance of 15 m, measured horizontally from the location of the flood level, if a study using accepted engineering and scientific principles is not undertaken.

Figure 4.1 Flooding Hazard Limit with Wave Uprush

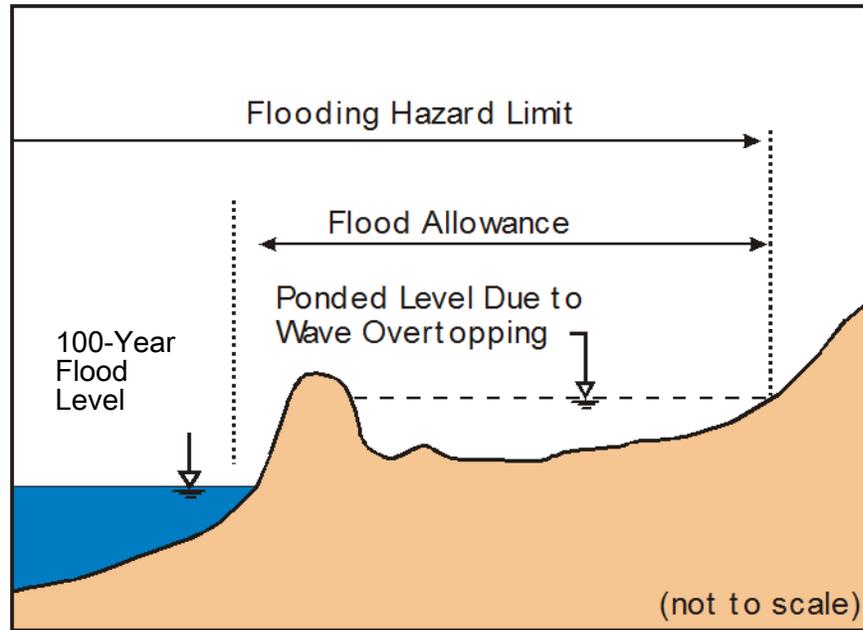
Where the shoreline is overtopped by waves or ponding occurs, the limit of the flooding hazard is to be determined by a study using accepted engineering and scientific principles (see Figure 4.2).

Figure 4.2 Flooding Hazard Limit With Wave Overtopping

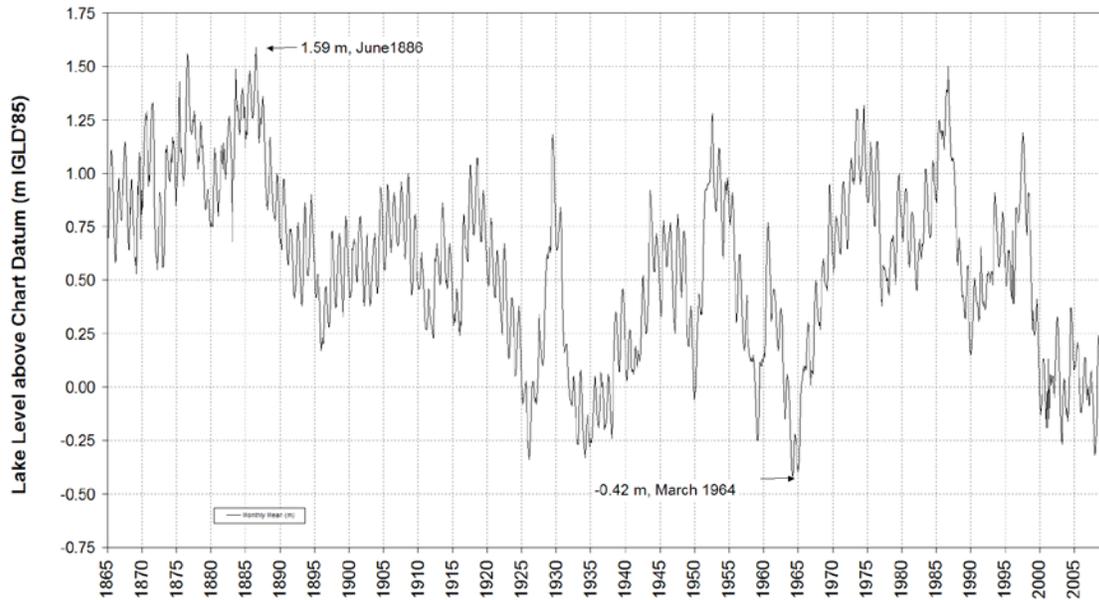
The potential influence of regulation structures on lake levels was reviewed for this study. Figure 4.3 presents monthly mean water levels for Lakes Michigan-Huron from 1865 to 2009 in metres International Great Lakes Datum (IGLD 1985). The conversion from IGLD to CGD at Point Edward is (IGLD 1985 – CGD = 0.04 m).

Figure 4.3 Historical Monthly Mean Water Levels on Lakes Michigan-Huron from 1865 to 2009

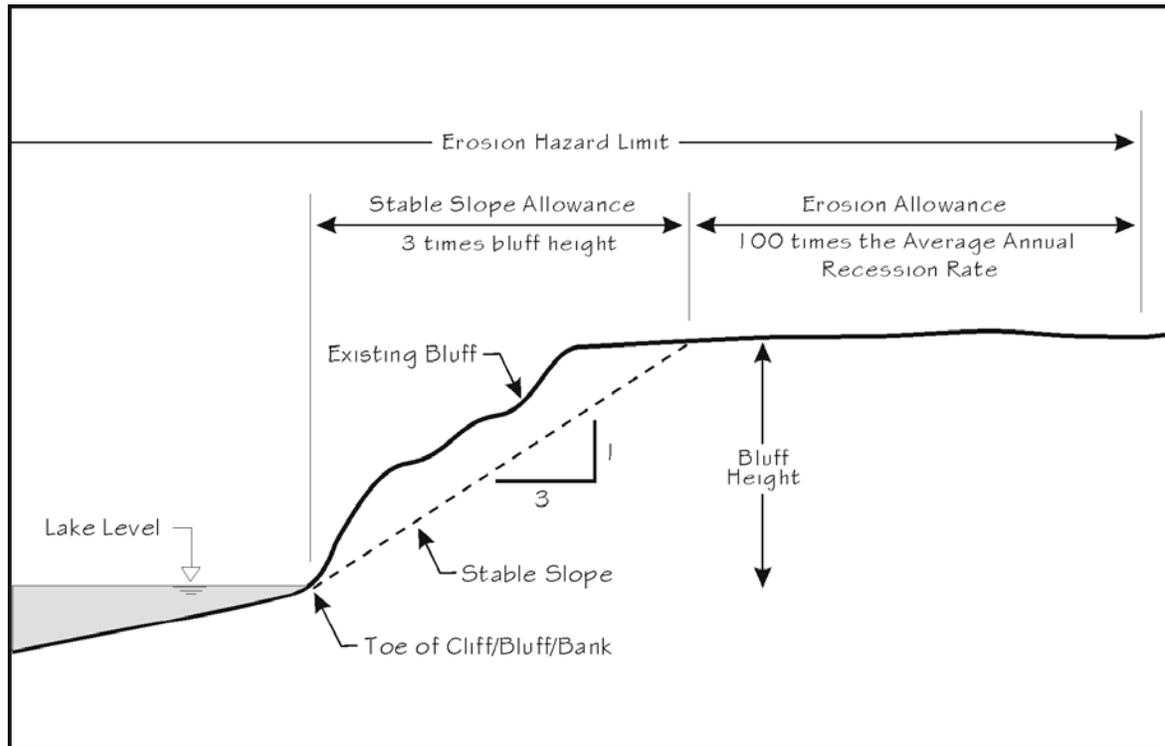
“the predicted long term stable slope projected from the existing stable toe of the slope or from the predicted location of the toe of the slope as that location may have shifted as a result of shoreline erosion over a 100-year period.”

Figure 4.4 Erosion Hazard Limit Defined by *Technical Guide* (MNR 2001a)

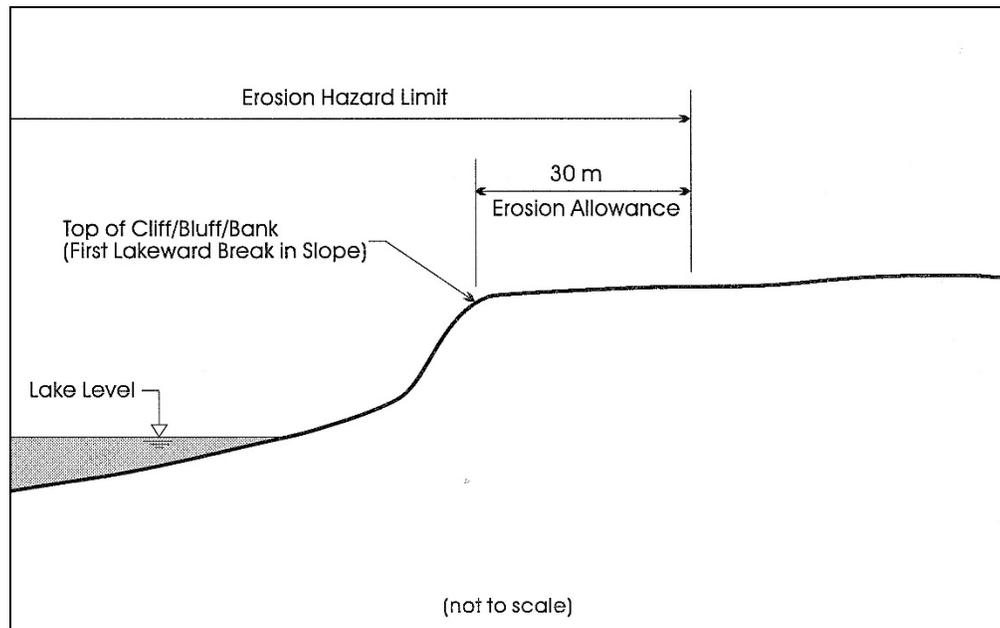
In the second step, the landward limit of the erosion hazard is calculated as a 30 m erosion allowance measured landward from the top of the shoreline cliff, bluff or bank, or the first lakeward break in slope, as shown in Figure 4.5. It is the greater of the landward measurements from Steps 1 and 2, which ultimately determines the landward limit of the erosion hazard. The second method of calculation would generally govern in situations where the existing slope is a flatter inclination than the stable slope allowance, MNR (2001a, 2001b).

Figure 4.5 Erosion Allowance Measured from First Lakeward Break in Slope

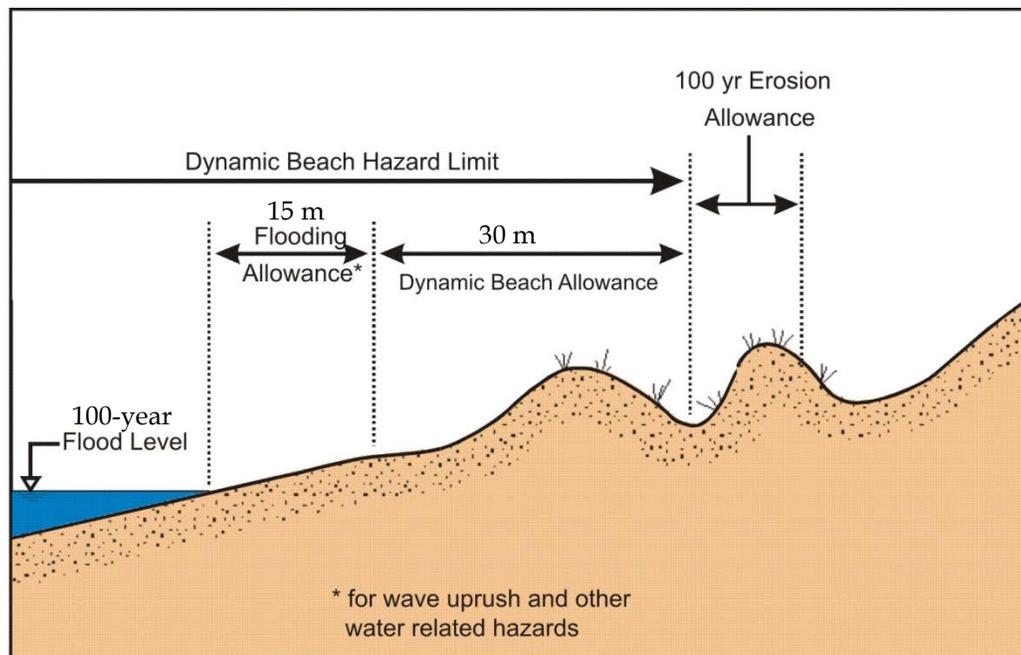
- The landward limit of the flooding hazard (100-year flood level plus a flood allowance for wave uprush and other water related hazards) plus a dynamic beach allowance based on a study using accepted scientific and engineering principles, plus 100-year erosion allowance.

Figure 4.6 Dynamic Beach Hazard Limit

The “flood level” and the “flood allowance” represent the flooding hazard, as described in Section 4.2. The flood allowance accommodates waves, which rush up the shoreline beyond the water level. The *Technical Guide* (MNR, 2001a) requires a flood allowance of 15 m, measured horizontally from location of the flood level, if a study using accepted engineering and scientific principles is not undertaken.

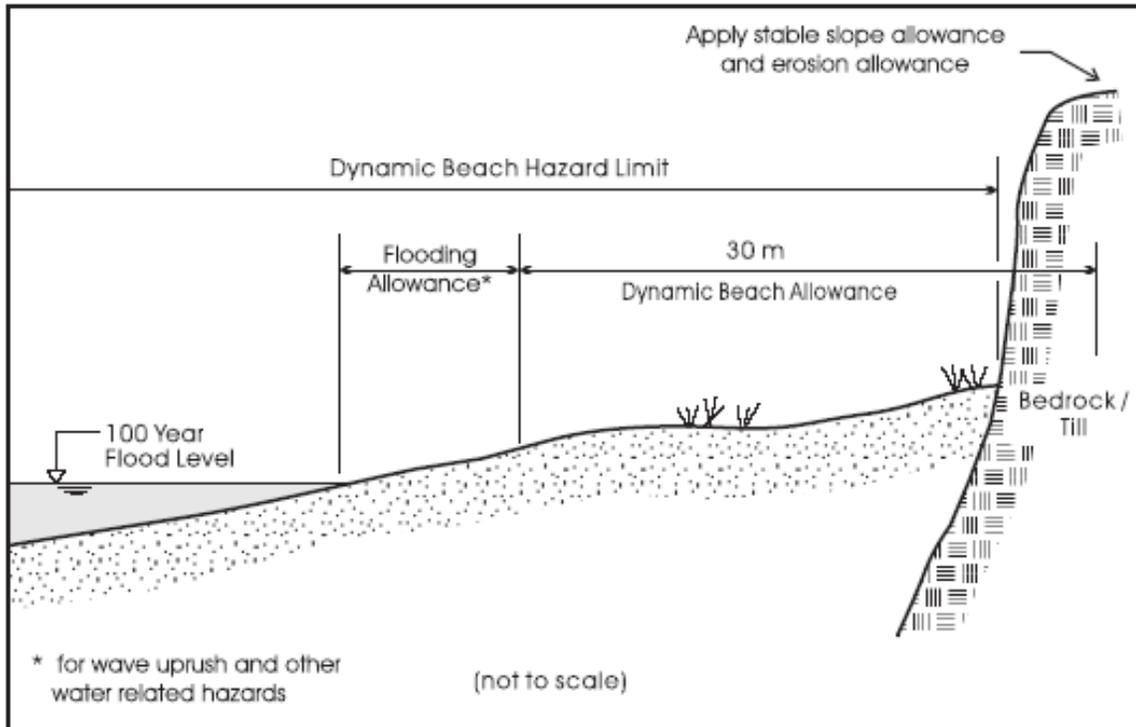
On dynamic beaches backed by a cliff or bluff, the calculation and definition of the erosion hazard is applied to the cliff or bluff feature and as such, recession of the beach is accounted for in the determination of the landward limit of the erosion hazard for the cliff or bluff feature.

Figure 4.7 Dynamic Beach Hazard Limit Backed for Bluff

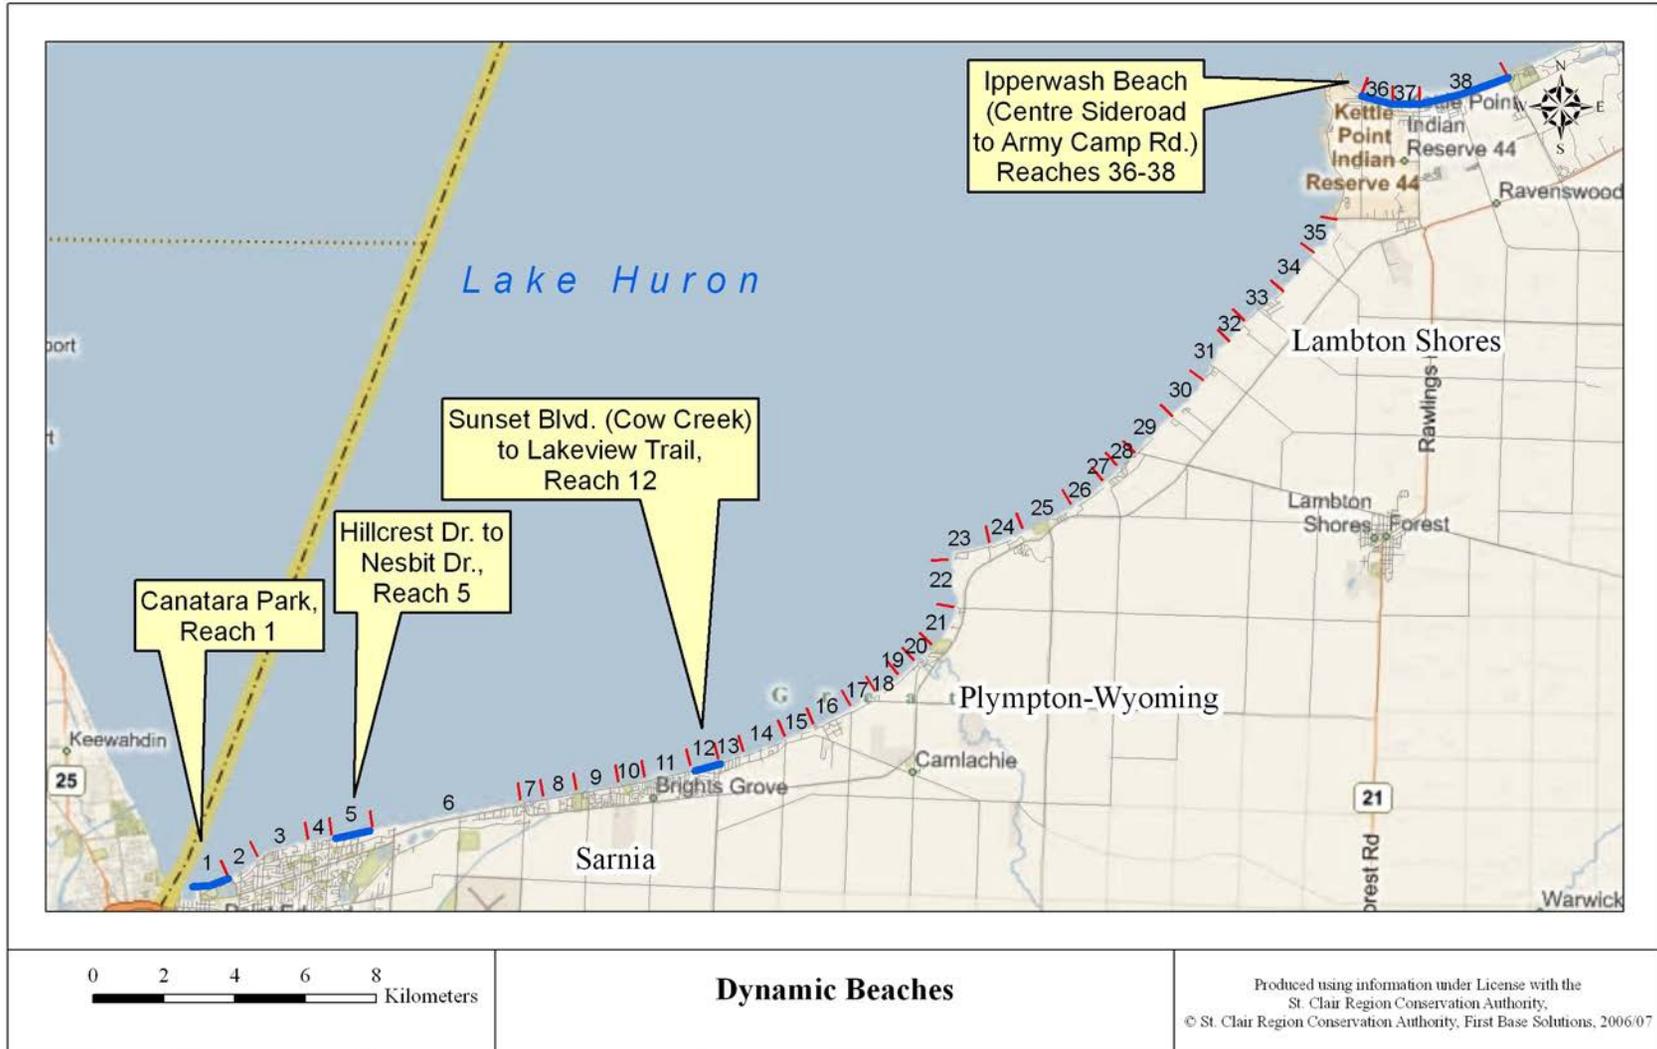
Figure 4.8 Dynamic Beach Locations

- Reach 12, Cow Creek (Huronview Trail to Lakeview Trail): The beach on the east side of the jetty at the mouth of Cow Creek is a fillet beach which was formed by accretion of alongshore sediment that was trapped following construction of the jetties at the mouth of the creek. The dynamic beach hazard limit was mapped at the transition from the unconsolidated beach materials to the low plain. The beach does not appear to be recessional based on a simple review of historic photographs and mapping but due to the overall recessional nature of the shoreline, an erosion hazard was also mapped. It should be noted that the stability of the beach is dependant on the continued presence of the jetties.

- Reaches 36 to 38, Ipperwash Beach (Centre Side Road to Army Camp Road): The beach is a fully developed dynamic beach with an established dune system. The dune system decreases in a southerly direction, approaching Kettle Point. The dynamic beach hazard limit was mapped at the standard 30 m from the flood hazard, extending to the landward side of the first main foredune. The adjustment of the beach profile to the lower water levels was taken into consideration by adjusting the beach profile as described in Section 4.4.3. The shoreline does not appear to be recessional and no erosion allowance was therefore applied.

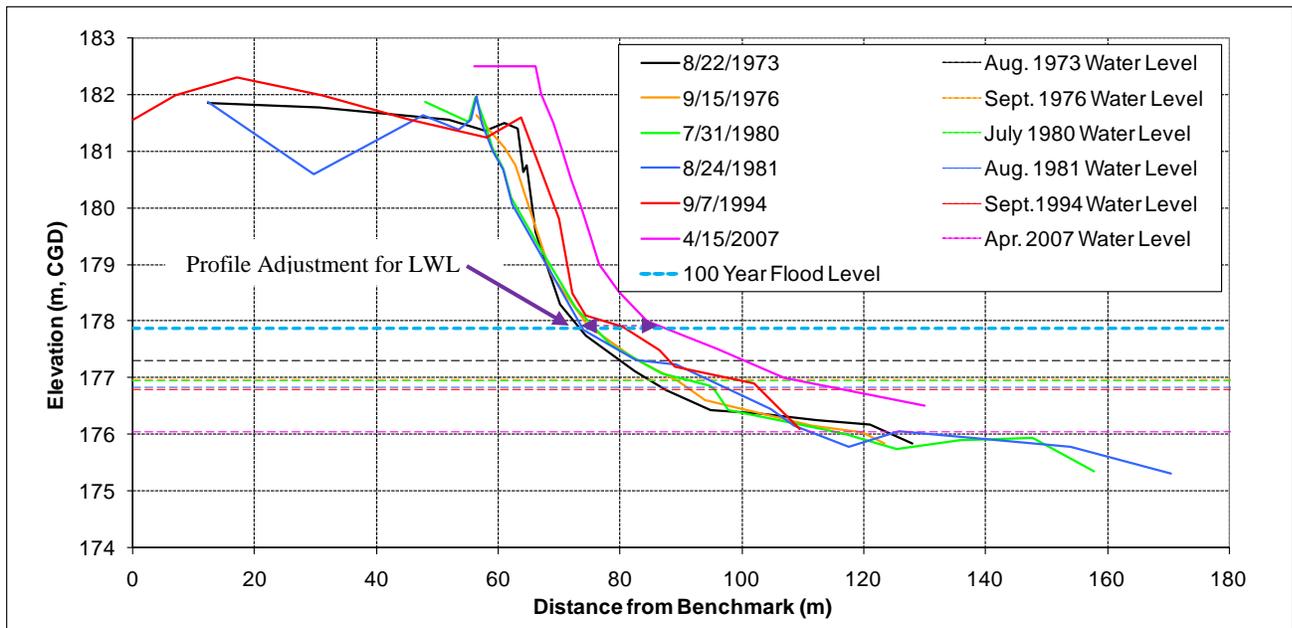
Profile data from six different years at beach monitoring station H-10-18 at Ipperwash Beach are shown in Figure 4.9. In each case, the beach profile and corresponding monthly mean water level are shown. The data from April 2007 was plotted from the 2007 topographic contours and orthoimagery used to delineate the hazard limits for this study. The 2007 profile is the furthest lakeward of the measurements and also corresponds to the lowest lake level (176.04 m CGD).

Figure 4.9 Monitoring Data from Profile H-10-18 Ipperwash Beach showing Profile Adjustment at Ipperwash Beach for Low Water Level

Hazard mapping is based on extreme conditions. The 100-year monthly mean high water level is 177.40 CGD at Ipperwash. This approximates the water levels that occurred during August 1973 (177.3 m CGD) and this profile was therefore used to quantify the profile adjustment made to the 2007 topographic contours and orthoimagery. From Figure 4.9, the profile adjustment at the 100-year flood level (177.88 m CGD) is 15 m. The 100-year flood level was therefore adjusted 15 m landward on the 2007 topographic contours at Ipperwash Beach (Reaches 36 to 38). This adjustment is reflected in the flood hazard limit and the dynamic beach hazard limit at these locations.

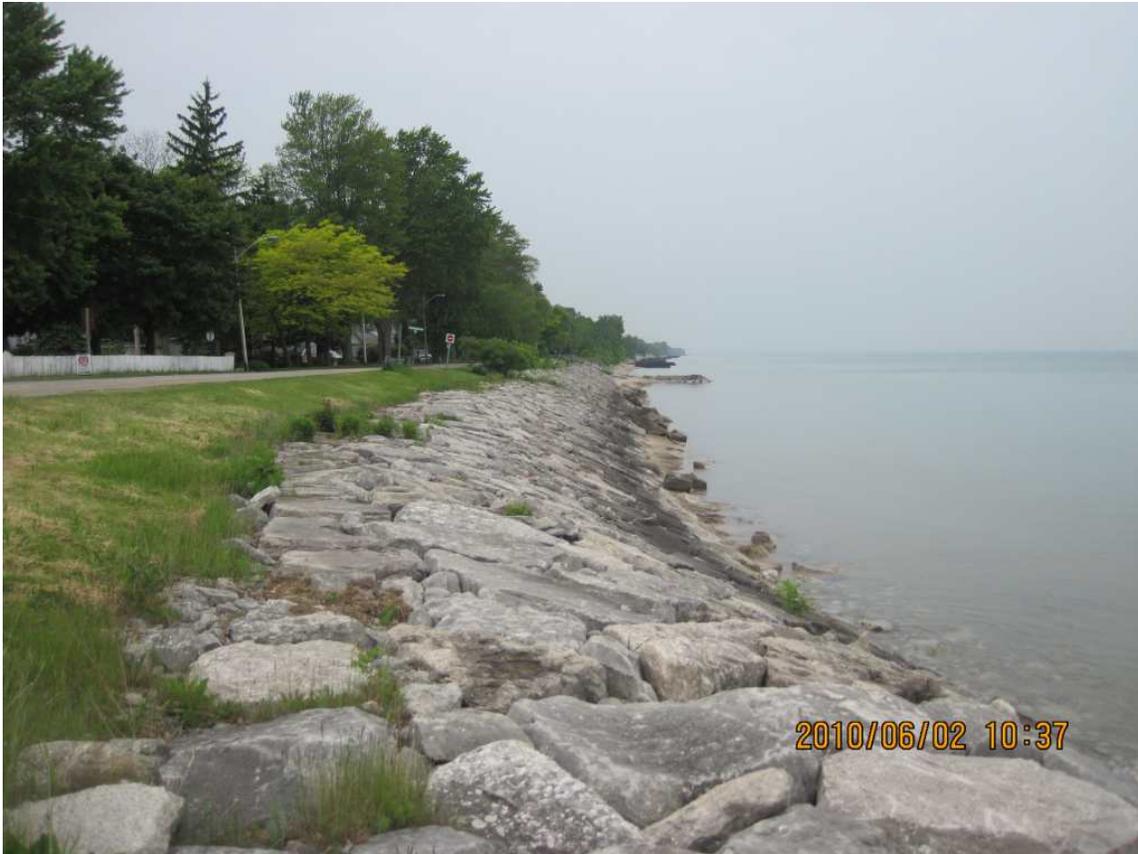
Figure 6.1 Armour Stone Revetment (Brights Grove; Site 26, Reach 11)

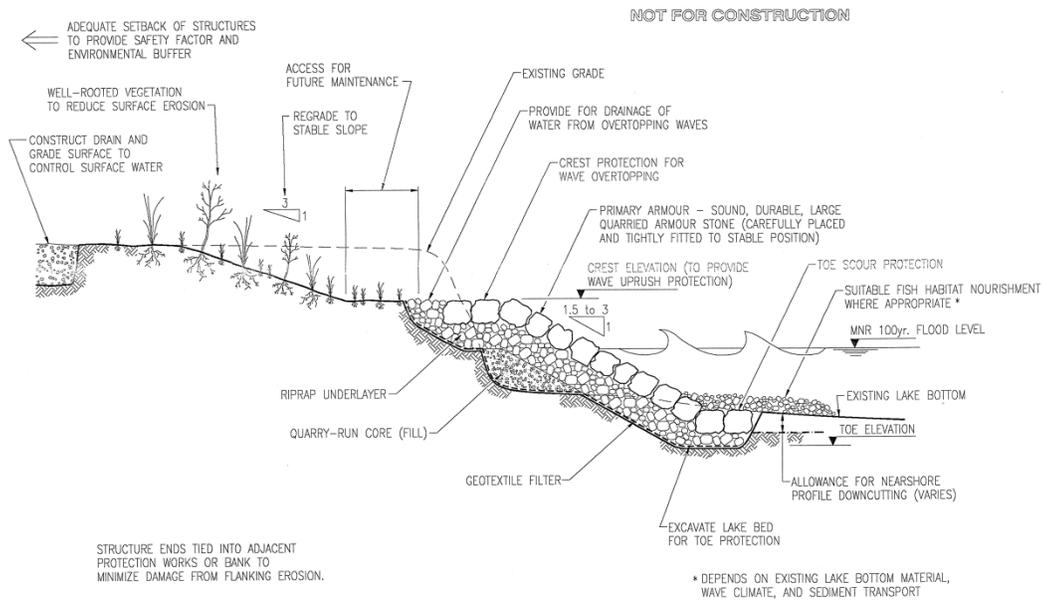
Other key design features for the armour stone revetment include: sound, good quality, durable armour stone with sufficient size to resist wave action and ice; sufficient crest elevation to protect against wave overtopping; riprap underlayer; and geotextile filter to prevent loss of backfill. The armour stone size is dependent on the wave height, the inclination of the revetment slope, number of stone layers and placement (i.e., degree of “interlocking”). Typically, the individual armour stones in an armour stone revetment have a mass of 3 to 5 tonnes for a single layer of armour; slightly smaller stones could be used with flatter slopes or double layers. A double layer of armour provides more “reserve capacity” (i.e., damage to a double layer armour revetment is more progressive than damage to a single layer). A qualified coastal engineer should design the revetment.

ARMOUR STONE REVETMENT DESIGN CONSIDERATIONS (NOT TO SCALE)

Figure 6.2 Armour Stone Revetment Design Considerations

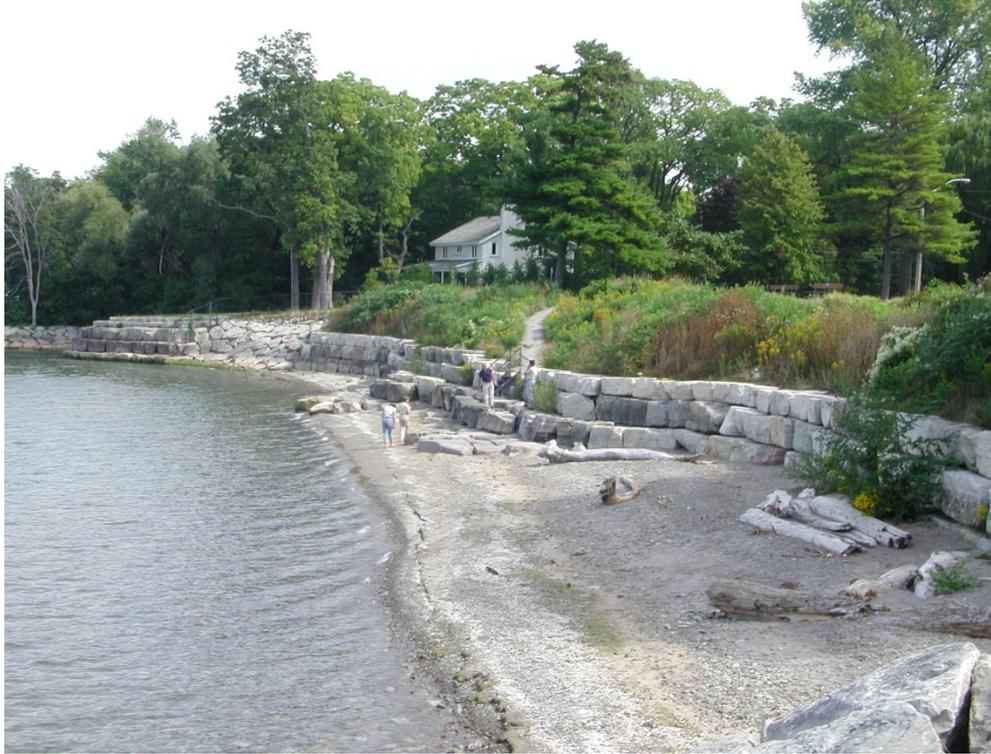
Seawalls are frequently used as shore protection and they may be constructed of cast-in-place concrete, stacked concrete, armourstone blocks or steel sheet piling. Figures 6.3, 6.4 and 6.5 show examples of stacked armour stone, steel sheet pile and concrete block walls respectively. Stacked stone and block walls must carefully consider the foundation conditions, as they are less flexible than revetments and more prone to collapse due to settlement and undermining. Vertical, impermeable walls (e.g., concrete and steel sheet pile) are generally not recommended due to concerns with wave reflection and scour. Vertical walls are rigid and have much less reserve strength (i.e., ability to withstand wave conditions exceeding the design wave) than armour revetments. Gabion baskets often have a limited life span when used on exposed shorelines and are generally not recommended for use on the open lake.

Figure 6.3 Example of a Stacked Armourstone Wall Outside of Study Area

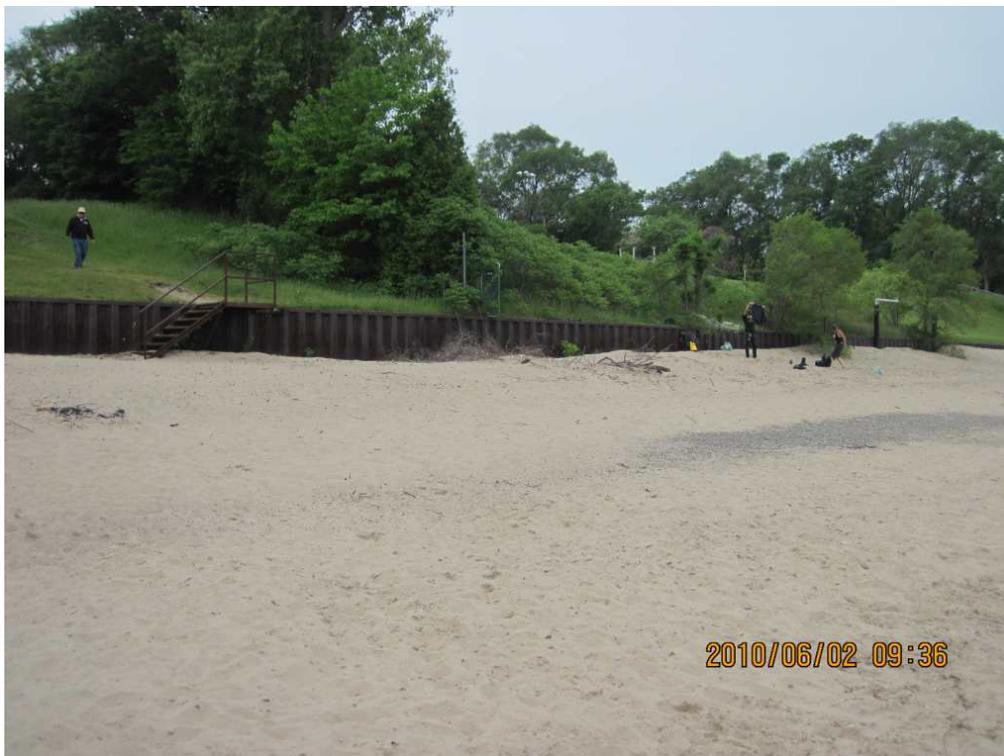
Figure 6.4 Steel Sheet Pile Wall (Blackwell Sideroad; Site 23, Reach 6)

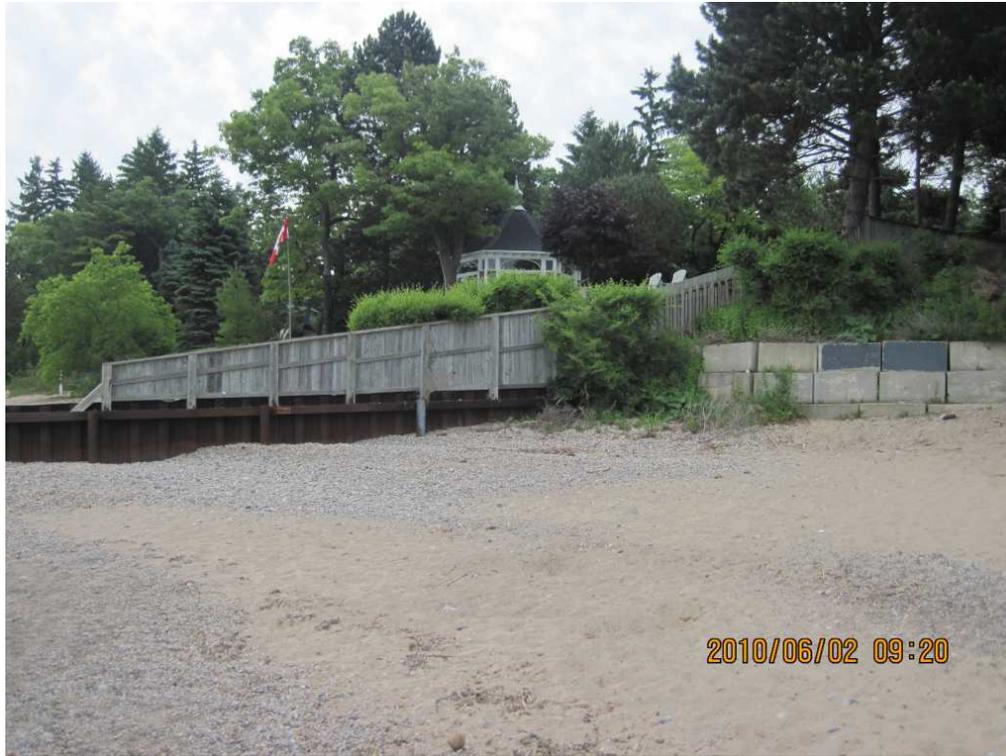
Figure 6.5 Concrete Block Wall (Modeland Rd.; Site 22, Reach 6)

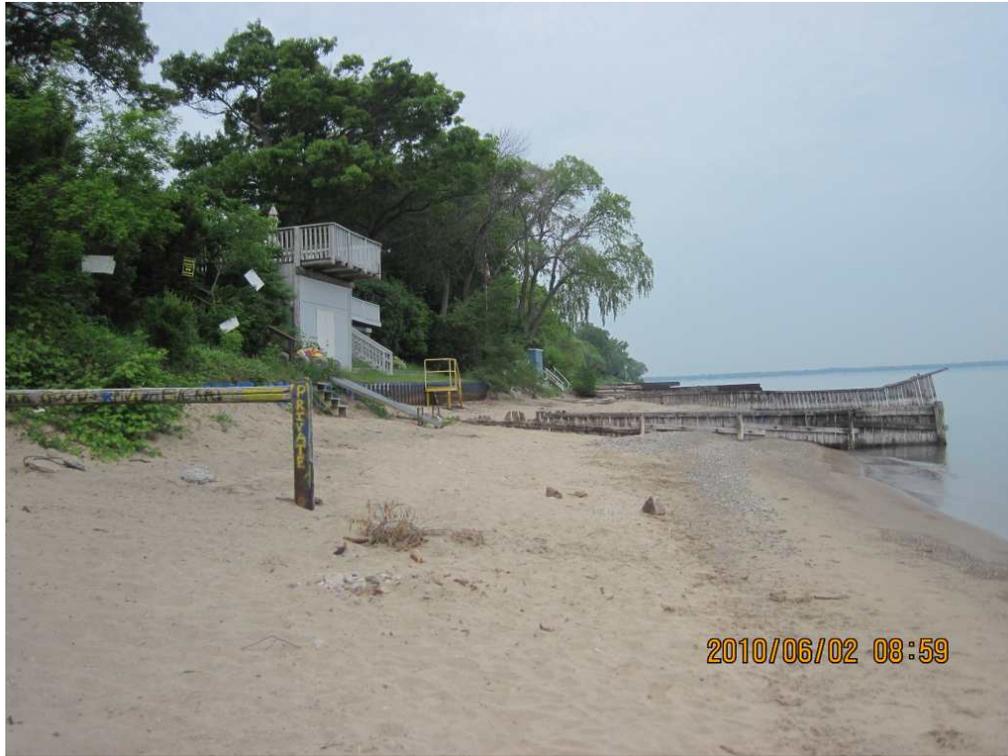
Figure 6.6 Timber Groynes with Steel Sheetpile Along Backshore (Murphy Rd., Site 21, Reach 4)

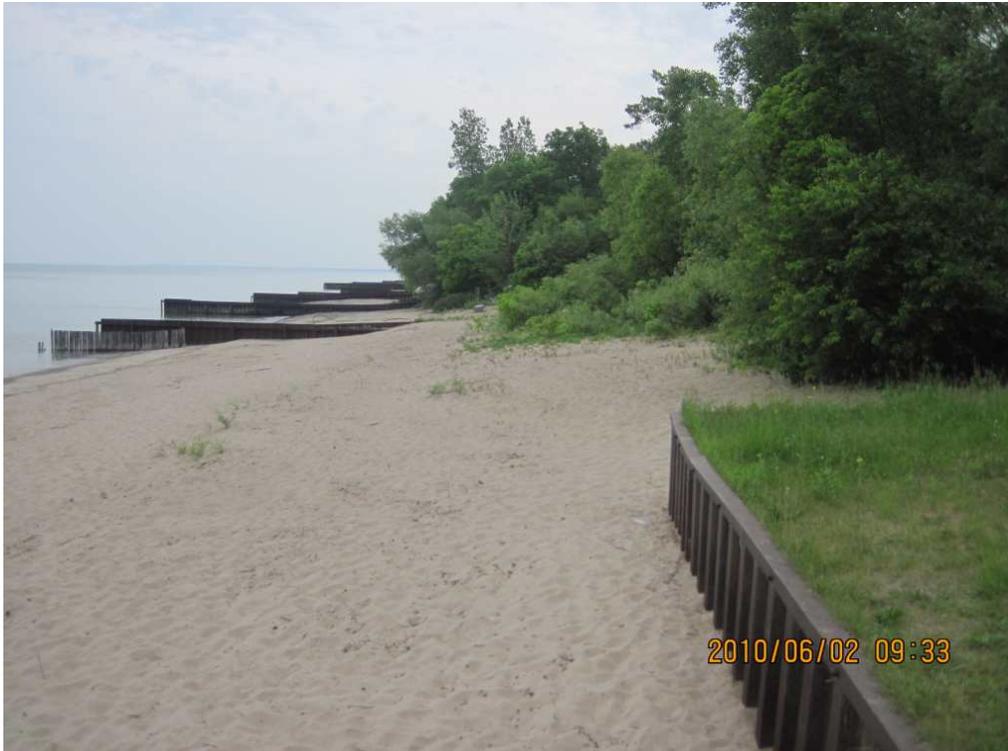
Figure 6.7 Steel Sheetpile Groynes (Blackwell Sideroad, Site 23, Reach 6)

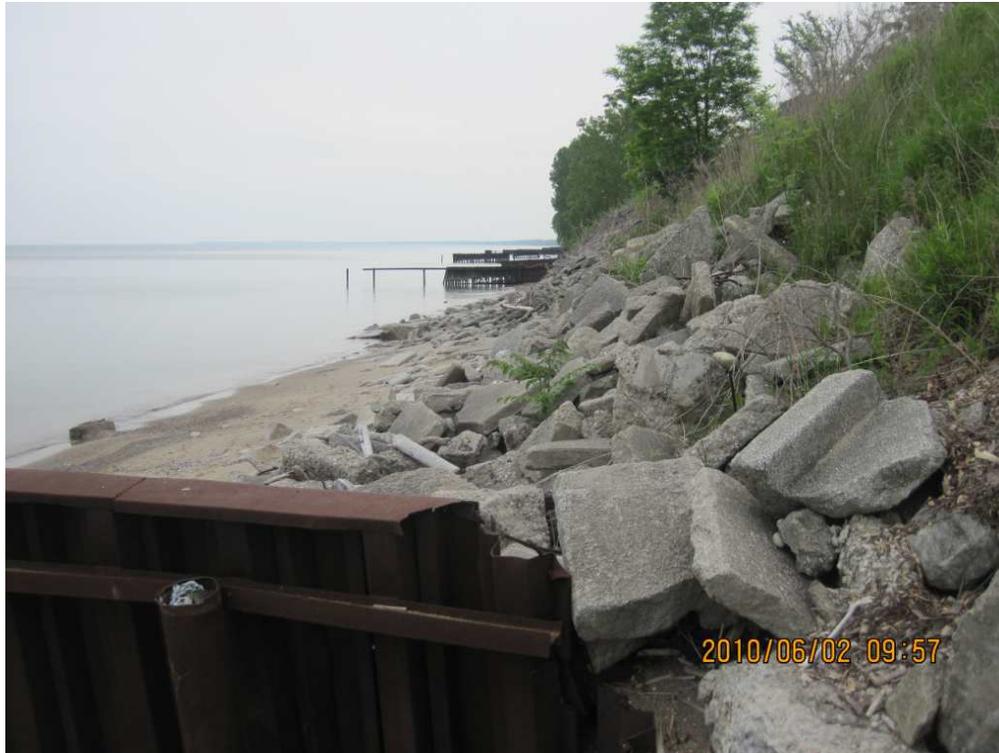
Figure 6.8 Steel Sheetpile Groynes with Rubble Bank Protection (Old Lakeshore Rd., Site 24, Reach 7)

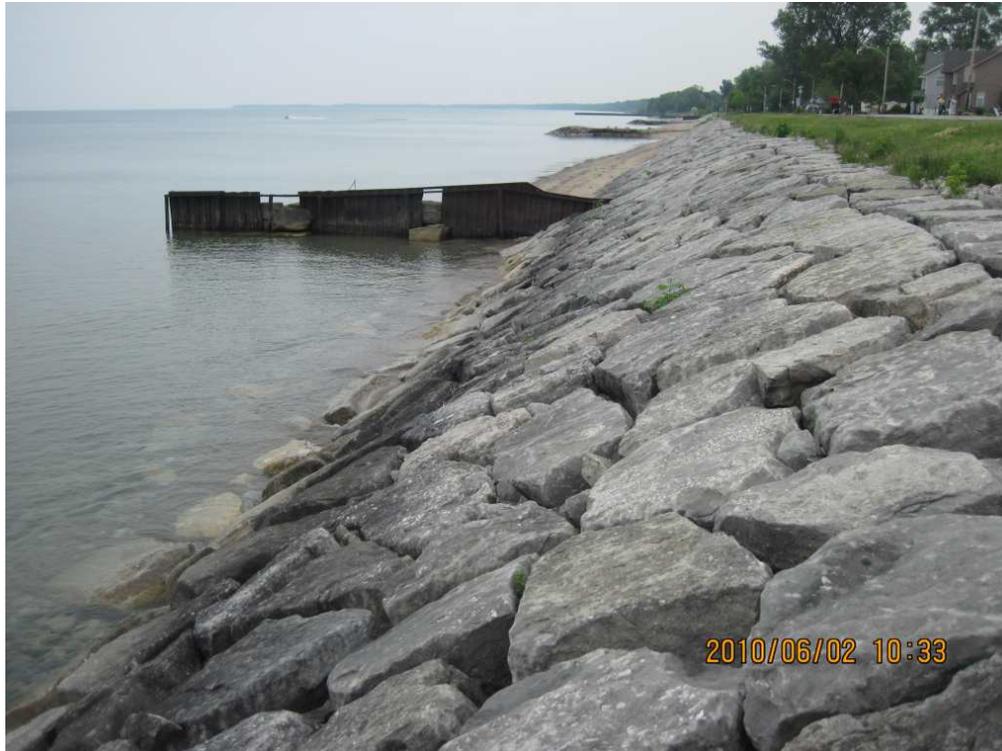
Figure 6.9 Steel Sheetpile Groynes with Armourstone Revetment (Brights Grove, Site 26, Reach 11)

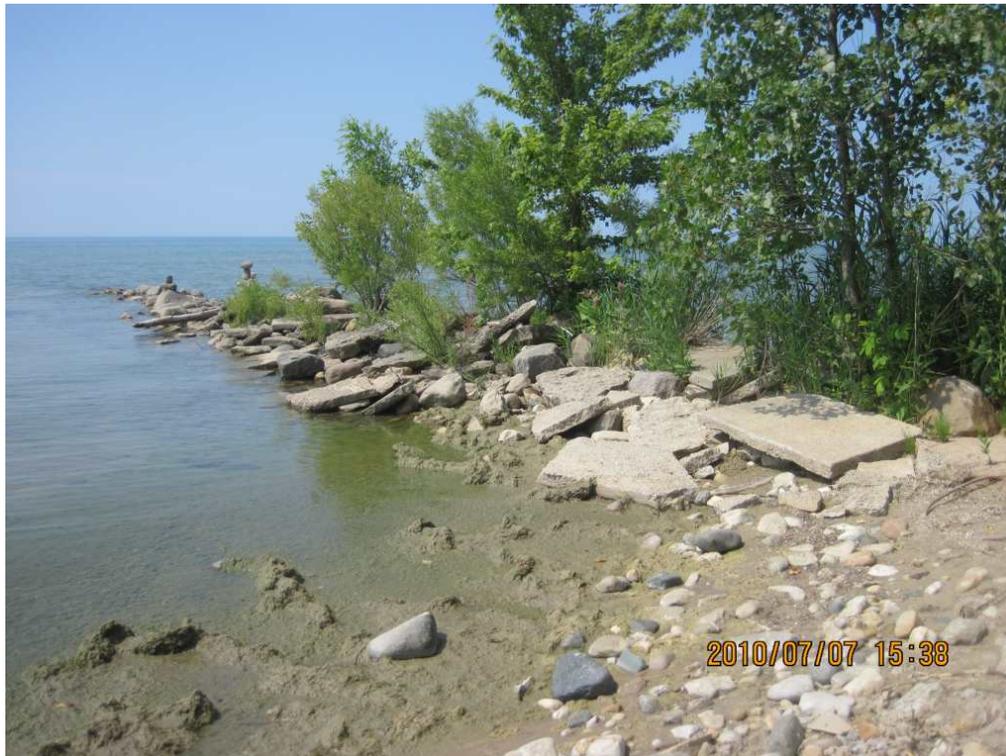
Within the study area, there are extensive examples of ad hoc protection consisting of dumped stone and concrete rubble, inverted concrete pipes and miscellaneous other materials. Figures 6.10 and 6.11 respectively, provide examples of ad hoc structures consisting of a groyne made from scrap concrete and rip rap dumped along the shoreline. Ad hoc structures are often ineffective in the longer term due to limited or no toe embedment (i.e., lack of consideration of nearshore downcutting), lack of geotextile filters, insufficient crest height to protect against wave overtopping, and poor quality materials.

Figure 6.10 Ad Hoc Protection (Concrete Rubble Groyne at Hilltop Rd.; Site 35 , Reach 29)
