Lake Huron Shoreline Management Plan Update - 2011

St. Clair Region Conservation Authority

December 5, 2011

W.F. Baird & Associates Coastal Engineers Ltd.

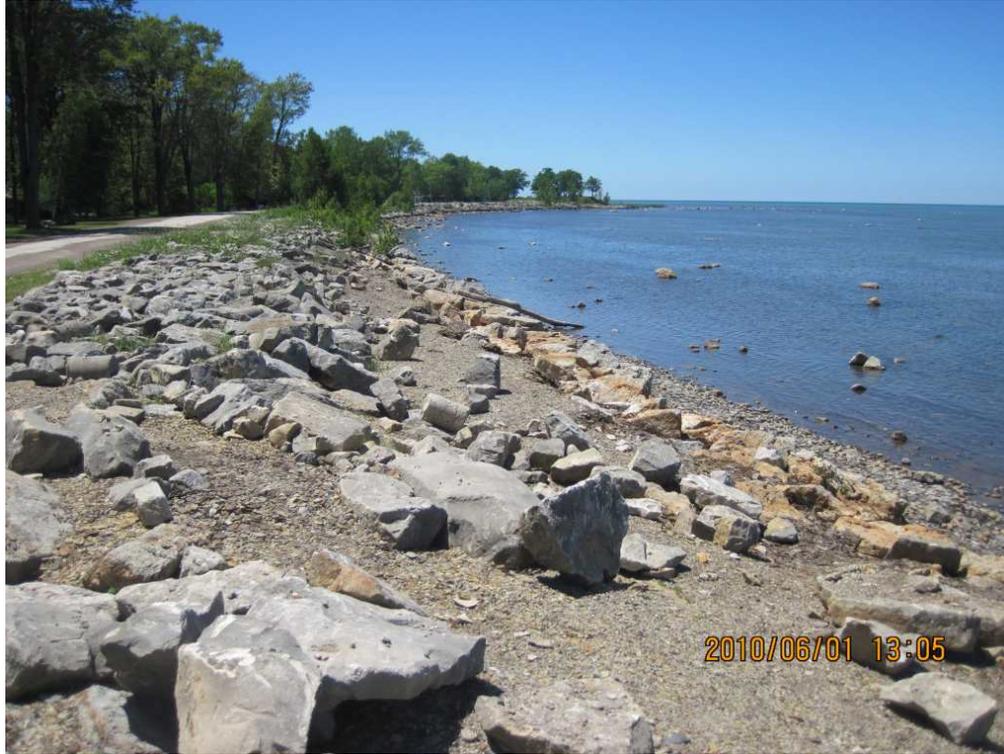
Figure 6.11 Ad Hoc Protection (Riprap Protecting Road at Kettle Point)

Within the study area, there are extensive examples of ad hoc protection consisting of dumped stone and concrete rubble, inverted concrete pipes and miscellaneous other materials. Figures 6.10 and 6.11 respectively, provide examples of ad hoc structures consisting of a groyne made from scrap concrete and rip rap dumped along the shoreline. Ad hoc structures are often ineffective in the longer term due to limited or no toe embedment (i.e., lack of consideration of nearshore downcutting), lack of geotextile filters, insufficient crest height to protect against wave overtopping, and poor quality materials.

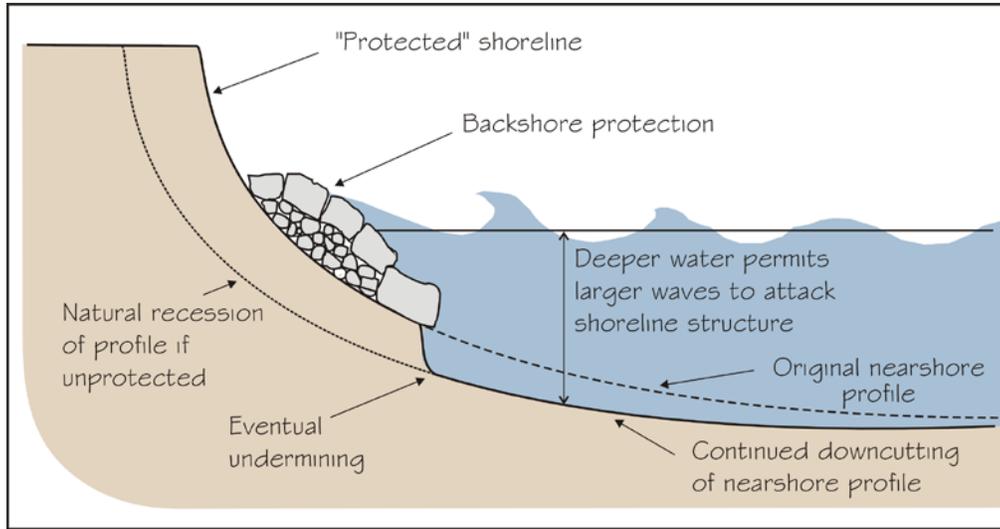
As described in the 1996 SMP and Reinders (1989), sections of the study shoreline feature cohesive or consolidated glacial sediment. As such, the controlling process for erosion of the shore is the permanent downcutting of the lakebed, which has significant implications for the design and lifespan of the shoreline protection. Specifically, downcutting of the nearshore lake bottom in front of a shoreline protection structure will eventually result in undermining of the structure leading to damage and perhaps failure of the structure as shown in Figure 6.12. In addition, this process will result in deeper water in front of the structure, thus allowing larger waves to attack the structure. For shore protection to be effective over the medium to long term, the design must consider the future downcutting of the lake bottom, and the larger waves, which will ultimately attack the structure.

Figure 6.12 Future Undermining of Structure Due to Downcutting

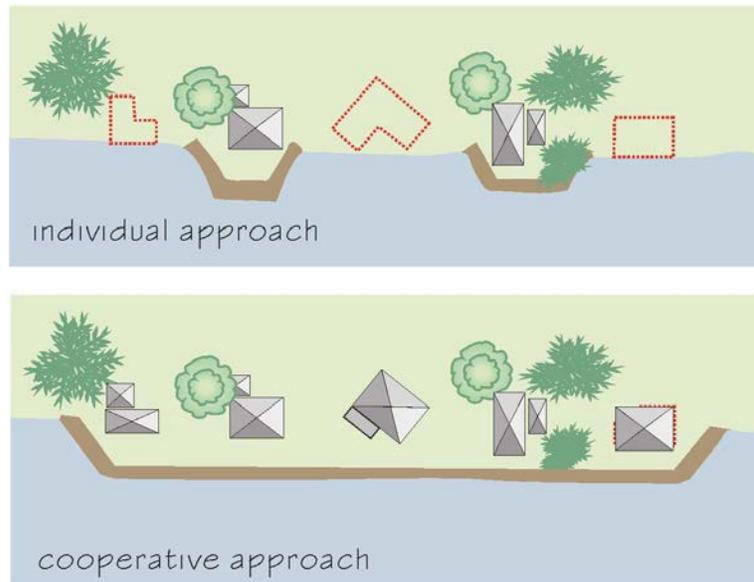
The importance of coordinated, cooperative protection (see Figure 6. 13) was described in Baird (1991); individual efforts are often outflanked, reducing the effectiveness and design life of the protection. This is particularly important in areas of high erosion such as Blue Point.

Figure 6.13 Cooperative Protection

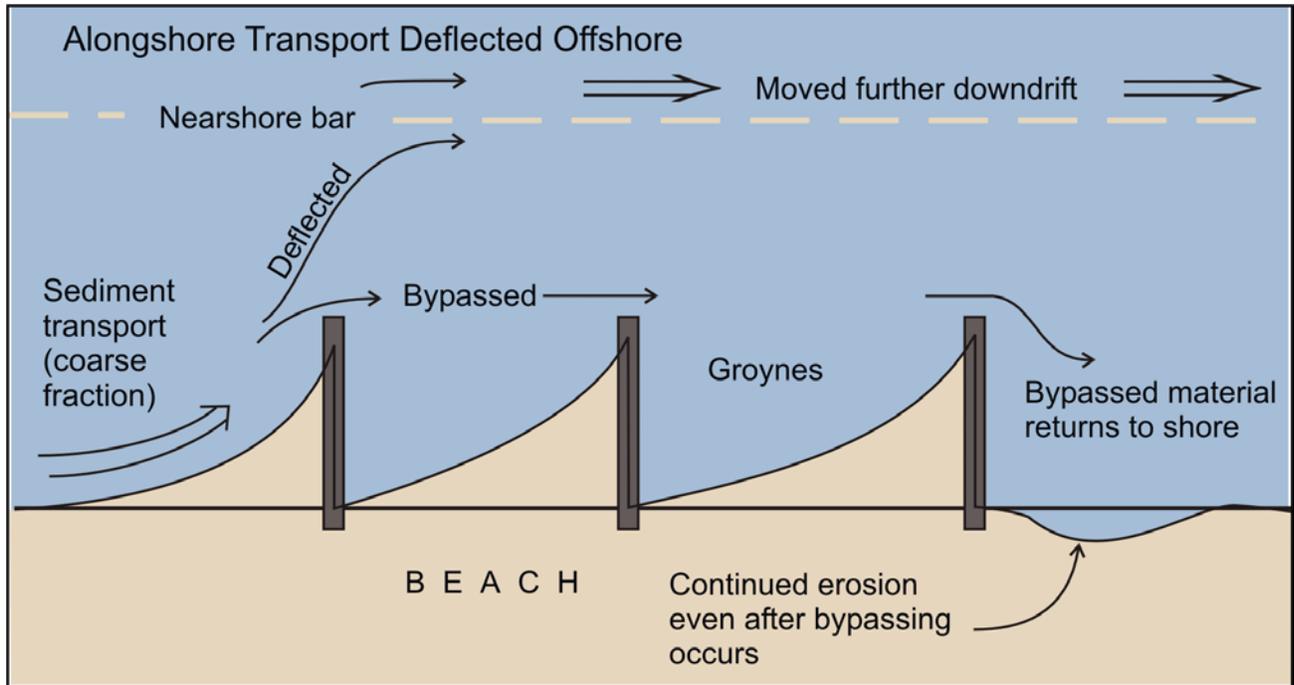
Structures that extend into the nearshore have the potential to trap sediment on the updrift side as well as divert or deflect sediment offshore, resulting in possible downdrift erosion (see Figure 6.14).

Figure 6.14 Potential Impacts of Groynes
