West Ipperwash Dynamic Beach Assessment

St. Clair Region Conservation Authority

W.F. Baird & Associates Coastal Engineers Ltd.

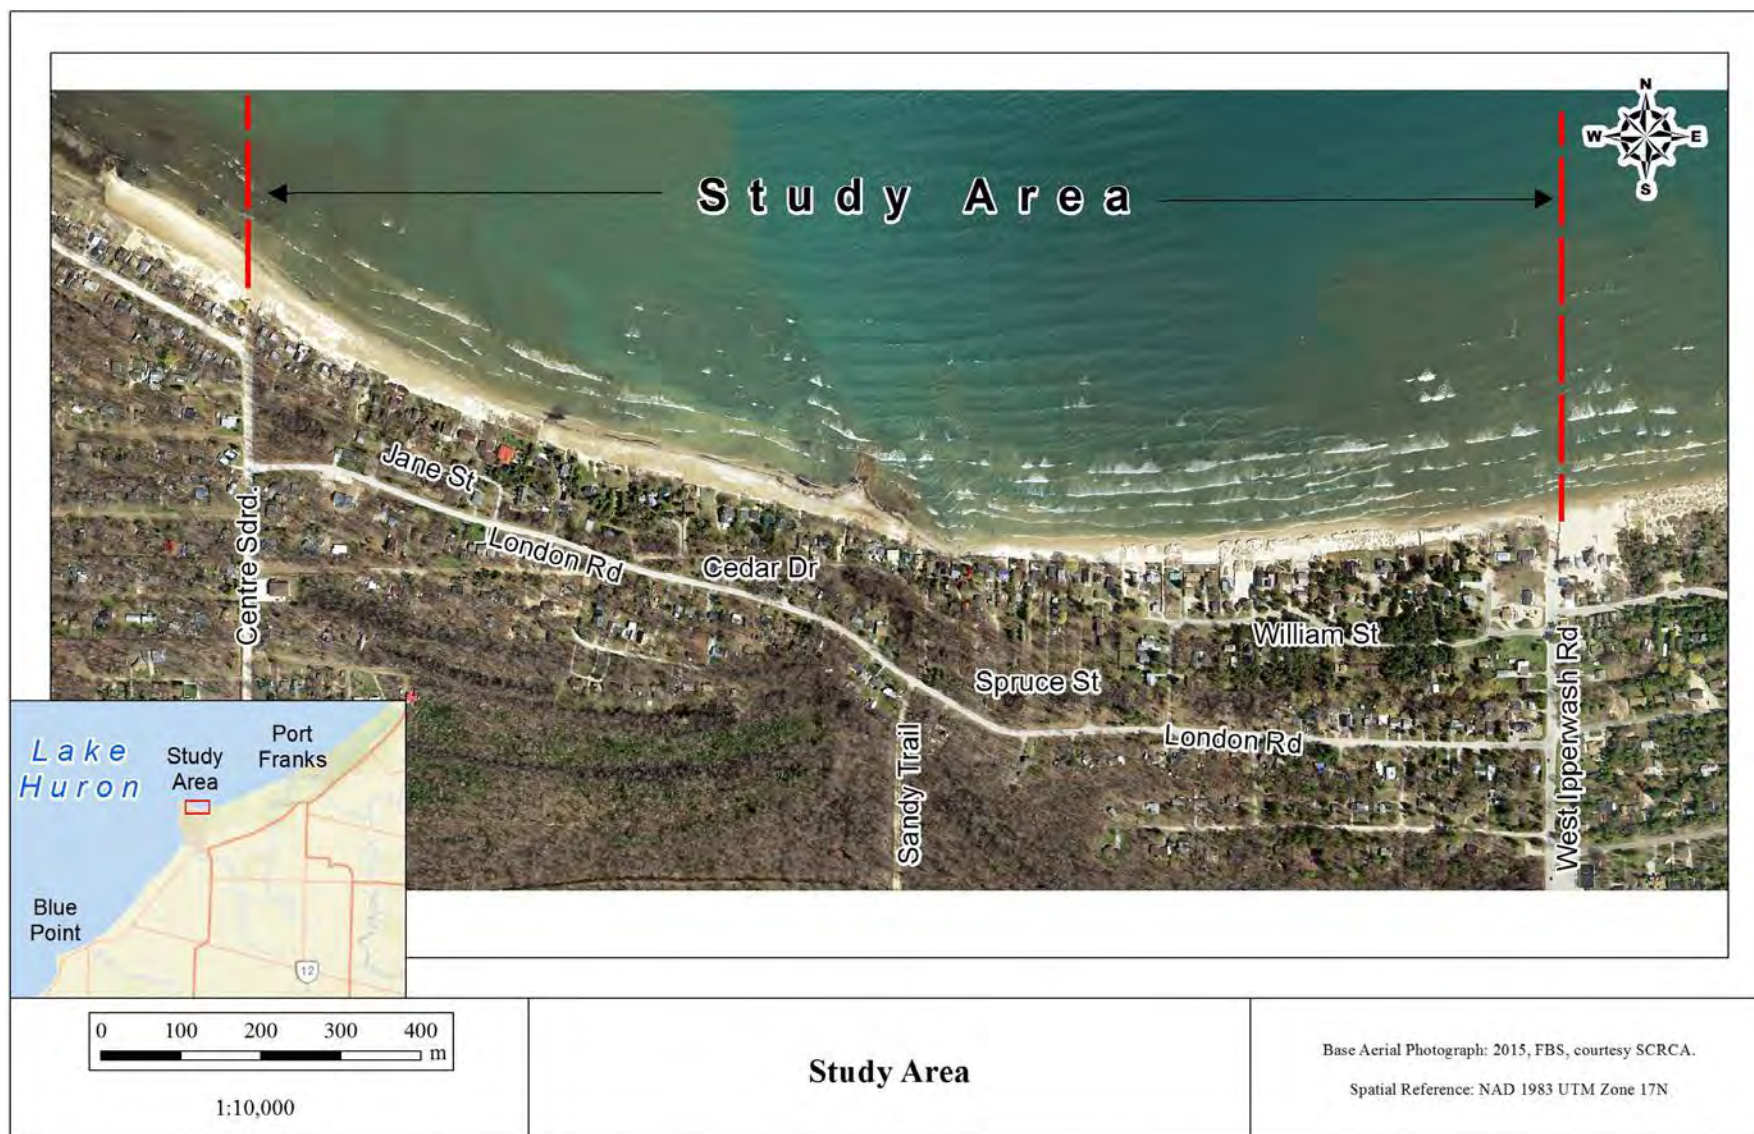
Figure 1.1 Site Location

This report provides an assessment of the dynamic beach hazard limit for West Ipperwash Beach, between Centre Sideroad and West Ipperwash Road in Lambton Shores, Lambton County. The site is located on the east shore of Lake Huron as shown in Figure 1.1.

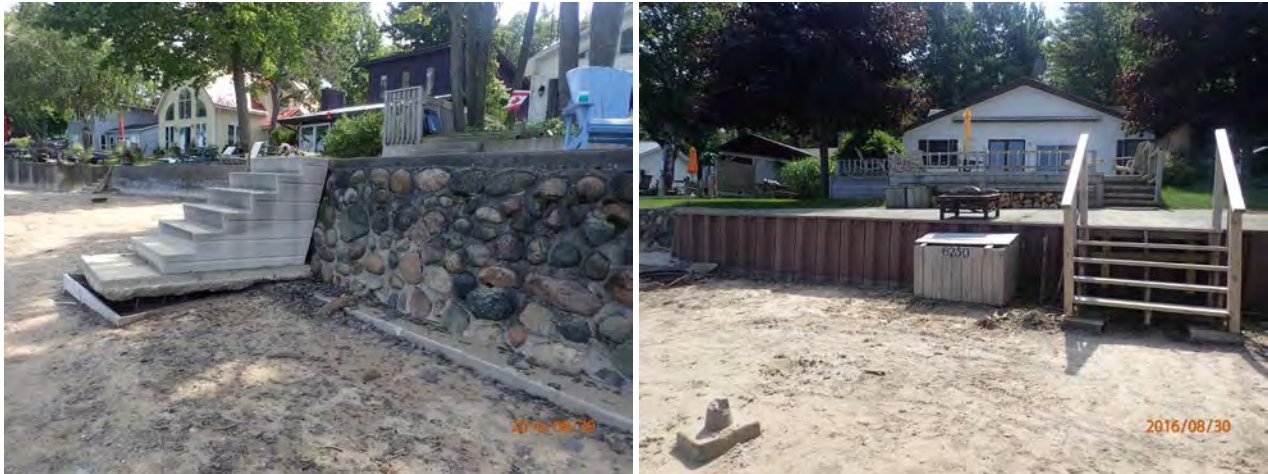
Figure 6.1 Examples of Stone and Concrete Seawall and Steel Sheet Pile Seawall in the Study Area

Seawalls have been constructed along much of the shoreline of West Ipperwash Beach. The seawalls are generally constructed of stone, concrete or steel sheet pile; examples are shown in Figure 6.1.

Some of the most common mechanisms for seawall failure include: overtopping and scour of the backfill, scour and undermining at the toe of the seawall, and flanking around the ends of the seawall when the adjacent property is not adequately protected.

In general, seawalls are not recommended on dynamic beaches. A beach offers natural protection against flood and erosion damage. Dunes absorb wave energy during large storms, protecting inland areas. They also provide a reservoir of sand to replace beach material that is carried offshore during a storm. The construction of seawalls prevents the beach from behaving dynamically. Seawalls restrict the natural beach response. When seawalls are constructed on the dynamic beach, wave reflection and scour occur when the wall is exposed to wave action. This may lead to ultimate failure of the wall and a reduction in beach width.

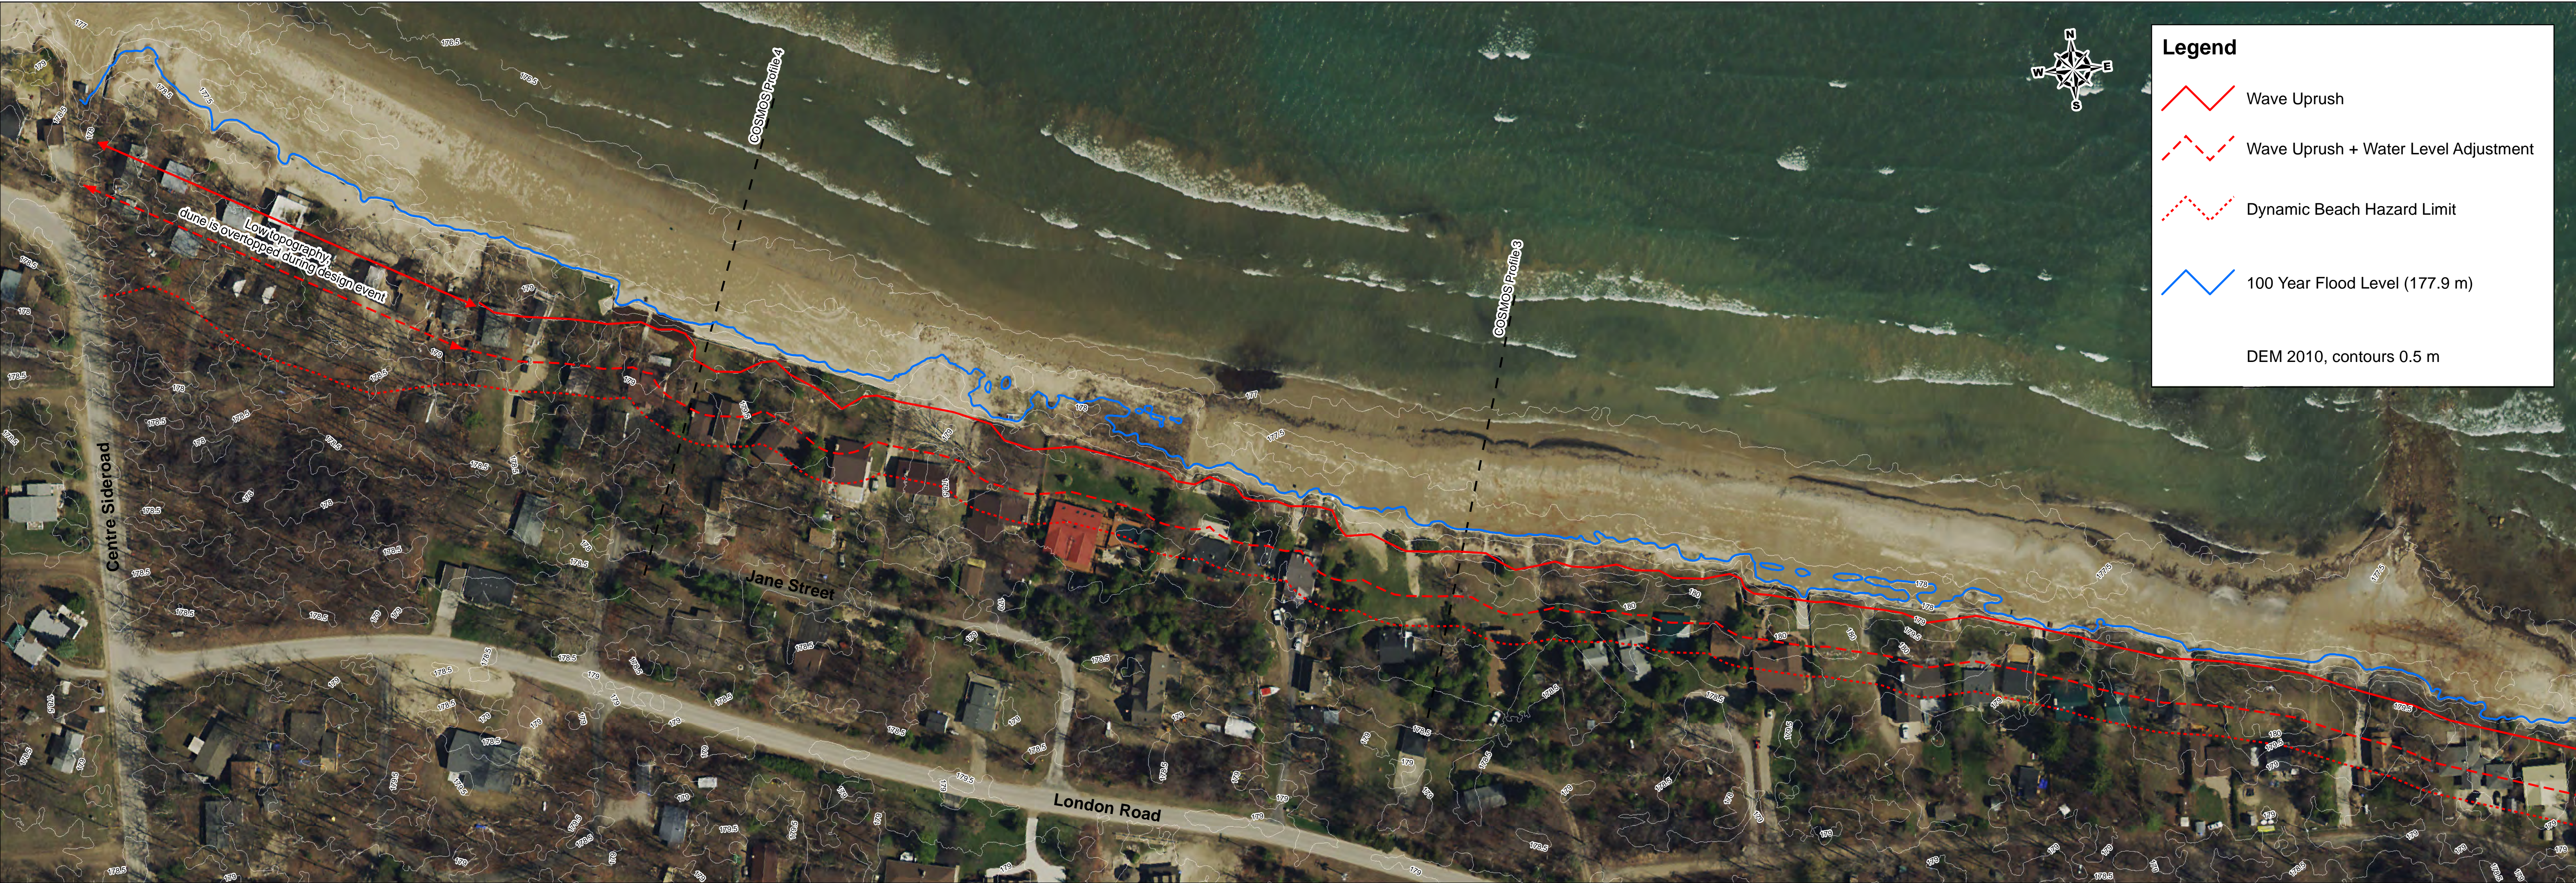
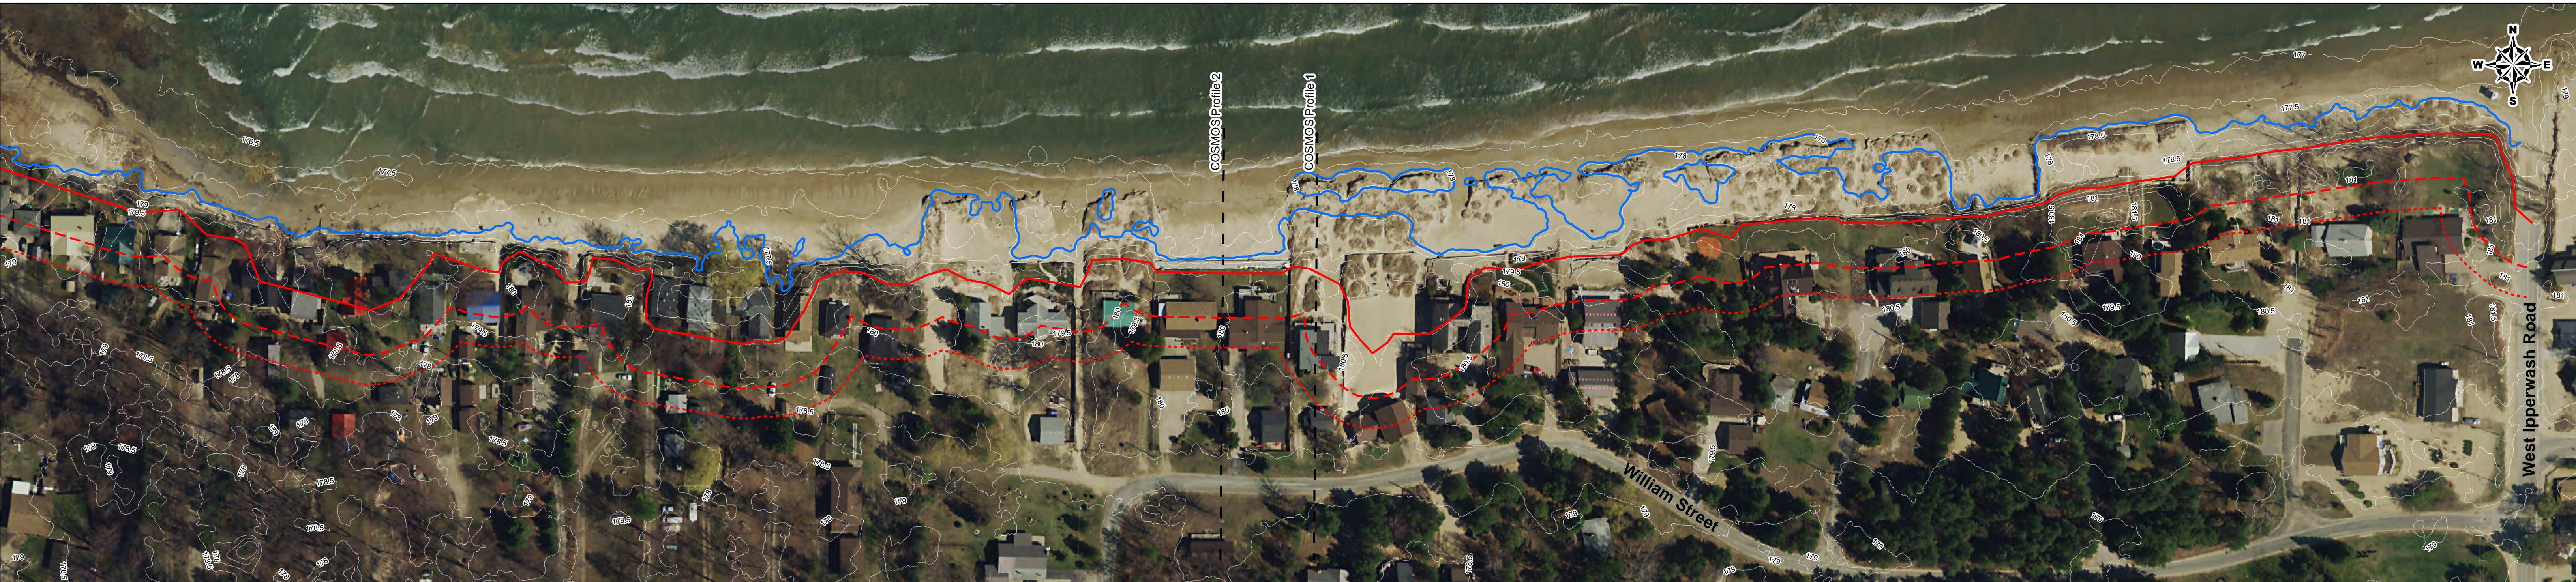
RECOMMENDED DYNAMIC BEACH HAZARD LIMIT MAPPING

At the west end of the study area, near Centre Sideroad, elevations are below the wave uprush elevation. The setback defined in the 2011 Shoreline Management Plan Update (Baird, 2011) is recommended in this area, as shown on the mapping in Appendix D. Additional measures may be required to address the flood hazard.

The recommended dynamic beach hazard limit is plotted in Appendix D.

2. The recommended dynamic beach hazard limit is plotted in Appendix D. The beach profile modeling supports an adjustment approximately 0 to 30 metres lakeward (dependent on location), to the dynamic beach hazard limit recommended in the Lake Huron Shoreline Management Plan Update - 2011.
