# A GREEN INFRASTRUCTURE CASE STUDY

On-farm green infrastructure to reduce sediment  
accumulation in Municipal Drain

## Case Study: On-farm Green Infrastructure to reduce sediment accumulation in Municipal Drain

**Drain:** McFadyen Drain

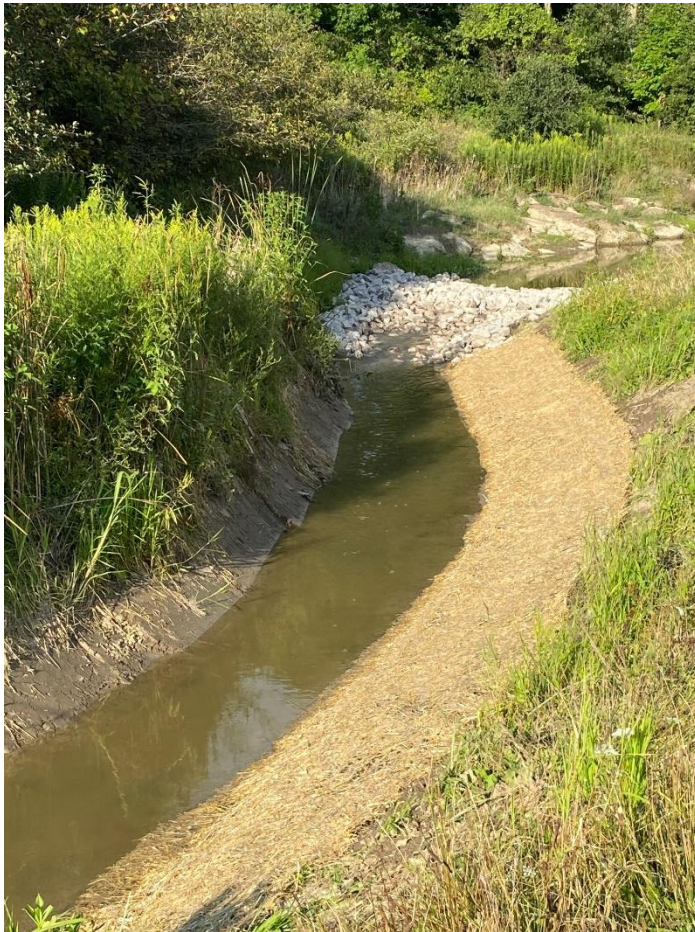
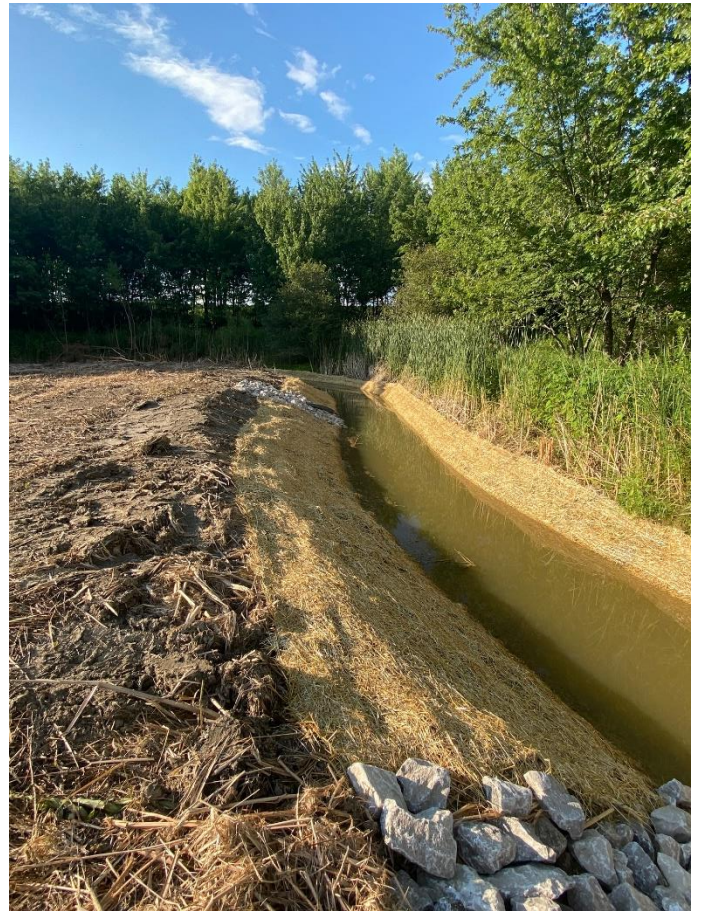
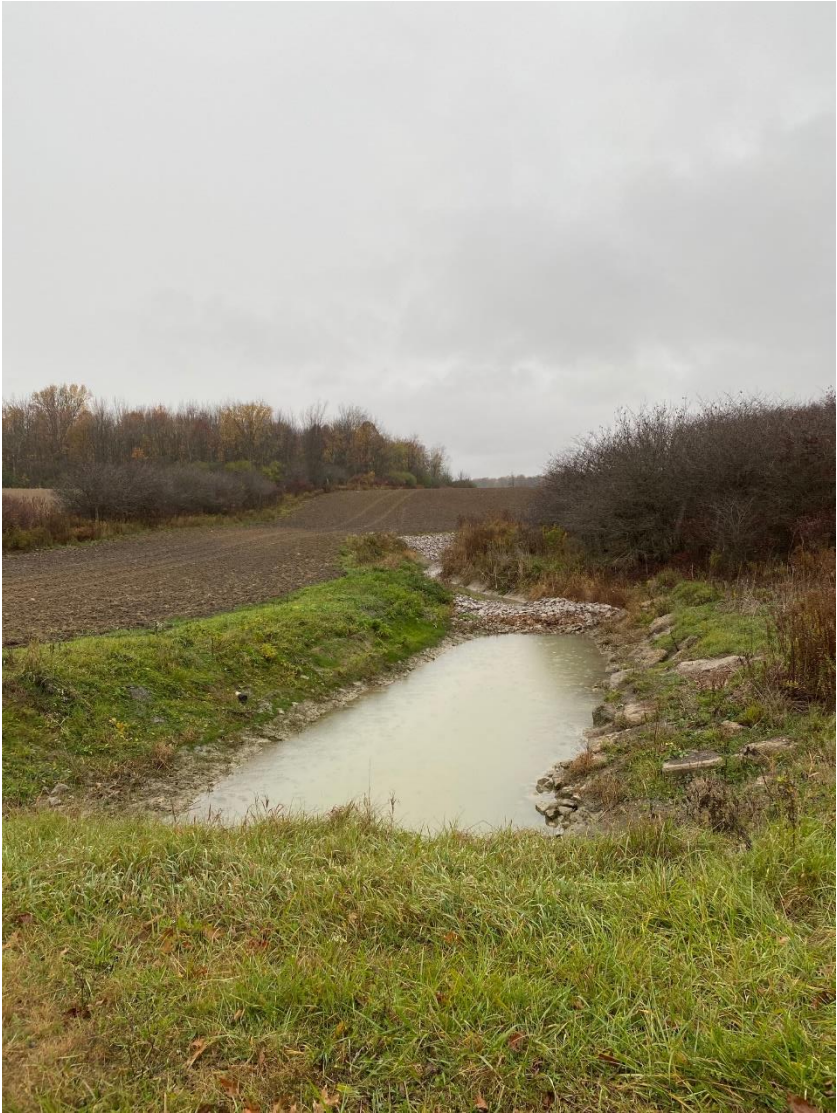
**Photos:**

**Best Management Practice:** One sediment trap complete with rock check dam, 8 rock chutes and erosion control matting.

**Sediment trap with rock check dam:** rock check dam designed as per specifications in the Department of Fisheries and Oceans Guidance for Maintaining and Repairing Municipal Drains in Ontario, the rock check dam is designed to slow water down as it moves downstream in order to protect the natural meanders. The sediment trap is designed to filter out and hold the fine sediments as it moves through the check dam. These two features work together to reduce erosion and sediment movement downstream.

**Rock chutes:** Build rock chutes at 8 locations along the drain within the side slope. The rock chutes will provide additional support to the drain banks by slowing overland flow entering the drain through low runs and reducing the sediment entering the system.
