Green Infrastructure in Rural Drainage

Case Study: DeCow Drain

Municipality: Municipality of Chatham-Kent

Objective: Reduce erosion along a steep portion of the drain.

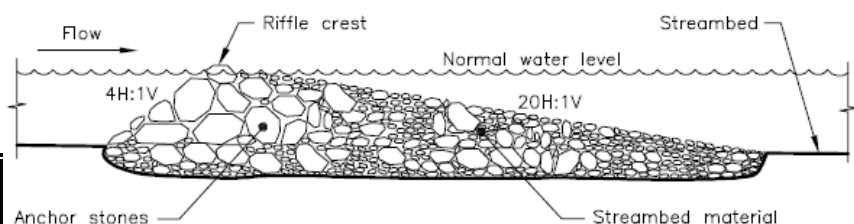
There was significant fall in this short section of drain and increased flow from a recent field tile installation that was causing a pit to form. By creating riffle pool structures, the water was slowed down, protecting the channel from erosion with the added benefits of giving sediment time to settle out and creating habitat. The project included the installation of a rock chute where overland flow entered the drain and 3 riffle structures in series along the steepest part of the watercourse. These riffles were constructed following Ontario Provincial Standard Drawing OPSD 222.050 for riffles on streambeds (diagram on the right).

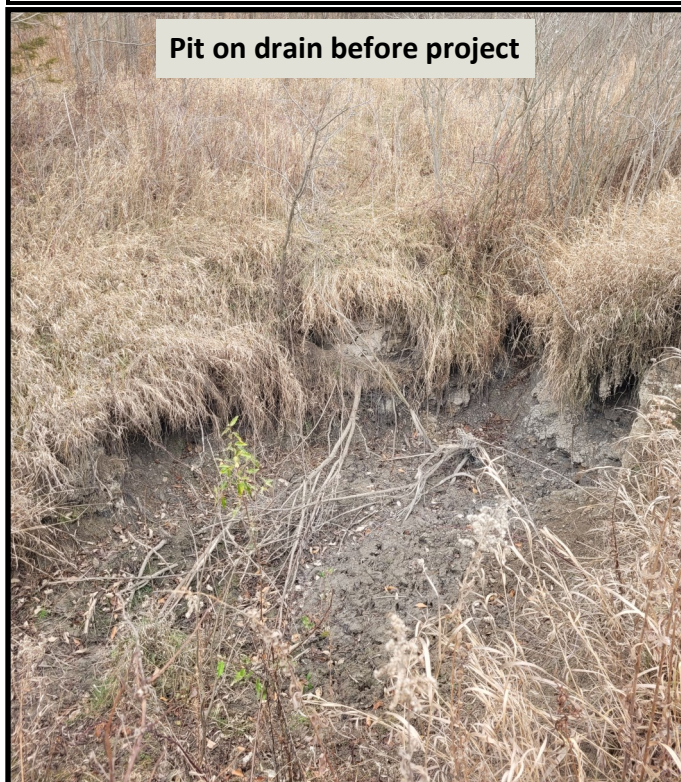
Pit on drain before project

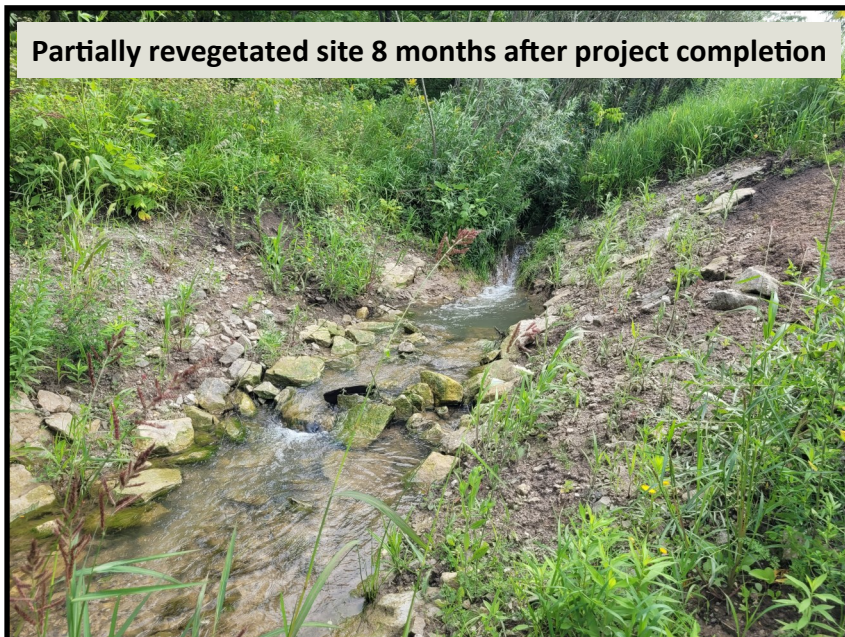
Partially revegetated site 8 months after project completion
