Board of Directors - Notice of Meeting

April 18, 2024

**Potential Removal of the Coldstream Dam
St. Clair Region Conservation Authority**

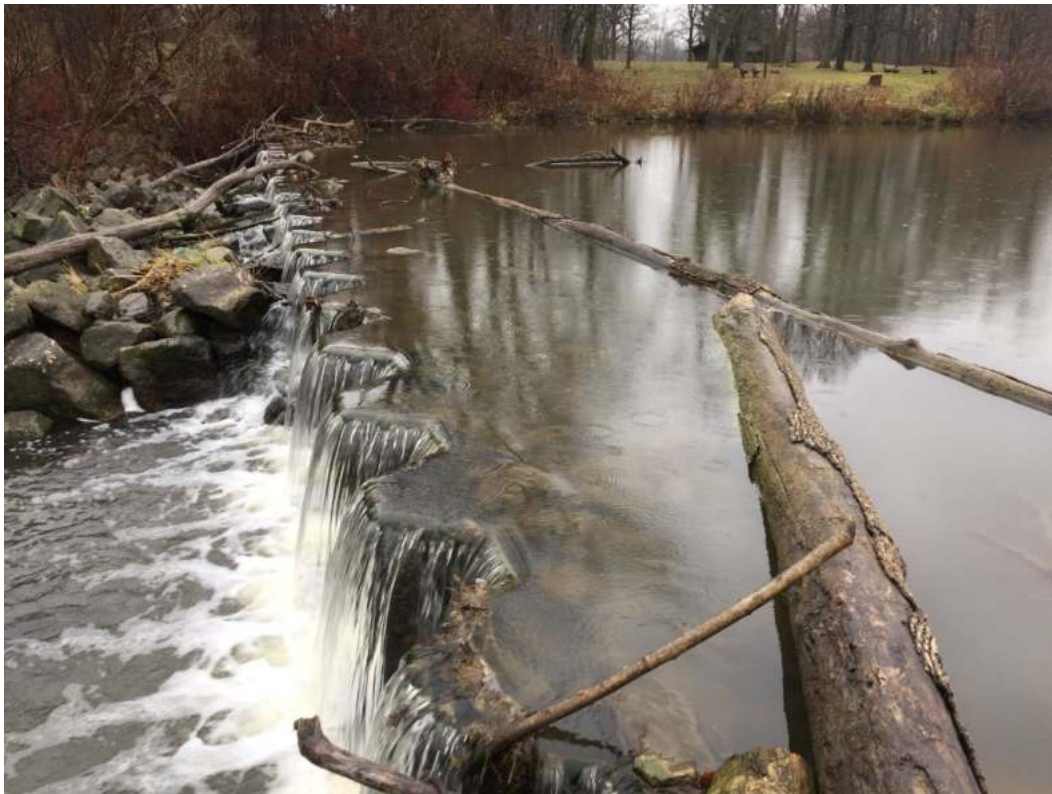
The downstream side of the sheet piling is protected by large armour stone (ranging in size from 16 inches to 24 inches in diameter) on a slope of approximately 3:1 horizontal to vertical. The armour stone provides protection to the soil material below the sheet pile wall from erosion. The sheet pile portion of the dam is approximately 45 m wide. The adjacent earthen berm portion of the dam (south of sheet pile dam portion) is approximately 40 m long.

Photo 1: Coldstream dam constructed of vertical sheet piling and downstream armour stone.

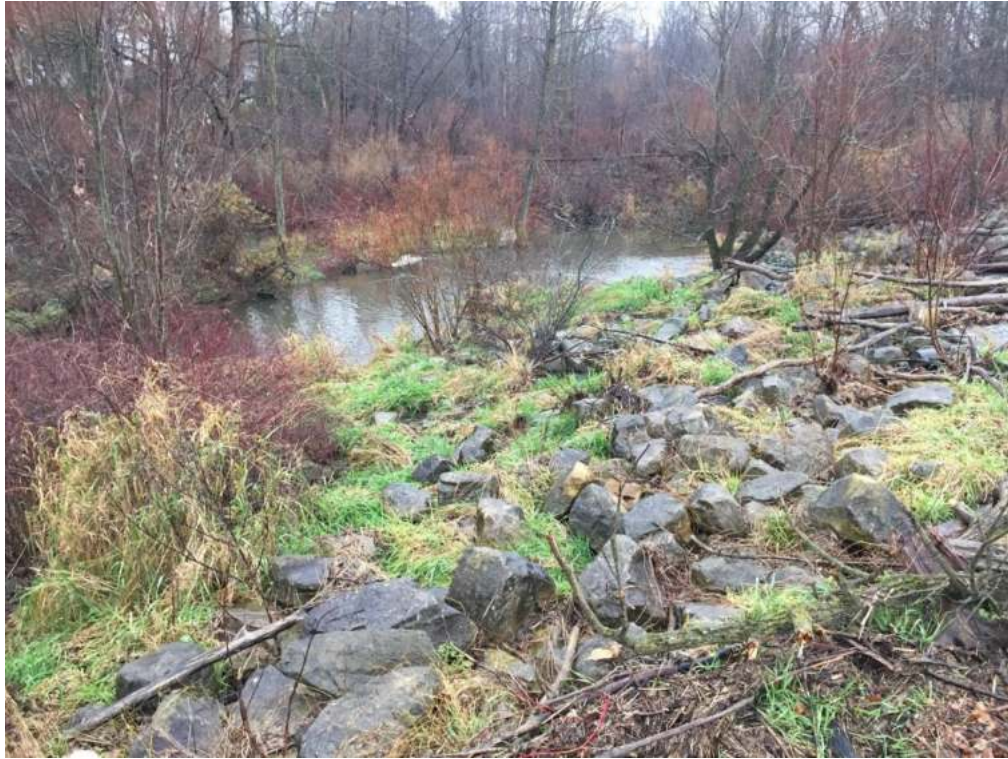
Photo 2: Large sloping armour stone placement on downstream side of sheet pile dam. Sydenham River downstream of dam visible in background.

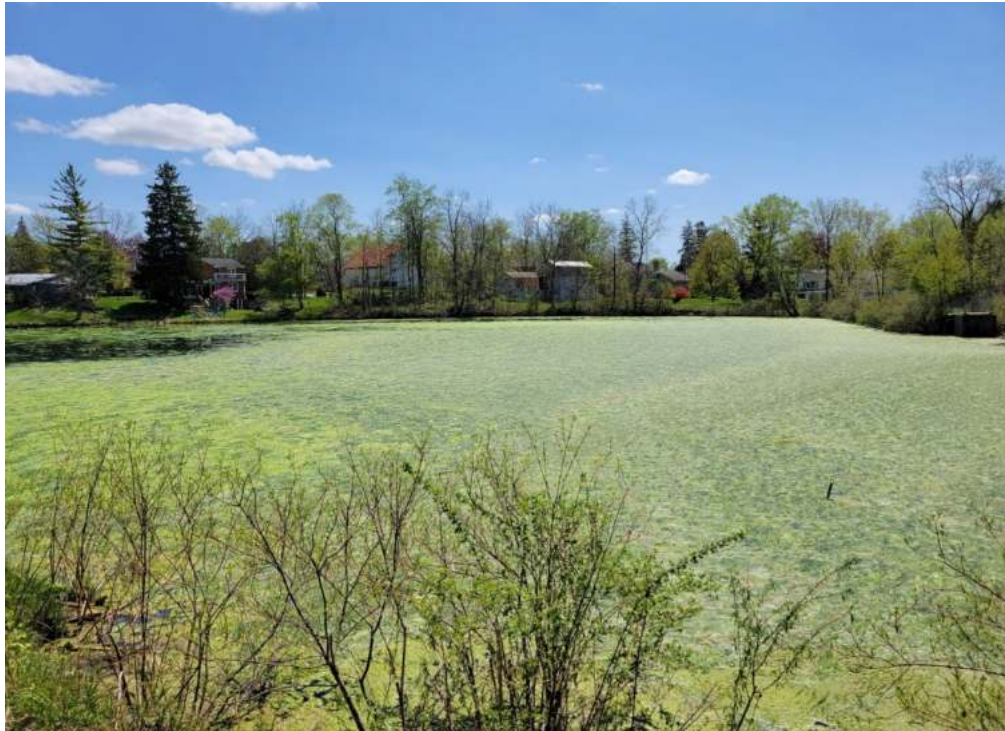
Photo 3: Algal bloom in the Coldstream dam head pond in May 2022. View to the southwest to the dam area from the Coldstream Conservation Area on the northwest shore. (SCRCA photo.)

As such, the dam is likely causing warming of the river water downstream of the dam as well as warmer temperatures in the head pond. As sediment accumulates behind the dam the reservoir has become shallower, leading to quicker warming of water and likely contributes to algal blooms during the open water period. Excess nutrient loading from upstream sources, including agriculture, may also contribute to algae blooms.

The following photos (**Photo 3** and **Photo 4**) depict unusually heavy algae blooms in the Coldstream dam head pond in May, 2022.

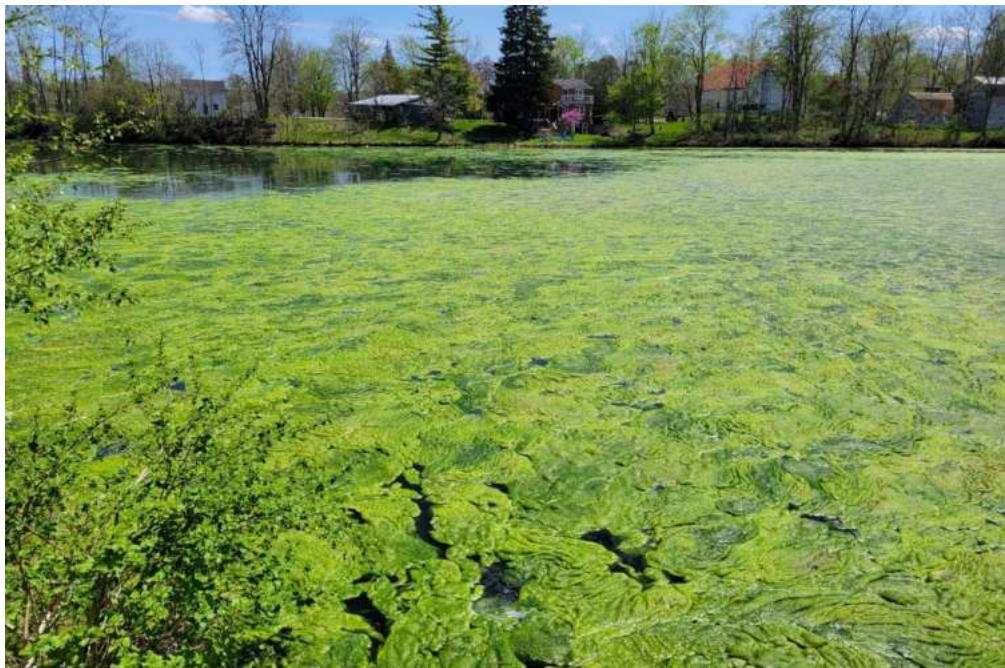
Photo 4: Algal bloom in the Coldstream dam head pond in May 2022. View to the east toward Ilderton Road from the Coldstream Conservation Area on the northwest shore. (SCRCA photo.)

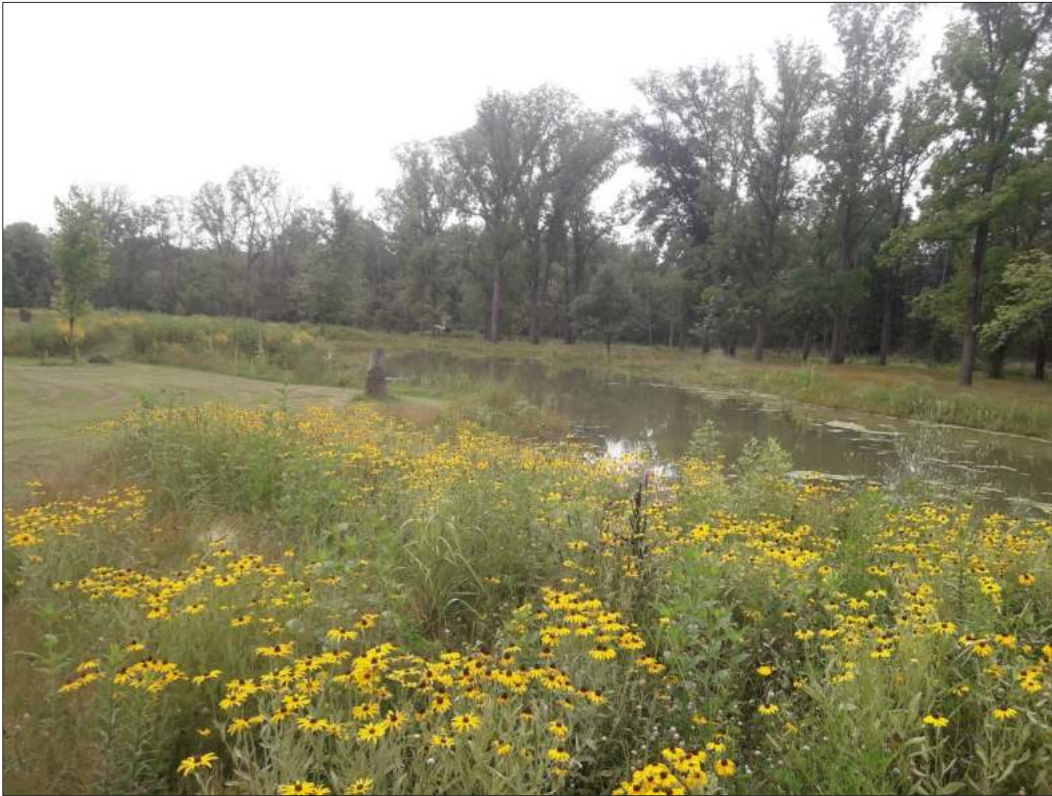
Photo 8: Wetland pond system with adjacent pollinator areas as well as maintained grass areas.

- iv) Shallow pool or pond features can be provided by excavating and shaping the remaining sediment. These water features (ponds) could be constructed deep enough to support fish year-round, and therefore provide public fishing opportunities. The water features can also be created as shallow wetland areas or shaped and located so they provide seasonal (ephemeral) wetland conditions.

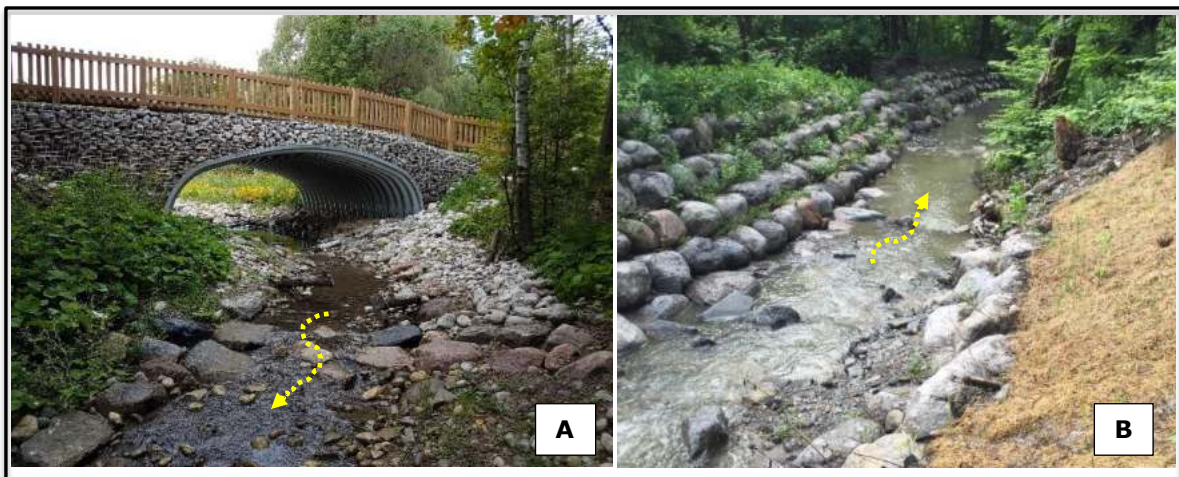
Example photographs of constructed channel bed grade controls and bank bioengineering techniques are included in **Figure 1**. **Figure 1A** displays a weir grade control supported by brush matting along the channel banks. The toe of the brush mattress treatment is reinforced with stone, for stability, while the upper banks gradually revegetate. In **Figure 1B**, the left bank is reinforced with a vegetative rock buttress to combat lateral migration. In addition, the bed is reinforced with hydraulically-sized stone weirs to combat downcutting while maintaining flow connectivity (and fish passage) through the restored reach. This represents a more robust design alternative applicable in areas where the erosion potential is high.

Figure 1: A) Typical vortex rock weir

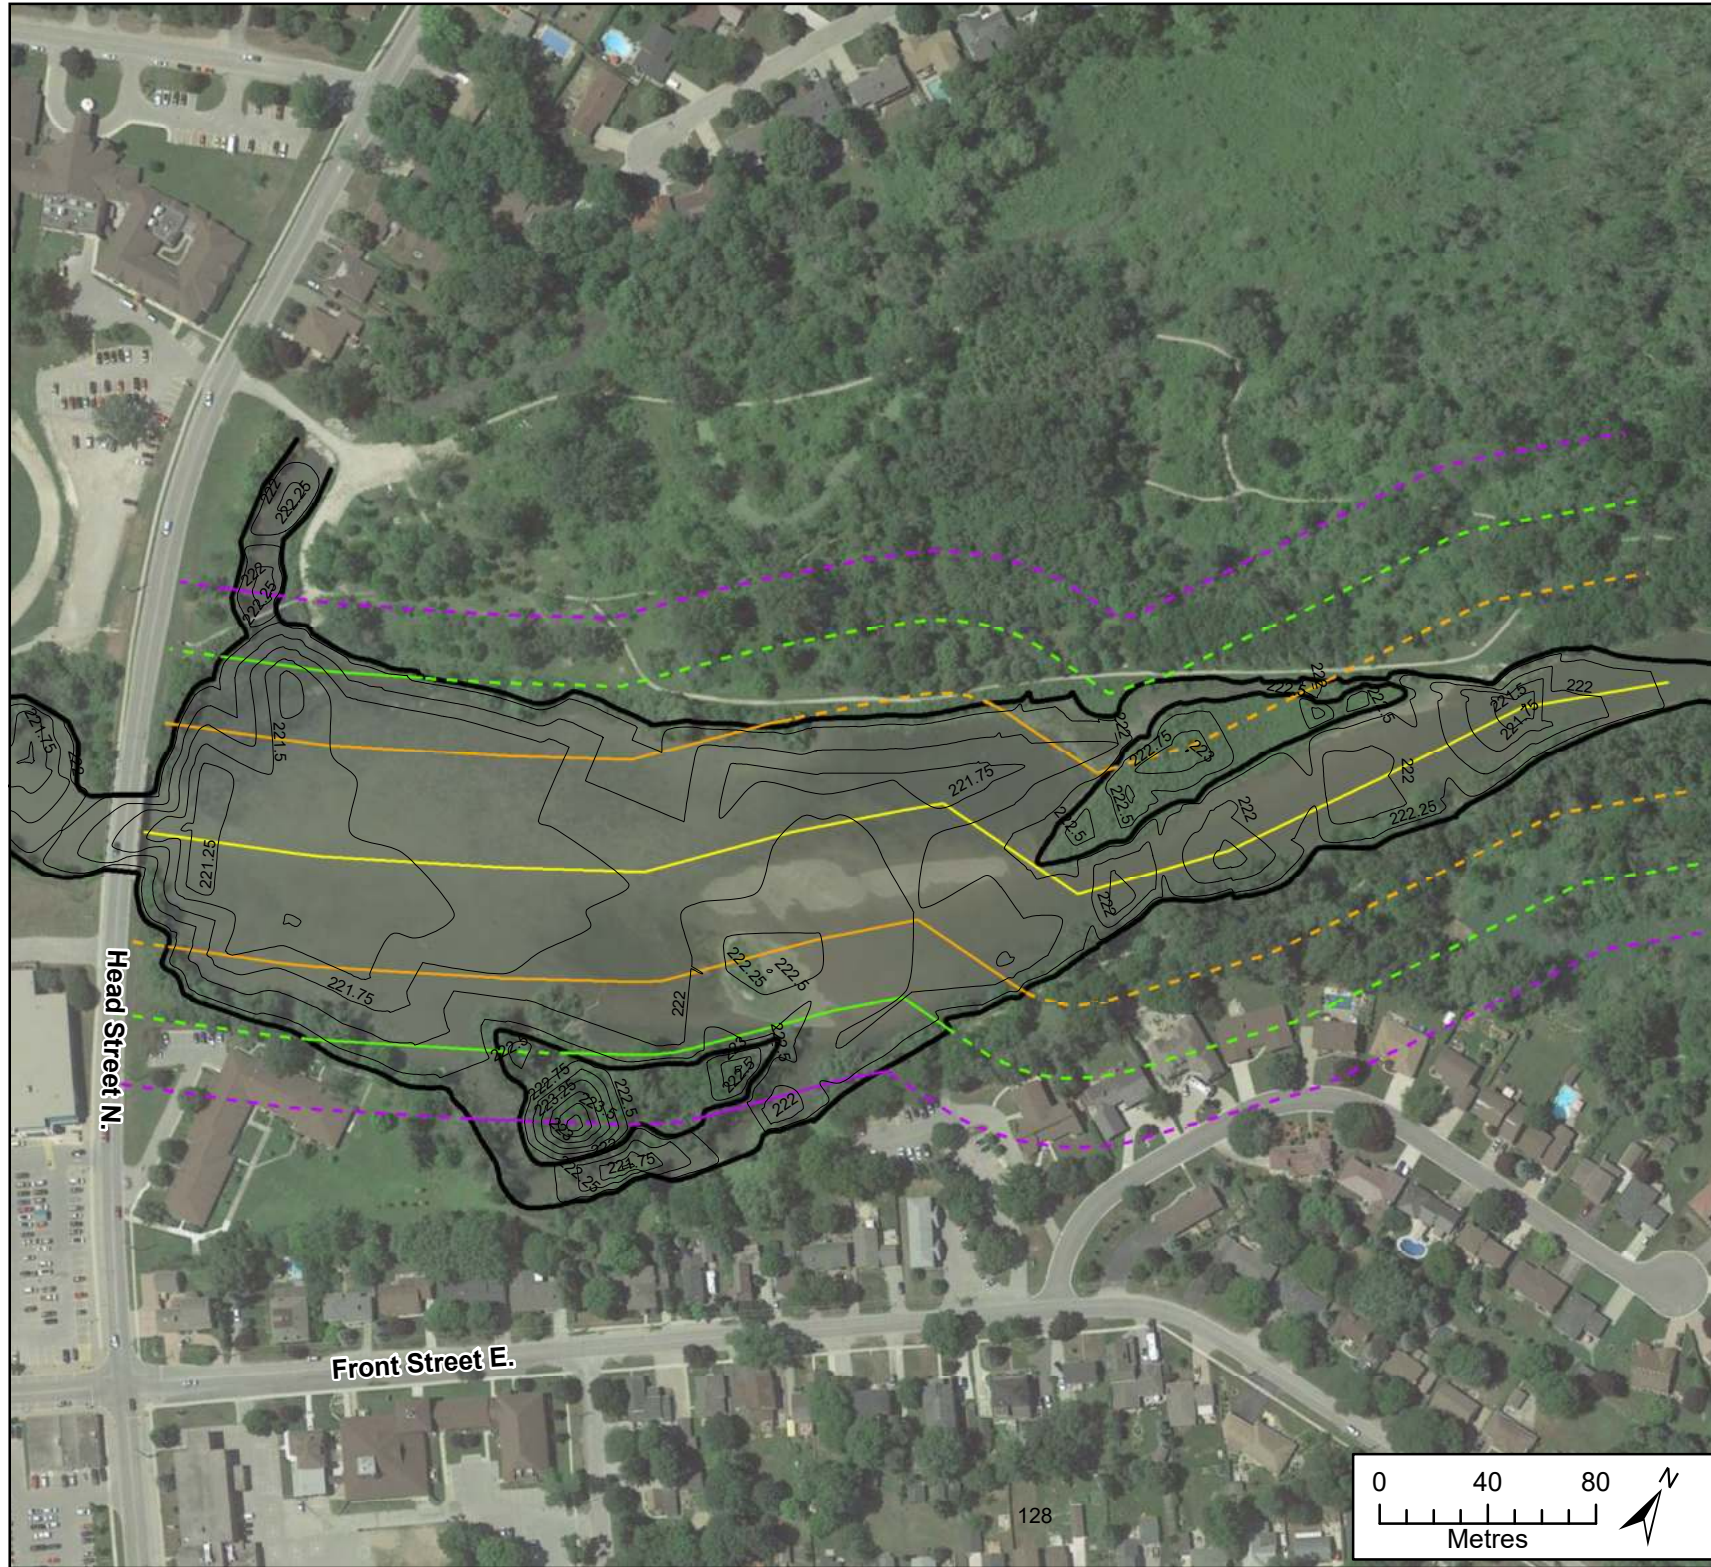
Preliminary MBW
Based on Historical Thalweg
Head Street Reservoir
Strathroy, Ontario

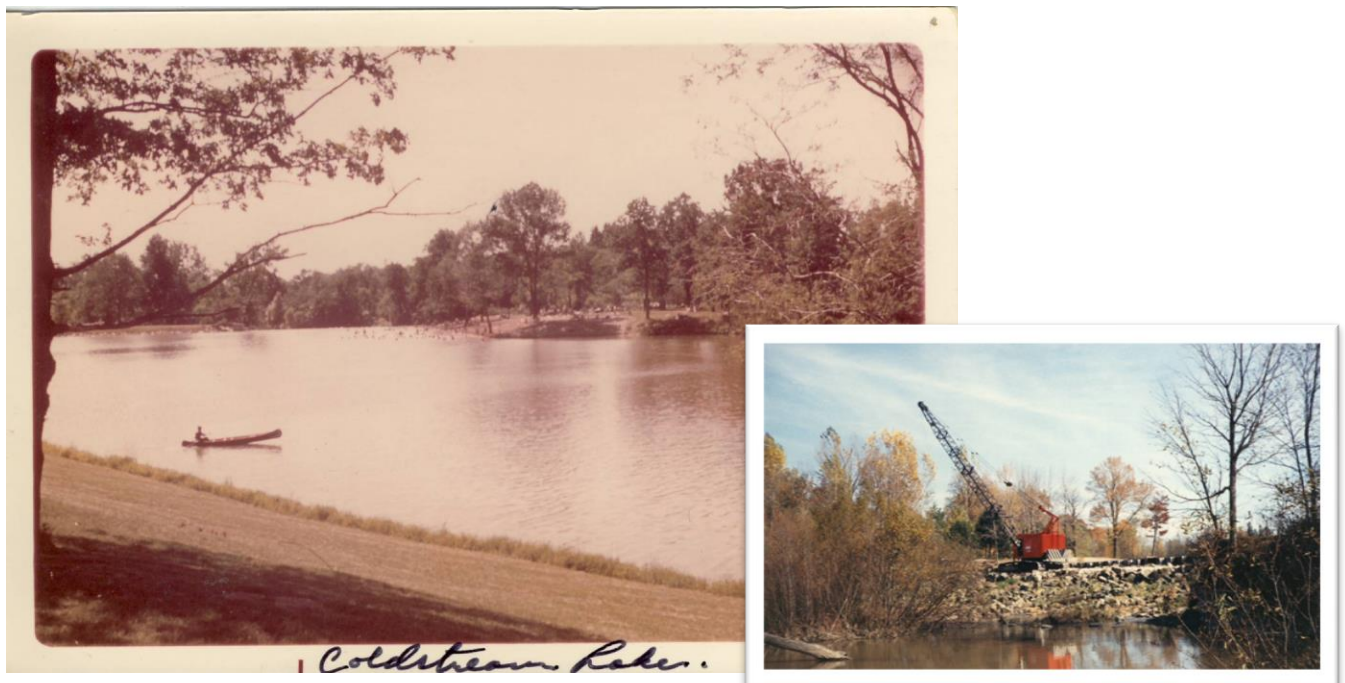
Figure 1 Right: Coldstream dam 1986, Left: Coldstream reservoir used for swimming and boating in the 1970's

The Coldstream Dam is located approximately 12 km northeast of Strathroy in Coldstream, Ontario in the headwaters of the east Sydenham River. Originally constructed in 1968, the structure is approximately 3.35m high and consists of a 45m long retaining wall of vertical sheet piles made of heavy gauge ARCH-Type individual sheets locked together at joint during installation. Large armor stone was placed on the downstream side of the dam ranging in size from 16-24 inches in diameter and placed on a slope of 3:1 horizontal to vertical. An earthen berm approximately 40m long is located at the southern end of the sheet pile dam. The dam does not contain any spillways or stop logs so there is no way to adjust the water levels in the reservoir. The dam is equipped with a low flow bypass valve however, the condition of the valve is believed to be non-operatable. The original purpose of the dam and reservoir was to support recreational opportunities like swimming, boating, and fishing.

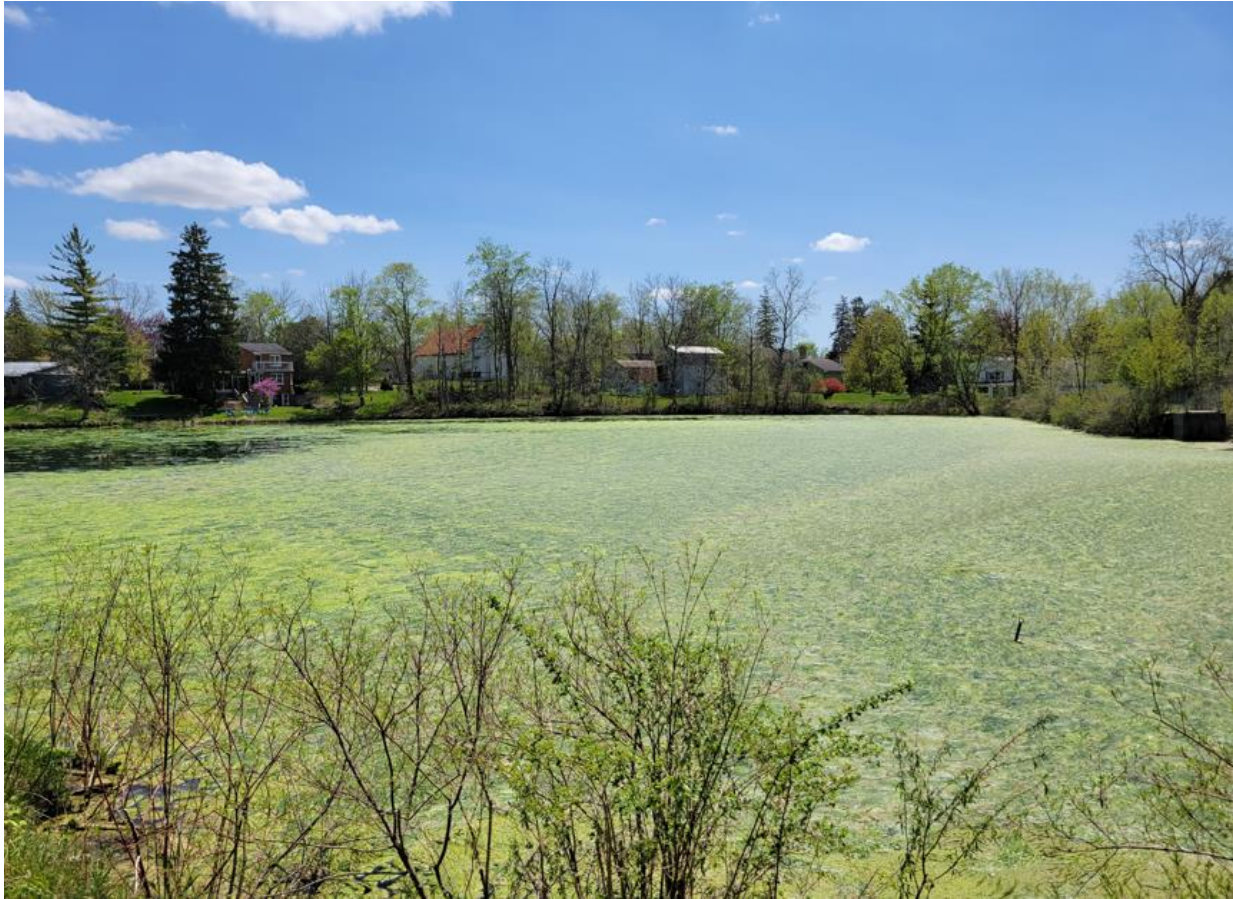
Figure 2 2022 Algal bloom in reservoir at Coldstream

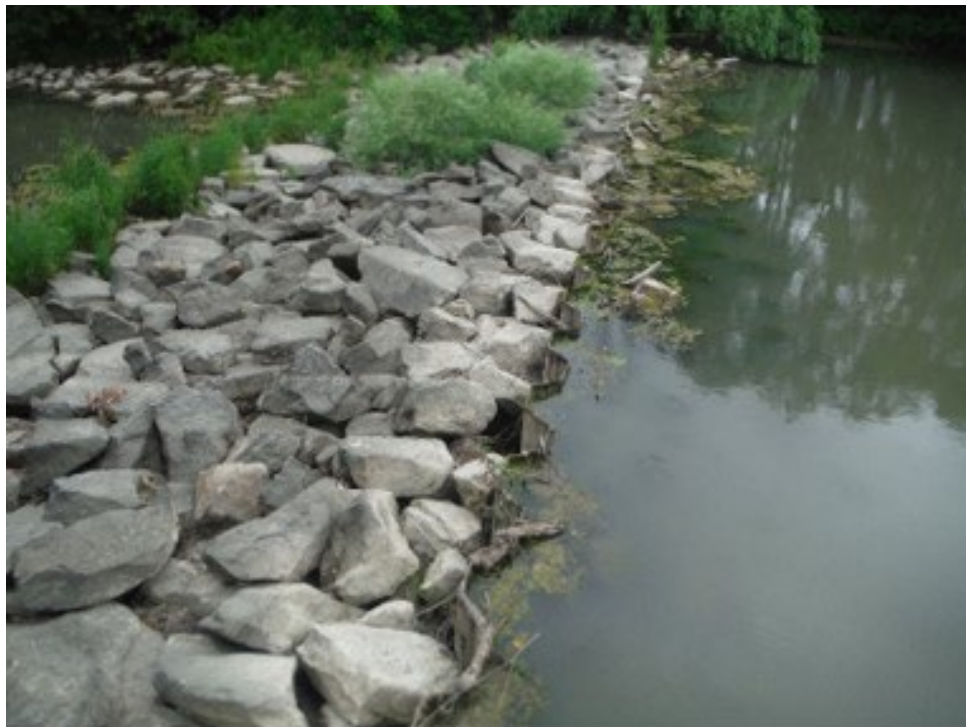
Photo 1: Head Street Dam vertical sheet piling and downstream armour stone.

The dam is approximately 1.4 m high (normal upstream water level compared to normal downstream water level). The dam consists of vertical steel sheet piles drove into the riverbed below, forming a continuous retaining wall. The piles are made of heavy gauge ARCH-Type individual metal sheets locked together at the joints during installation. These types of sheets are usually used in so called 'shallow construction' meaning that the sheet piles are not driven to a significant depth into the riverbed, and therefore do not form a fixed vertical cantilever. The downstream side of the sheet piling is protected by large armour stone (ranging in size from 16 inches to 24 inches in diameter) on a slope of approximately 7:1 horizontal to vertical. The rip rap provides protection to the soil in front of the wall from scoring and erosive effect of the water flow over the wall. The dam is approximately 45 m wide.

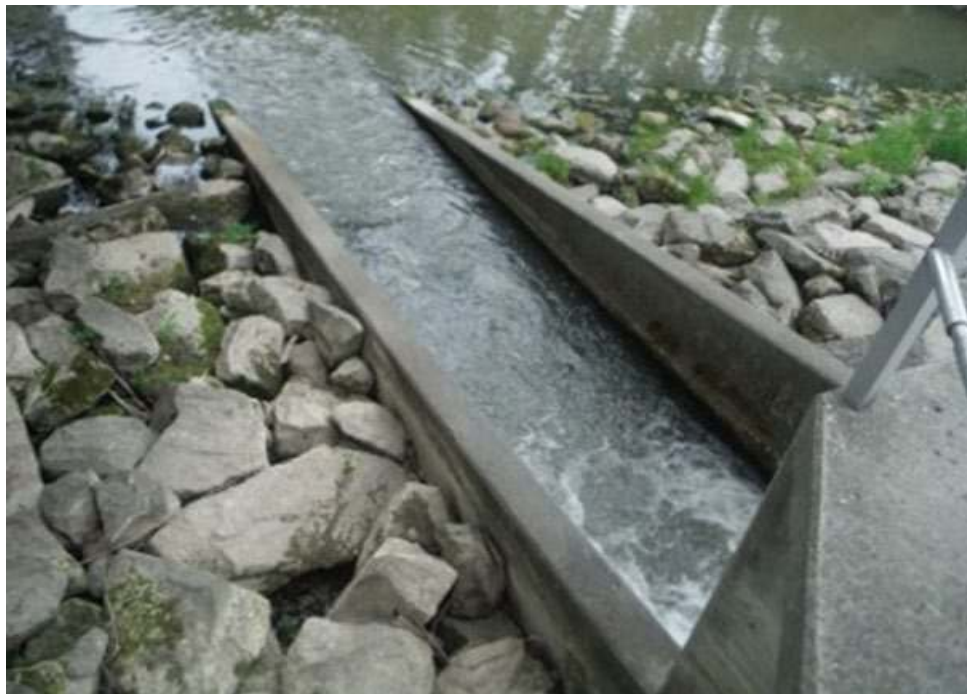
The south end of the dam also features a concrete spillway equipped with stop logs that allow water levels in the head pond to be adjusted. However, all stop logs are normally kept in the spillway such that water levels are equal with the top of the adjacent sheet piles. The spillway opening is protected by removable metal grating. The spillway is accessed via a flat plate concrete bridge. The bridge and the platform on top of the spillway are protected by an aluminum guard.

Photo 2: View of the Head Street Dam concrete spillway.

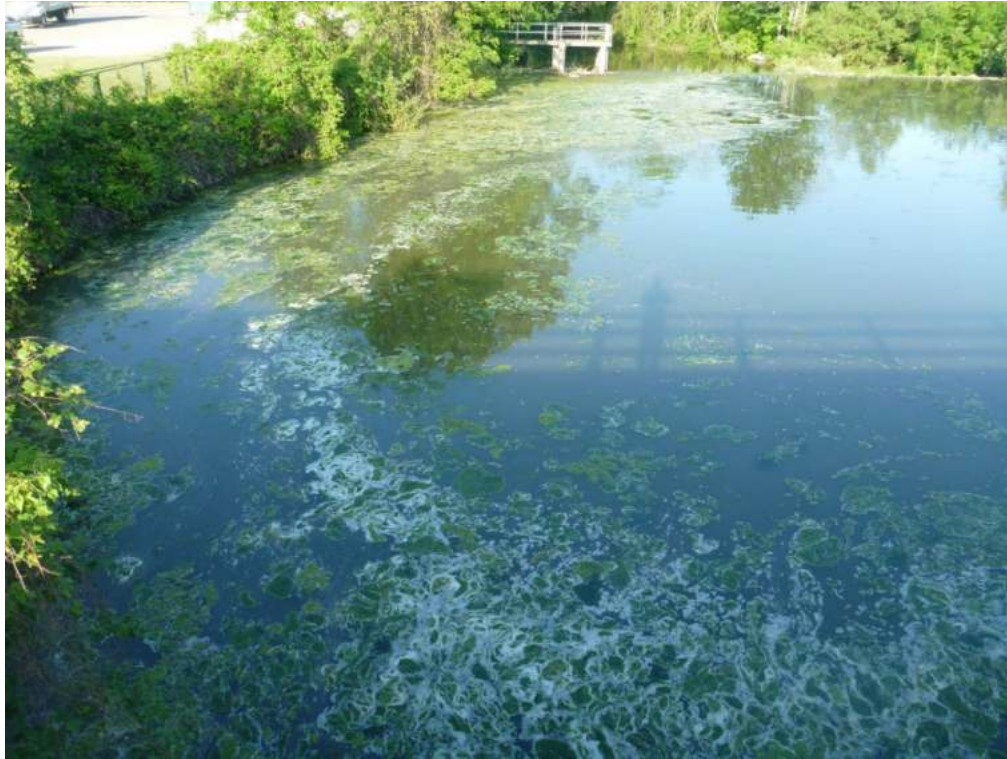
Photo 3: Algal bloom in the Head Street Dam reservoir, downstream of the Head Street Bridge along the south shore.

As sediment accumulates behind the dam, the reservoir has become shallower, leading to quicker warming of water and likely contributes to algal blooms in the dry summer months. The following photos (Photo 3 and Photo 4) depict typical algal blooms in the Head Street dam reservoir.

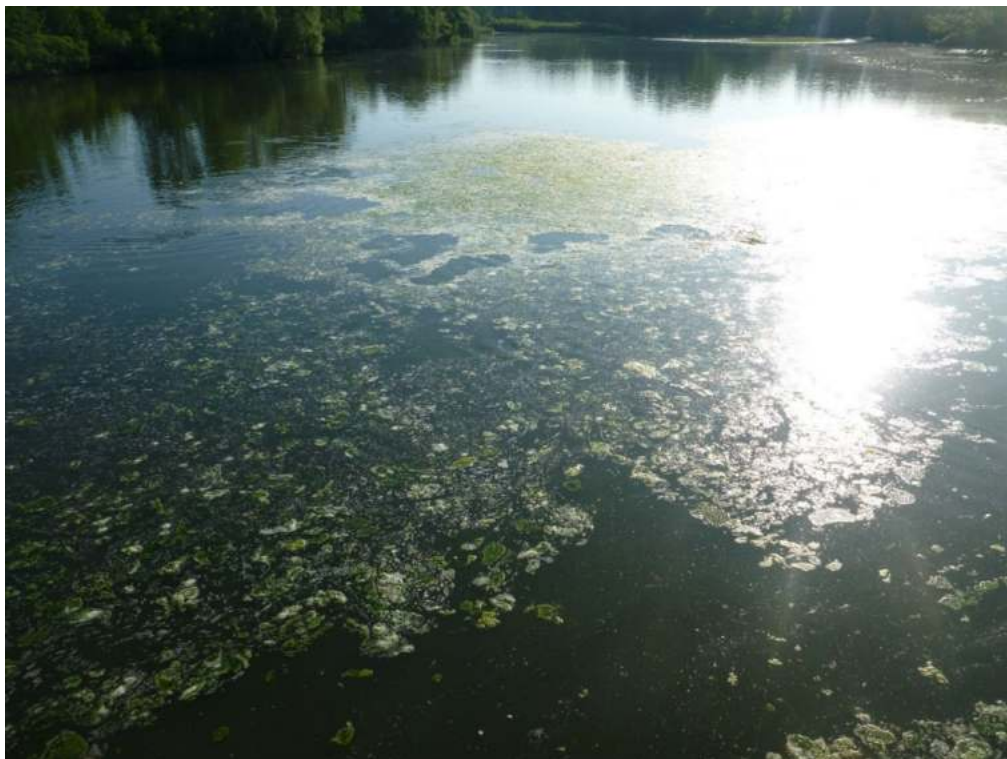
Photo 4: Algal bloom in the Head Street Dam reservoir, upstream of the Head Street Bridge.

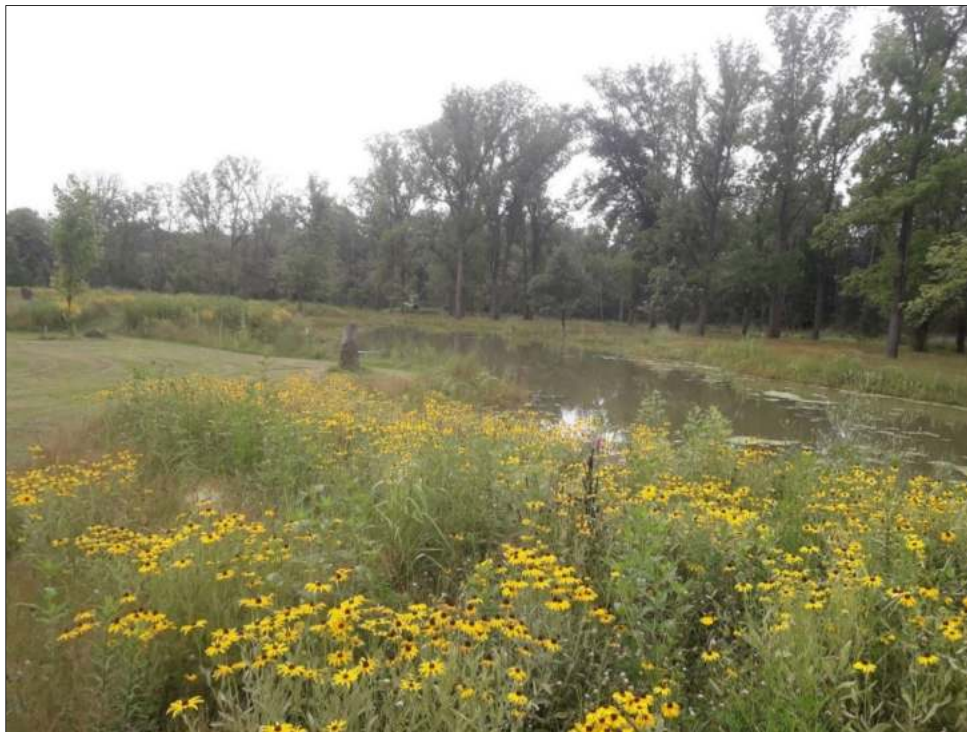
Photo 9: Wetland pond system with adjacent pollinator areas as well as maintained grass areas.

- iv) Shallow pool or pond features can be provided by excavating and shaping the remaining sediment. These water features (ponds) could be constructed deep enough to support fish year-round, and therefore provide public fishing opportunities. The water features can also be created as shallow wetland areas or shaped and located so they provide seasonal (ephemeral) wetland conditions.

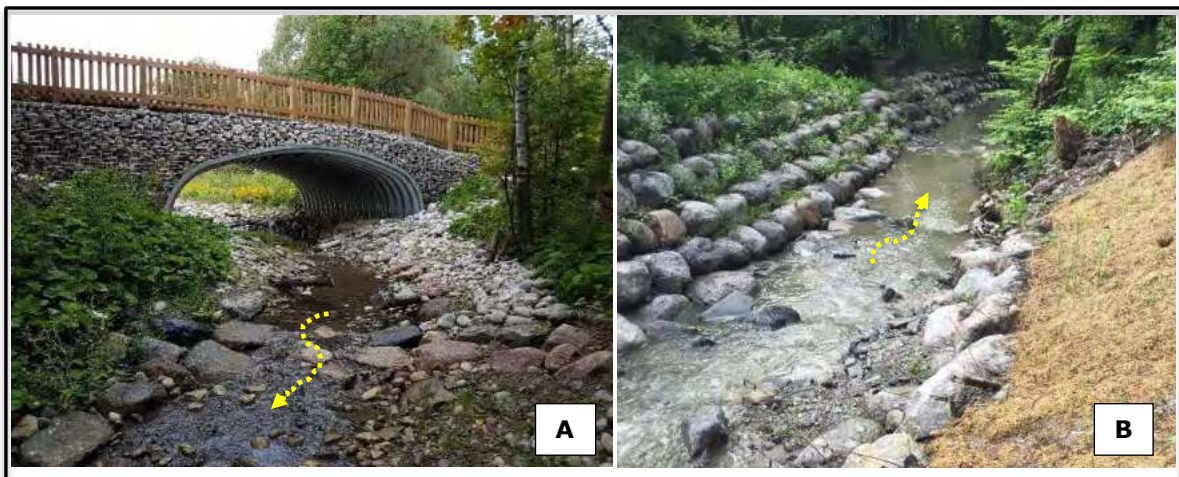
Figure 1: A) Typical vortex rock weir

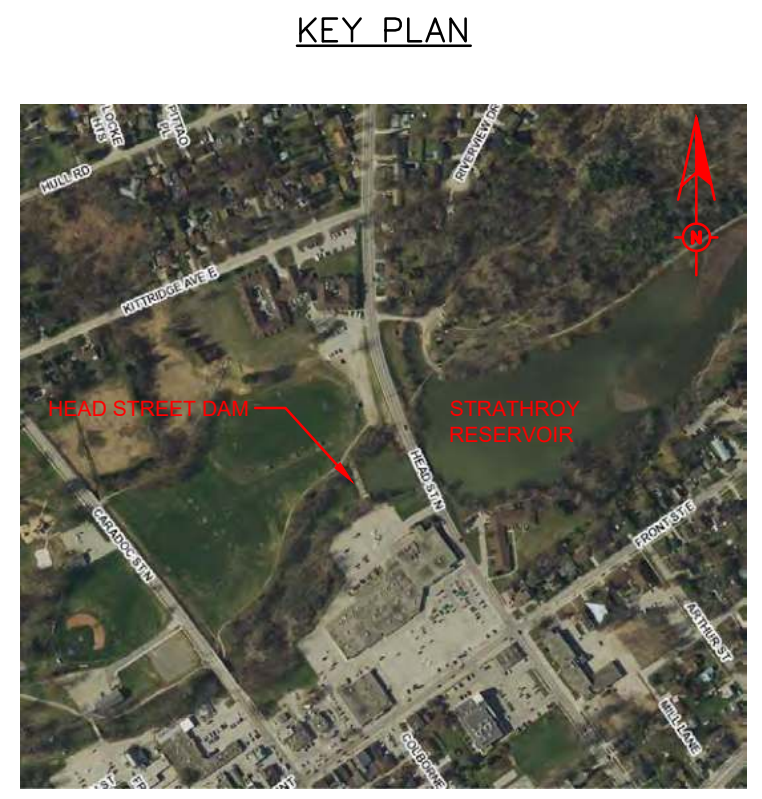
Title: 100-YEAR FLOOD INUNDATION OF THE EAST SYDENHAM RIVER THROUGH STRATHROY HEAD STREET DAM

Flood Inundation of the Area Surrounding the Head Street Dam

NOTE: 100 YEAR FLOOD FLOW IN THE EAST SYDENHAM RIVER THROUGH STRATHROY IS ESTIMATED AS 125.3m³/s. AS PROVIDED BY THE SCRCA.

- ISL. ISLAND
- SCRCA ST. CLAIR REGION CONSERVATION AUTHORITY
- ← FLOW DIRECTION
- EDGE OF WATER (NORMAL WATER LEVEL)
- 100-YEAR FLOOD INUNDATION AREA (POST DAM REMOVAL)
- 100-YEAR FLOOD INUNDATION BOUNDARY (PRE-DAM REMOVAL)

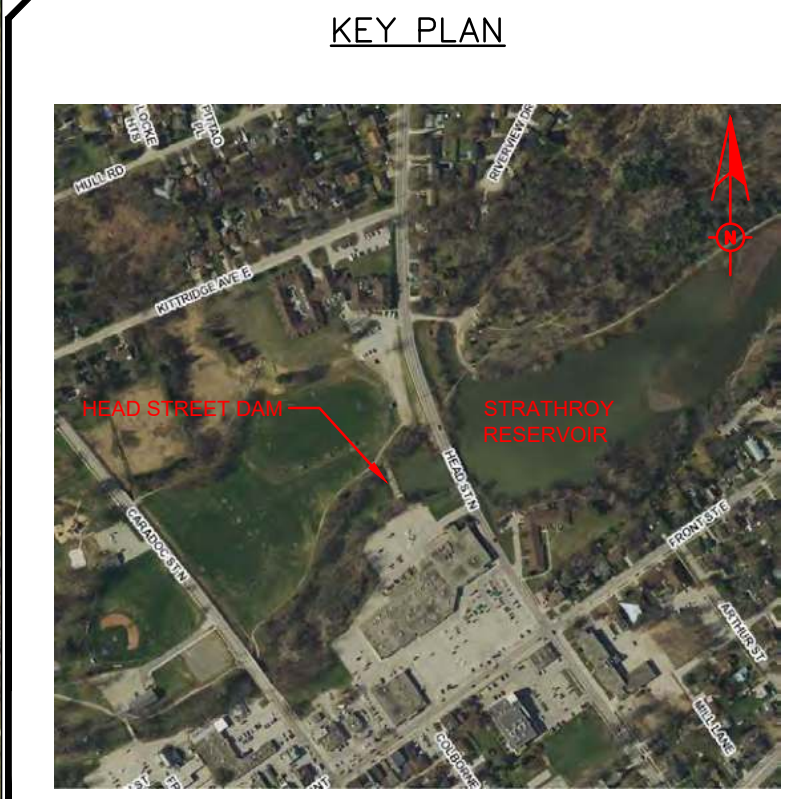
Title:
100-YEAR FLOOD INUNDATION OF THE EAST SYDENHAM RIVER THROUGH STRATHROY HEAD STREET DAM

NOTE: 100 YEAR FLOOD FLOW IN THE EAST SYDENHAM RIVER THROUGH STRATHROY IS ESTIMATED AS 125.3m³/s. AS PROVIDED BY THE SCRCA.

- LEGEND**
- ← FLOW DIRECTION
 - EDGE OF WATER (NORMAL WATER LEVEL)
 - 100-YEAR FLOOD INUNDATION AREA (POST DAM REMOVAL)
 - 100-YEAR FLOOD INUNDATION BOUNDARY (PRE-DAM REMOVAL)

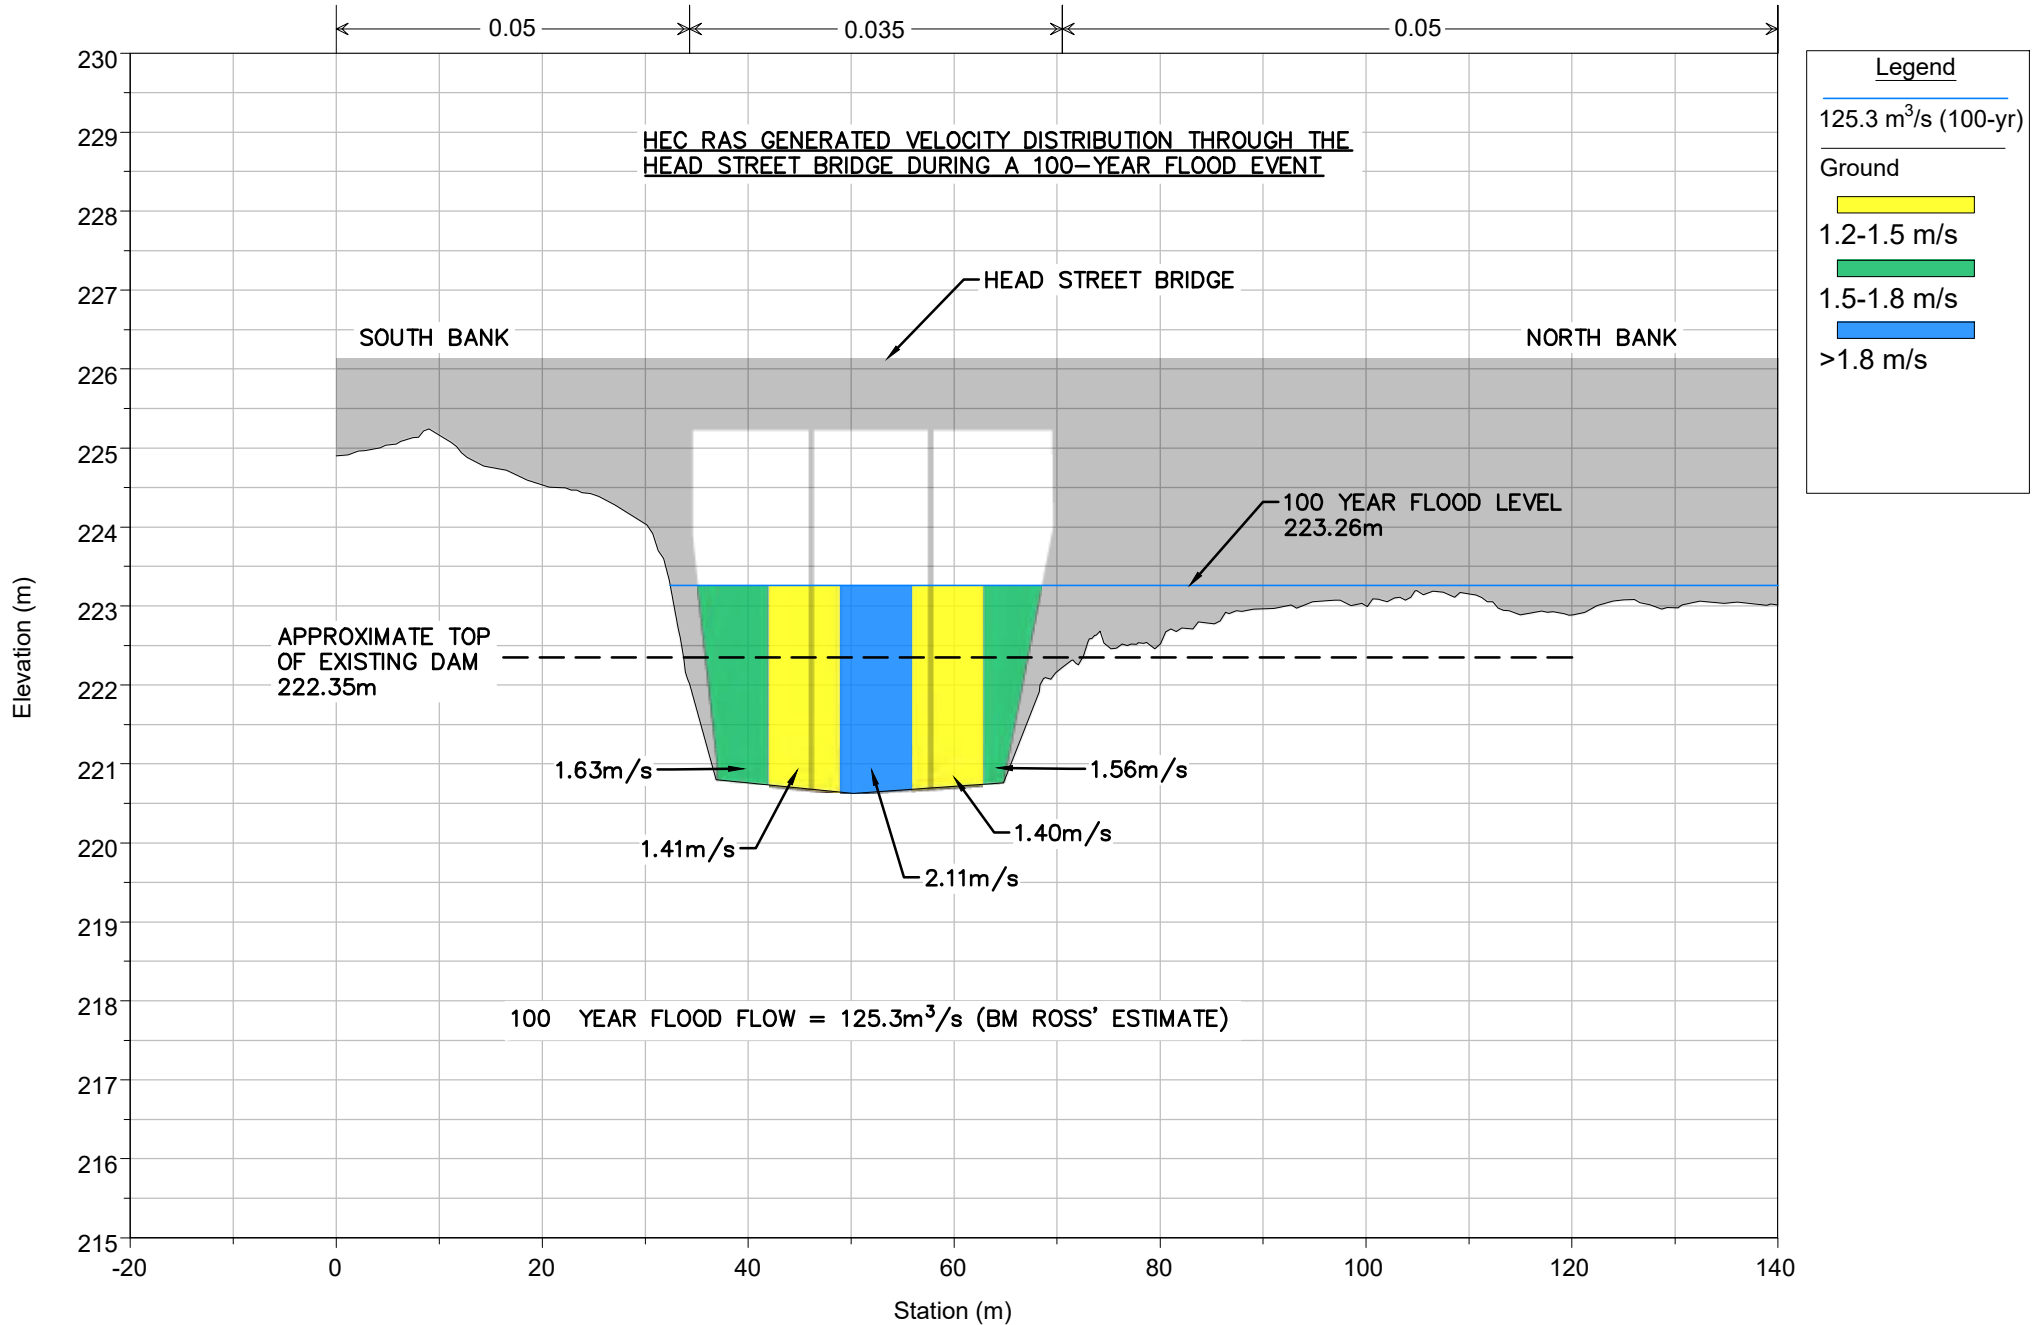
Figure 2: Head Street Dam - Post Dam Removal

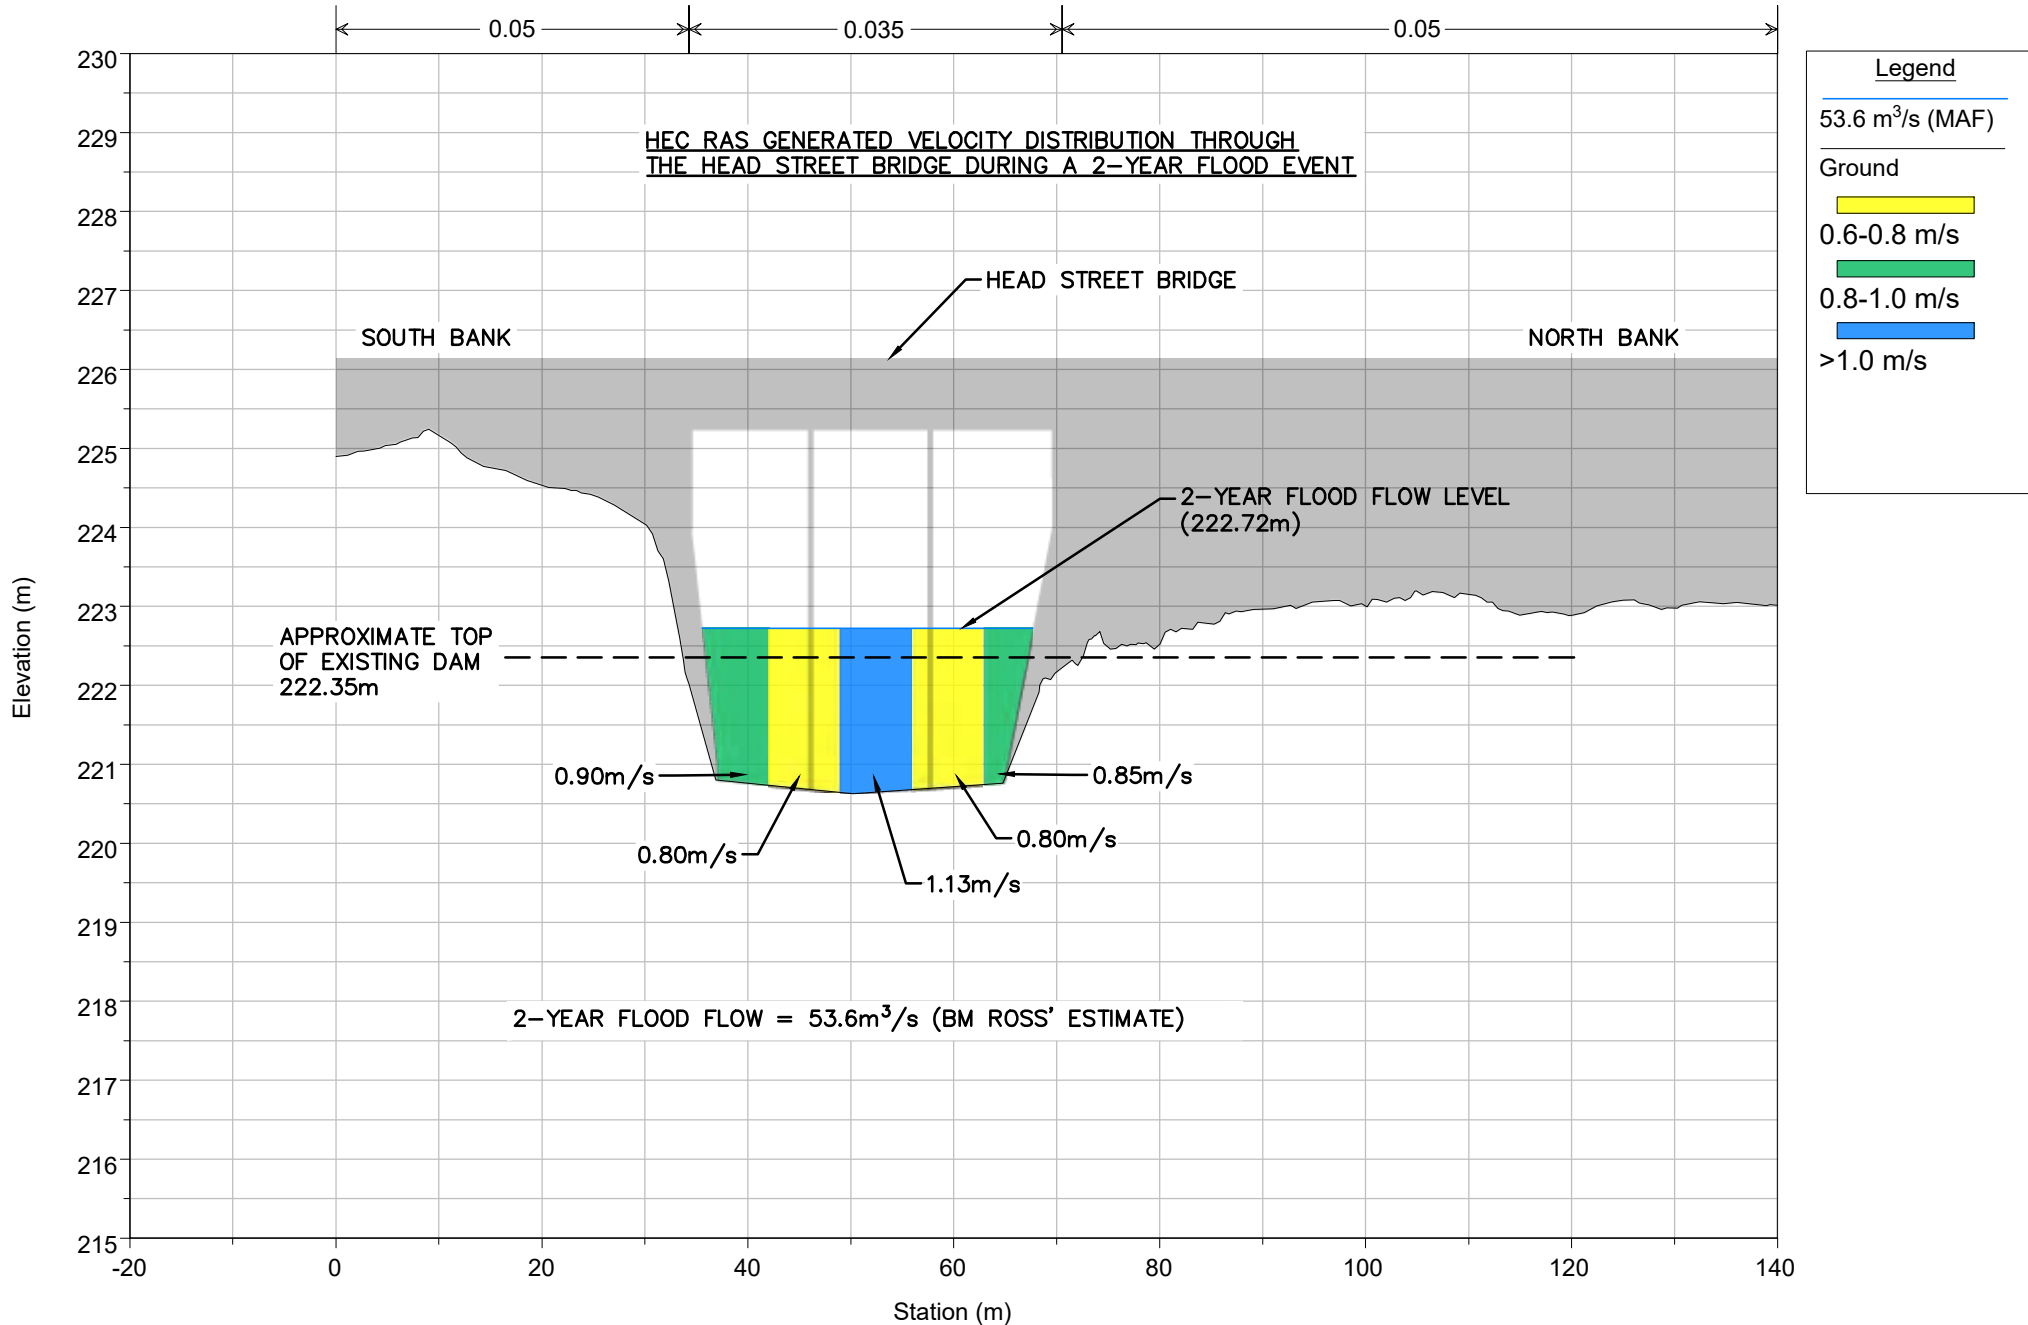
Figure 4: Head Street Dam - Post Dam Removal

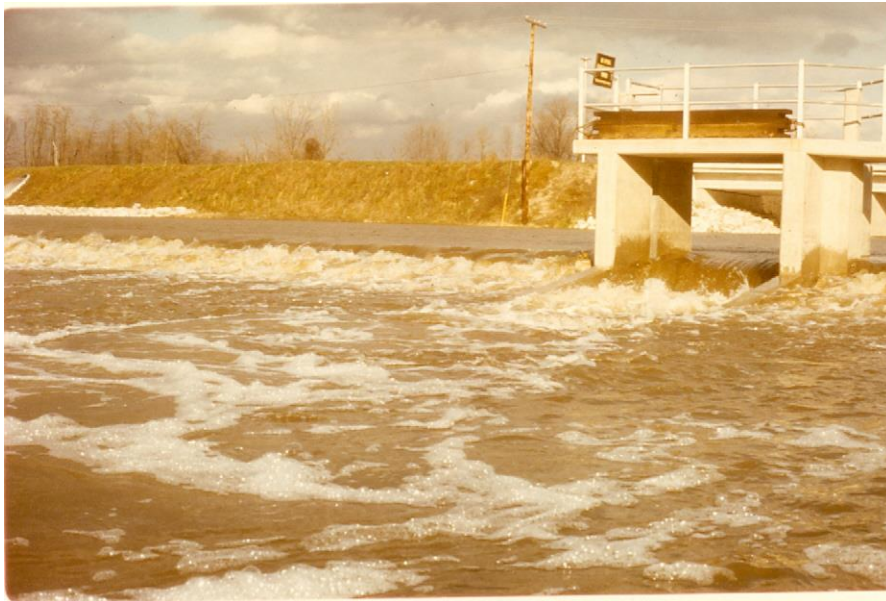
The Head Street Dam is located approximately 70m southwest (downstream) of the Head Street bridge in Strathroy, Ontario on the east branch of the Sydenham River. Originally constructed in the 1970s, the structure is approximately 1.4m high and consists of a 45m long retaining wall of vertical sheet piles imbedded in the riverbed with large armor stone placed on the downstream side of the dam for added stability. The south end features a concrete spillway equipped with eight stop logs that allow water levels in the head pond (reservoir) to be adjusted. The purpose of the reservoir was to provide flood attenuation and recreational opportunities.

Figure 1 Head Street Dam after construction in the 1970s
