Board of Directors - Notice of Meeting

April 18, 2024

**Potential Removal of the Coldstream Dam
St. Clair Region Conservation Authority**

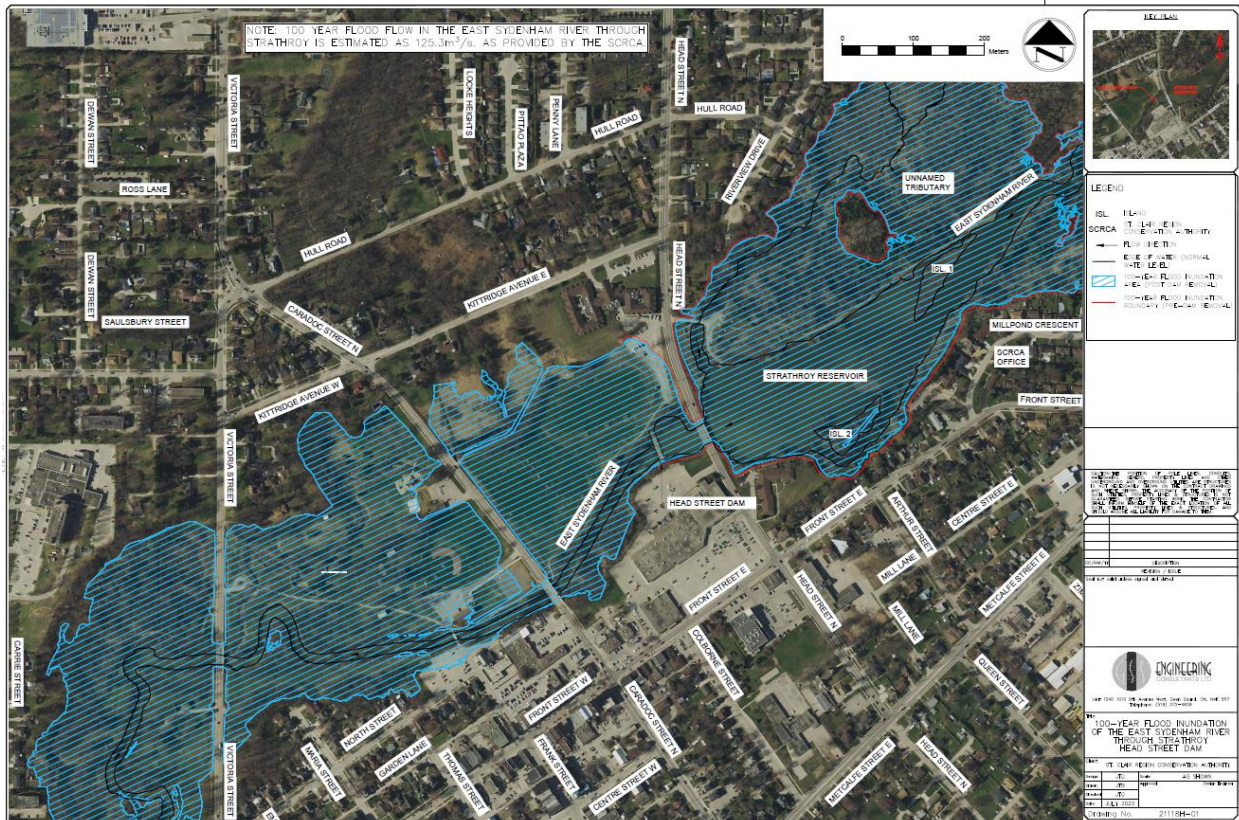
Figure 3 100-year Flood Inundation of the East Sydenham River through Strathroy

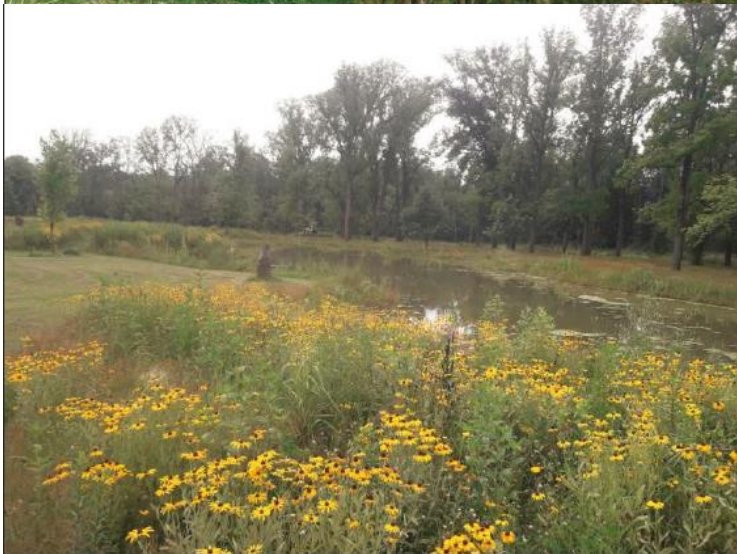
Water features such as shallow wetland areas or ephemeral pools for amphibians and deeper ponds to support fish communities can be located adjacent to the new channel location and enhance habitat in this area; these types of features would be constructed offline and would not be directly linked to the new channel.

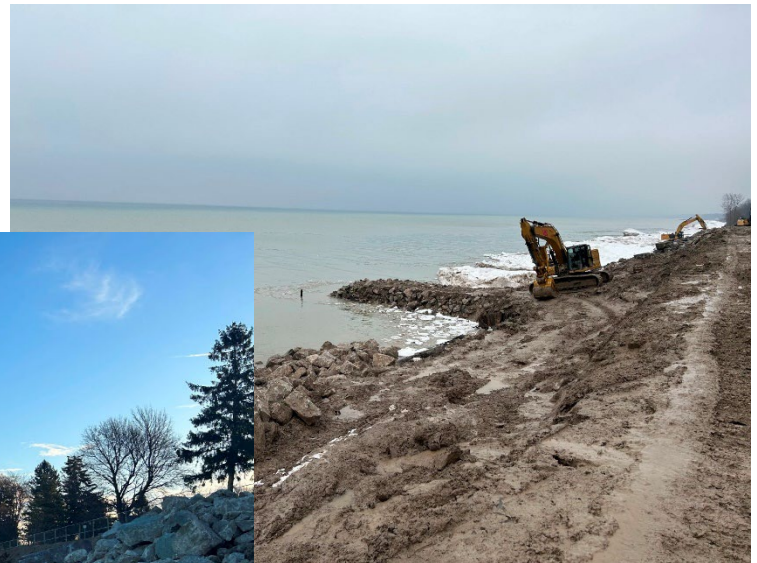
Construction Progress - Penhuron Drive to Kenwick Street Shoreline

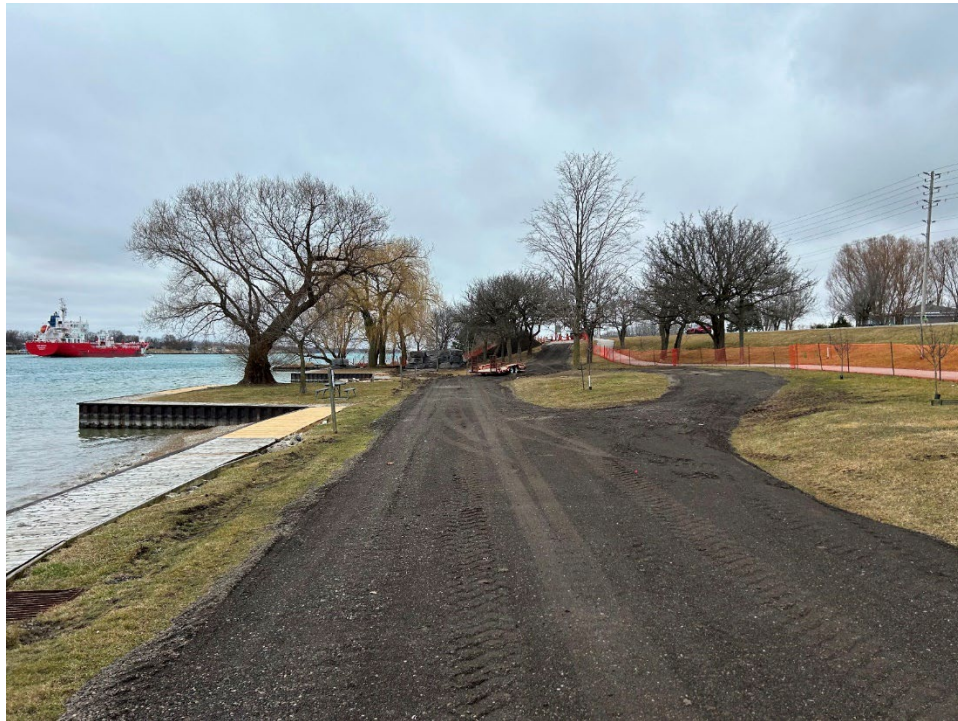
Seager Park – On site construction access preparation

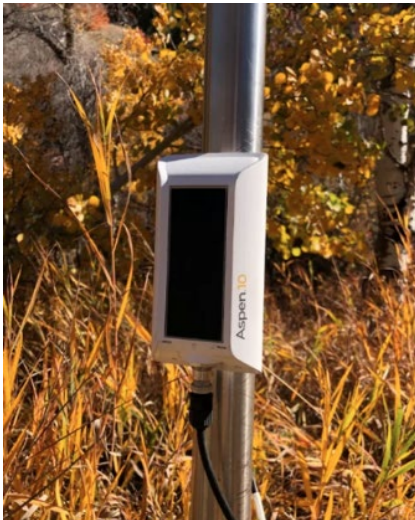
Aspen10 Internet of Things (IoT) Edge Device

These state-of-the-art sensors are an all-in-one unit and are smaller than the conventional doghouse stream gauges. They have built in solar panels, and batteries and will be able to communicate to a cloud service either through GOES Satellite or cellular communication. Because of the size of the sensors they can be placed in locations that wouldn't have been able to have a traditional doghouse stream gauge.

The location of the sensors will be located at bridges that have experienced road closures in the past and at other areas of key interest across the watershed. Municipalities will be involved and approval will be sought out to determine the appropriate placement of sensors.

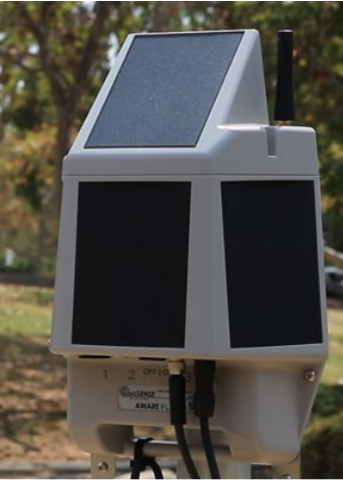
The Advanced Warning Equipment (AWARE) Flood System by AWARE Monitoring Systems.

The additional sensors will be used in conjunction with our current stream gauges to improve early warning communication to our municipalities during flood conditions. This will enable municipalities to deploy their staff to ensure roads are closed.
