## **A.W. Campbell Conservation Area Master Plan**

Last Management Plan: March 1981

Date Updated: May 2025

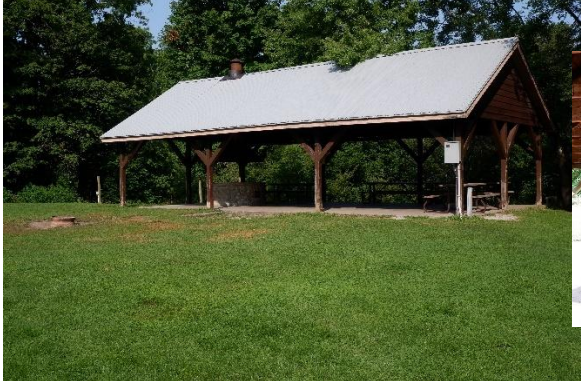
| | | <p>Rectangular pavilion #1 in Group C<br/>Camping area with stone fire pit (inset) and chimney</p> |

| | <ul style="list-style-type: none"> <li>Upgrades to Group C pavilion (replace wood posts and fascia)</li> </ul> | \$8,000-\$12,000 |

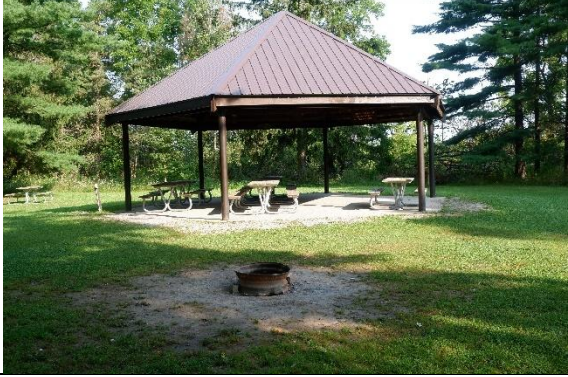
| | <p>Hexagonal pavilion<br/>#3 behind Group B<br/>camping</p> |

| <b>Infrastructure</b> | <ul style="list-style-type: none"> <li>Replace concrete in Group B pavilion (or remove pavilion if Group B camping is abandoned in the future)</li> </ul> | \$10,000-\$12,000 for new concrete |

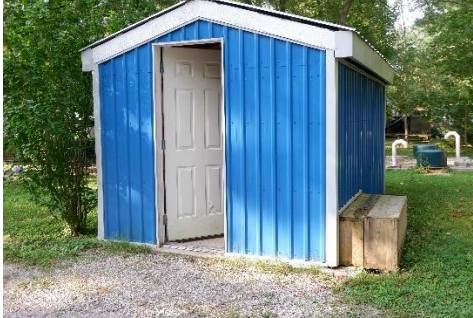
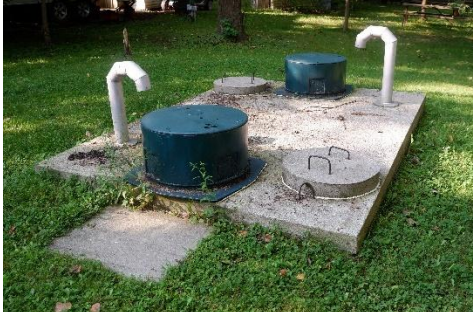
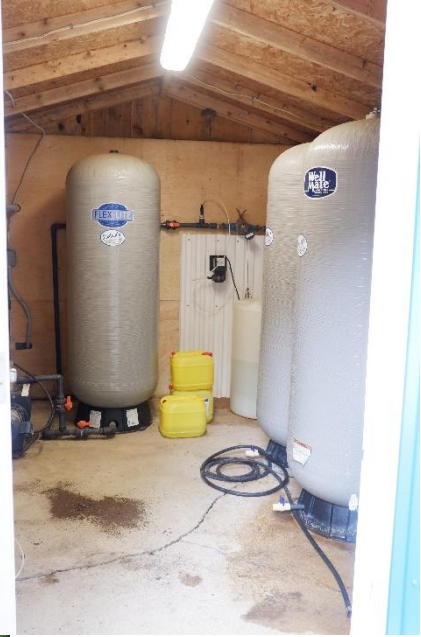
| | <p>Chlorinated water treatment system located in pump house</p> |

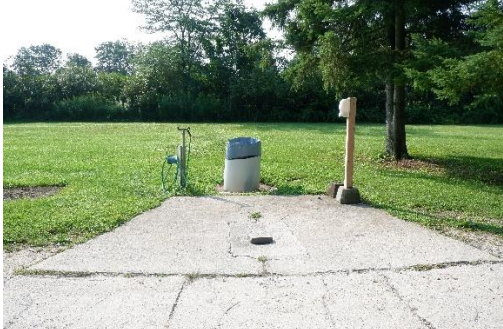
| | | <p>Dumping station located along south side of property</p> |

| <p>Dumping Station and septic system - (septic tank, gravity feeds to leaching bed) located on southern boundary of seasonal camping area</p> | <p>Station and septic system currently being designed for replacement and environmental compliance approval.<br/>Occasionally has congestion as trailers line up to use dump station on common departure days.</p> |

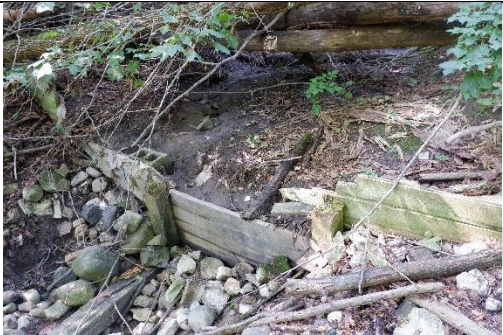
| | | <p>Smallest dam structure located along the abandoned trail</p> |

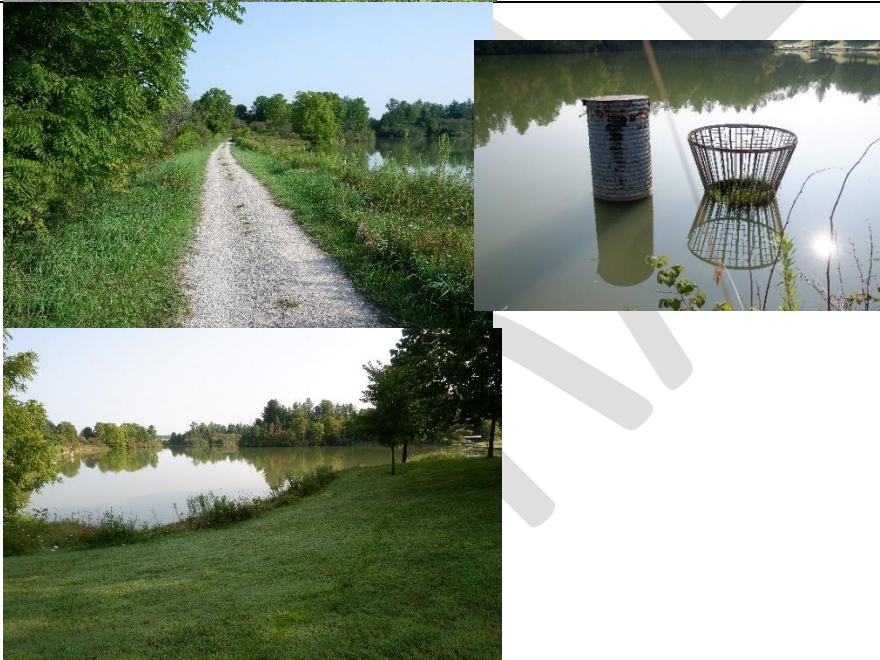
| | <p>Reservoir and dam on Morrogh Creek, overflow structure (inset)</p> |

observation, and fishing opportunities. Swimming was a popular activity at the time of construction until the 1990's when high bacteria levels found in the water made it unsafe for swimming. Cautionary signage has since been posted to warn visitors. Access to the reservoir is from the day use area where a removable dock is installed next to the canoe and kayak rental stand. A trail system exists along the perimeter of the lake, providing viewing opportunities and access to unofficial fishing locations.

Due to the increase in nutrients and bacteria in the water algal blooms have been observed in the reservoir annually and in one instance toxic blue-green algae was documented. It is unclear whether it is point source or non-point source factors contributing to the high nutrient levels in the reservoir.

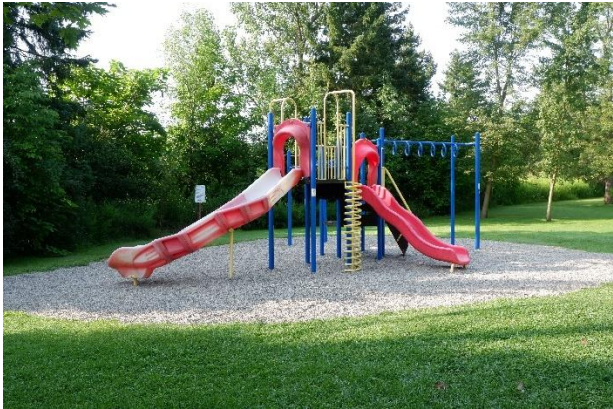
| | <p>Little tikes Playground designed for ages 5-12 years old, installed in 2002, located along south of seasonal camping east of the washroom building.</p> |

| Description | Comments |
|---|---|
| Playground – little tikes brand, located south of seasonal camping | Installed in 2002, equipment in fair condition but with some compliance issues. Designed for users ages 5 to 12 years old. Swing set replaced in 2024. |

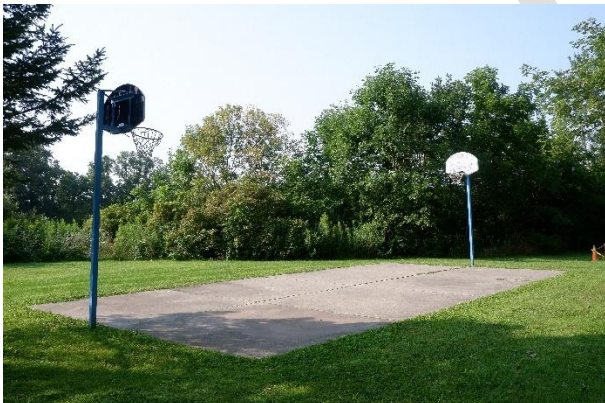
| | <p>Basketball court located on southern edge of campground west of washroom building.</p> |

| Description | Comments |
|---|---|
| Basketball court - cement 40'x20' pad | Used both for basketball and road hockey. Facility is older and in poor condition. Usage varies year by year based on the current seasonal camper population. |

| | <ul style="list-style-type: none"> <li>Replace basketball court with a larger facility, install better quality hoops that extend further into court</li> </ul> | \$50,000-\$80,000 |
