St. Clair River Shoreline Restoration Assessment and Design of Restorative Works

Report to Great Lakes Sustainability Fund and Project Partners

St. Clair Region Conservation Authority
April 2006

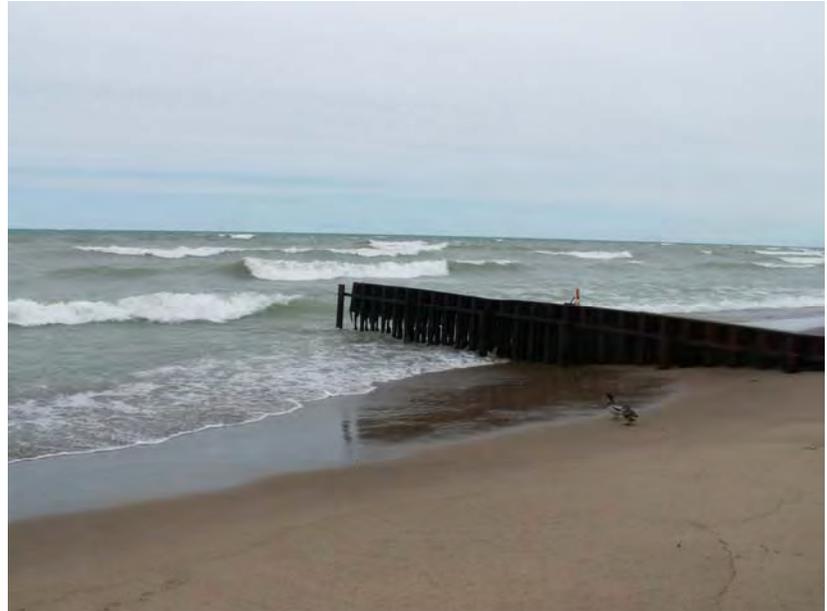
- Little protection exists at the site
- Steel sheet pile groynes assist in maintaining a significant beach

- Existing protection (groynes) are in fair to poor condition

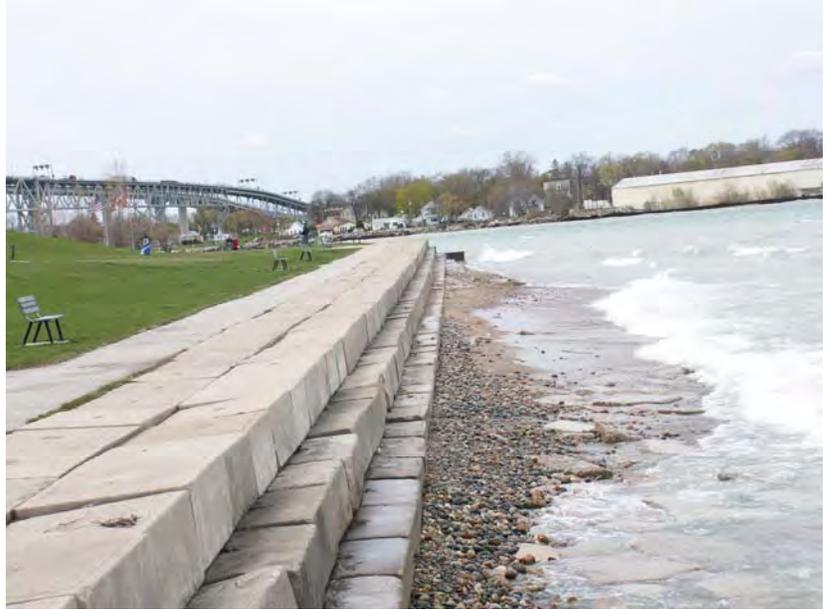
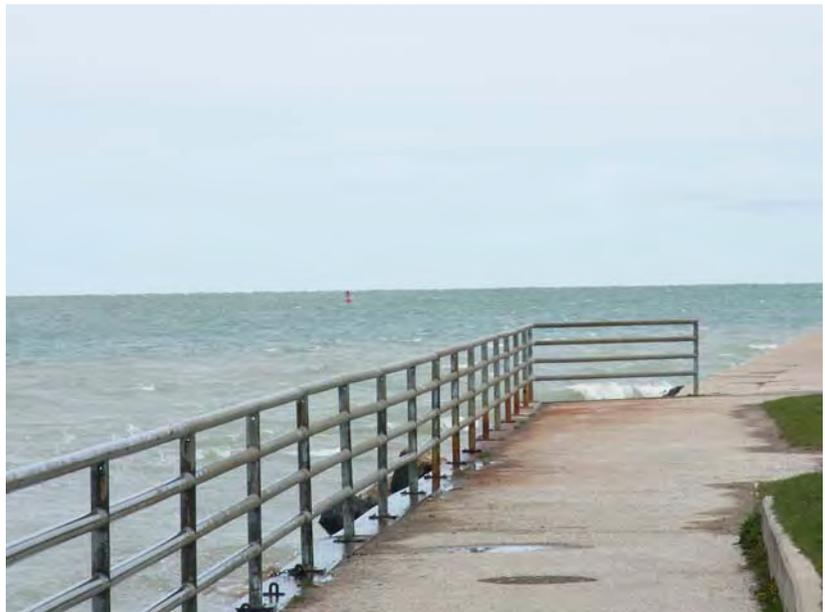
Property 2

- Three types / styles of protection safeguard the property
- The northern portion, along the south shore of Lake Huron, is protected by stepped concrete blocks
- The central portion, at the mouth of the Lake, is protected by a steel sheet pile wall which encases and protects the outfall for the plant
- The southern portion, along the shore of the St. Clair River, is protected by a combination stepped and sloped armourstone revetment
- Protection ranges from 2.5 to 4 metres in height
- Both the stepped concrete block revetment and the stepped and sloped armourstone protection are fronted by rip rap providing additional protection and habitat opportunities

- Southern portion of the protection was constructed in 2003, the northern protection was constructed in the mid 1990's, while the steel sheet pile wall in the central section predates its flanks
- The protection of each portion is in good condition and should not require repair or replacement over the next 20 years
- The protection wraps from the foot of the Lake around and down the St. Clair River shoreline providing a variety of near shore conditions

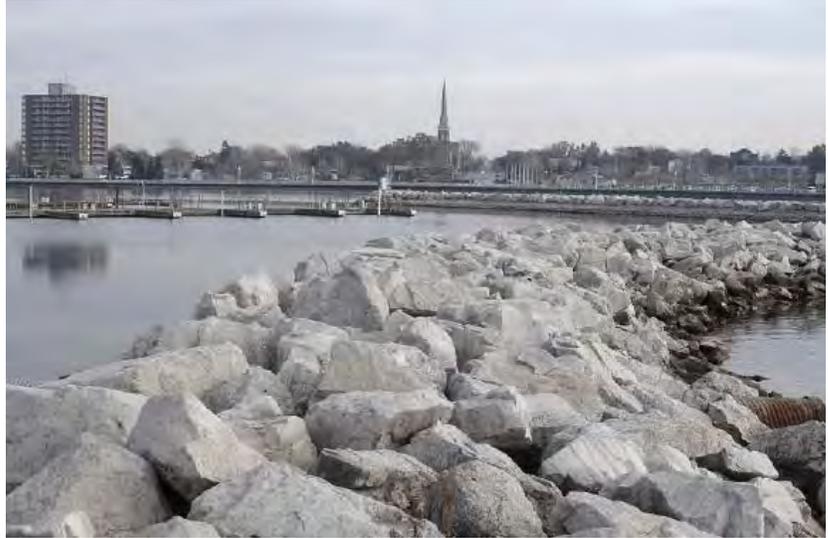
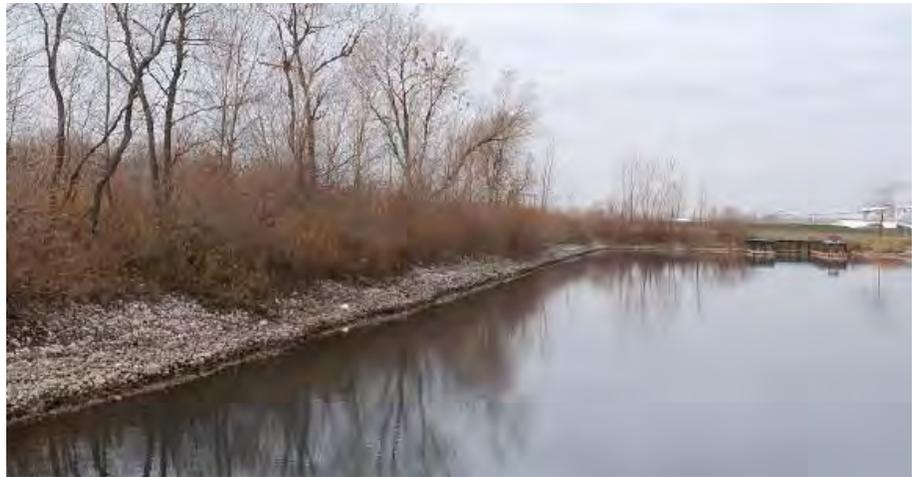
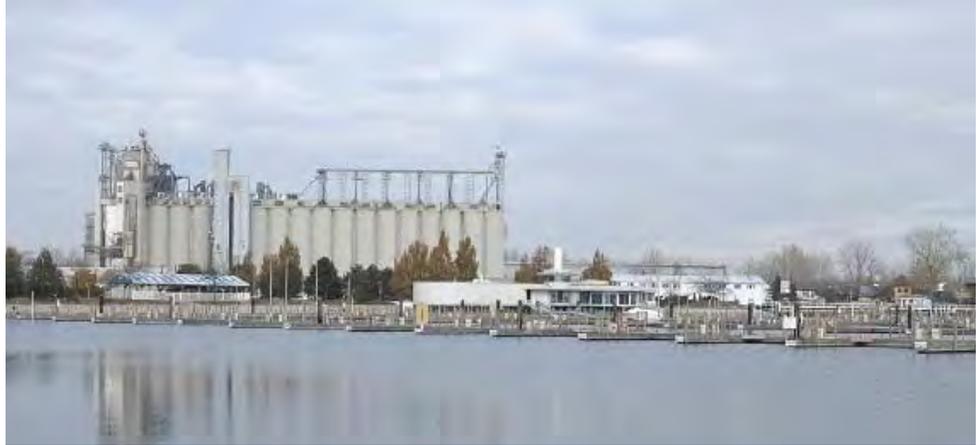
Property 6

- Shore protection for the marina is a combination of an small armourstone revetment, steel sheet pile retaining walls and a rip rap revetment
- The Marina is protected from the St. Clair River by an armour stone revetment that is approximately 240 metres long
- The crest of the revetment extends approximately 1 metre above the backshore grade to an elevation of approximately 178.0 metres
- The west shoreline inside the marina is protected by rip rap which extends up to the tableland of the park
- The estimated elevation of the tableland is approximately 178.5 m to 179.0 m.
- Extending 150 m along the inside of Sarnia Bay Marina is a steel sheet pile dock to the breakwater
- Along the north shore of the marina, approximately 400 m in length, is a shoreline protected by rip rap revetment

- The armour stone revetment and breakwater both appear to be in good condition
- The steel sheet pile wall and the rip rap revetment also appear to be in good condition
- There are some maintenance issues with the boat ramp, specifically bolts and anchors that are loose
- As a result the boat ramp is in fair to good condition

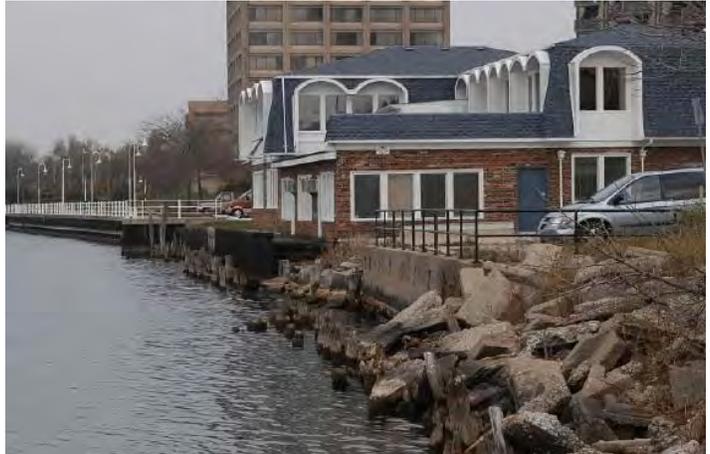
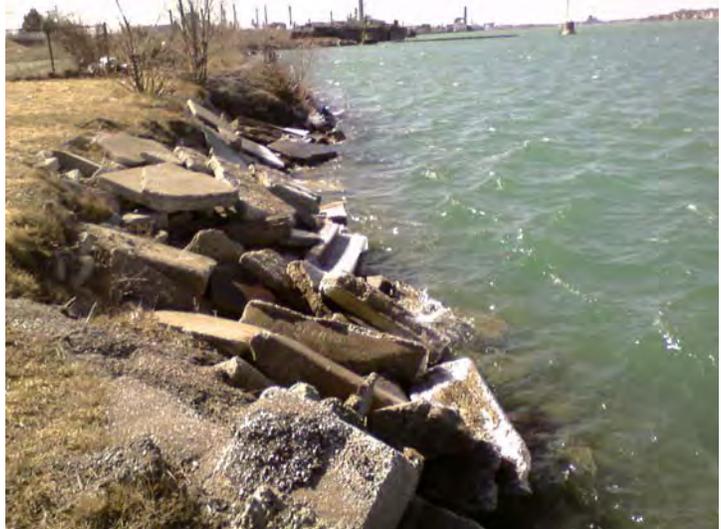
Property 10

- There are various structures along this 720 metres of shoreline
- At the north end is short reach of steel sheet pile wall which is in very poor condition

- A pier which extends from the shoreline approximately 35 m into the water is a part of ice deflecting structure put in place to protect the train loading dock to the south and is protected with concrete blocks

- Offshore of the pier are two caissons which anchor an ice boom
- The first caisson has as a steel sheet pile base with concrete cap

- The second caisson farther offshore appears to have a stepped concrete face at the waterline with no steel sheet pile protection visible
- The shoreline is protected with long pieces of concrete rubble

- The steel sheet pile wall at the north end is in poor condition
- The steel sheet pile wall at the end of Davis Street is in good condition
- The concrete blocks of the pier have shifted and there has been erosion of the fill material from behind the blocks
- Rip rap in most areas is oversized and is having a negative impact on the structure
- The slope is too steep in several areas

- Opportunities exist to remove the current protection and replace it with softer protection with variations in slope and depth and in the contouring of the shore
- The new protection will set a new baseline for the development of the remainder of the property
- Where possible the concrete rubble could be broken up into rip rap size material and reused to fill voids and modify the underwater slope, rip rap would be placed on top of the remaining concrete rubble
- Any debris would be removed or unacceptable material (rebar, etc.) would be removed from the site
- As a result it has been reviewed and draft designs for new protection undertaken as a part of this study

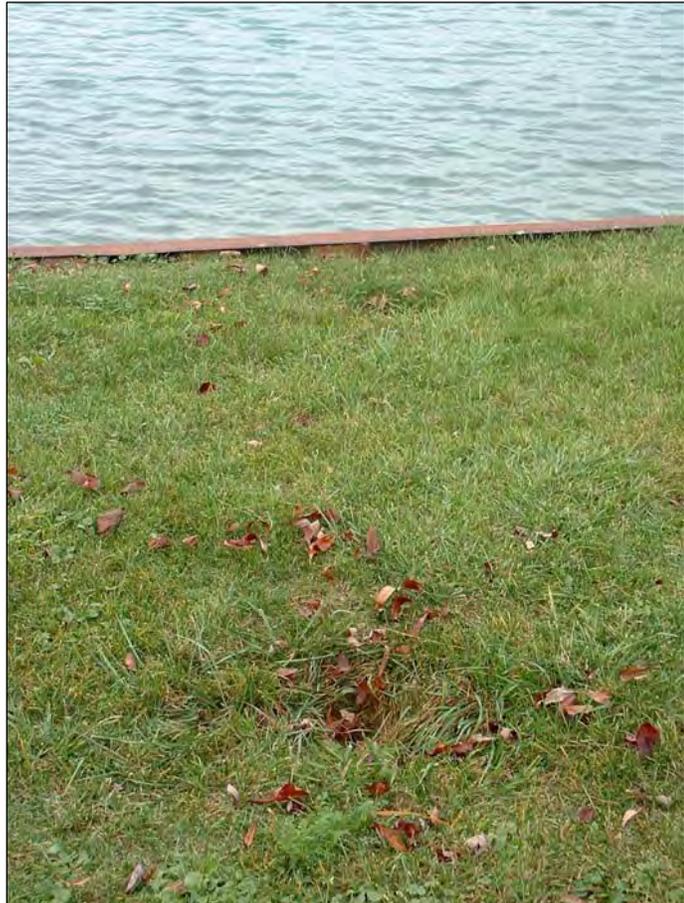
- The surface of the wall is in fairly good condition
- The wall is vertical in all locations and there does not appear to be any movement of the wall
- There is an outfall in this wall and it appears to be in good condition, however, there are two twelve inch depressions in the ground surface, two to three metres behind the wall at the outfall and may be an indication of a fault in the drain

- The existing protection is in good condition and is not expected to be replaced in the short term
- Further investigation is required to determine if an opportunity exists to place rip rap at the toe of the steel sheet pile wall to improve habitat opportunities

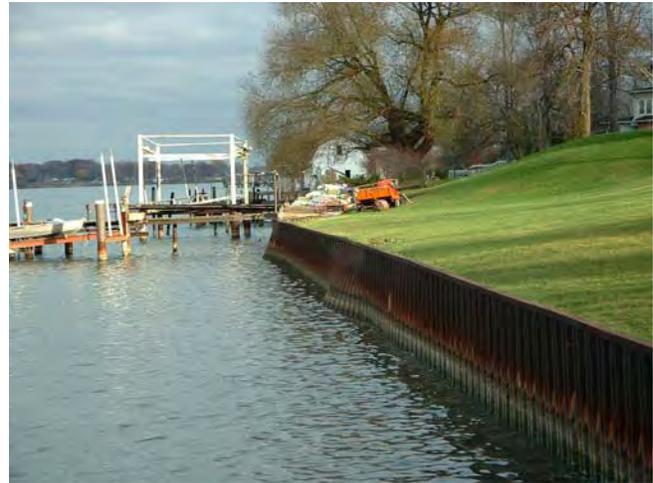
- The shoreline protection at this location is a capped, driven sheet pile wall
- This site is currently included in an ongoing St. Clair Township slope stability study. (Beresford St.)

- The retaining wall and cap surfaces are in fair condition, exhibiting signs of structural instability at certain locations
- Depressions are noted in the soil behind the retaining wall at every tie rod

- The depressions are occurring directly above the nuts and washers used to secure the tie rods into the wall and it is for this reason that is felt that the problem can be attributed to the potential failure of the tie backs

- Also, the locations of the tie rods are areas where the retaining wall is experiencing bowing and again can be related to the failure of the tie rods

- At the west end of the wall there is an exposed outfall
- The soil surrounding the outfall has been lost as the outfall has corroded through

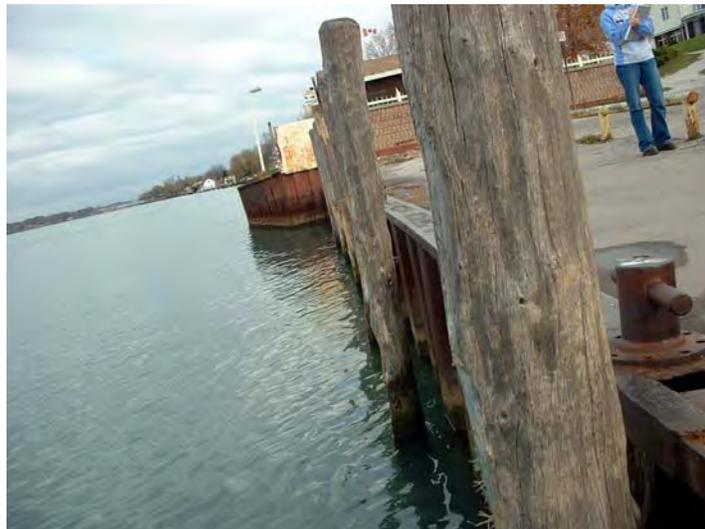
- The boat launch wall is in good condition and has undergone relatively recent repairs that appear to be sufficient
- There are slight depressions in the asphalt behind the wall
- The concrete floor of the boat launch appears to be in good condition as well
- There does not appear to be any erosion at this location
- The wooden spiles that are protecting the wall from impact damage are functioning and in good condition

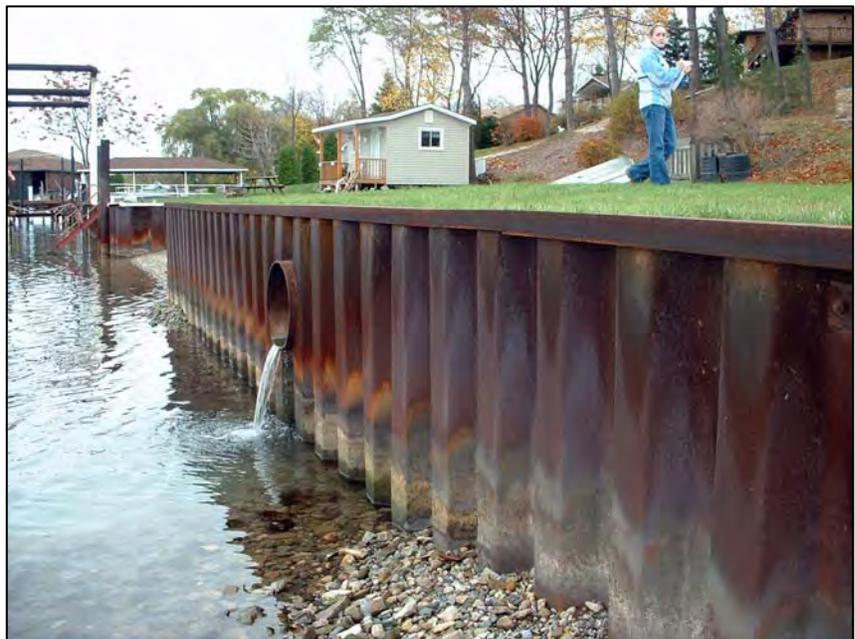
Property 19

- The property is protected by a steel sheet pile wall with a steel cap
- The property is just over 3 metres in length and there is one outfall

- The wall and the outfall are in good condition
- The wall is vertical but does show a small loss of material behind it

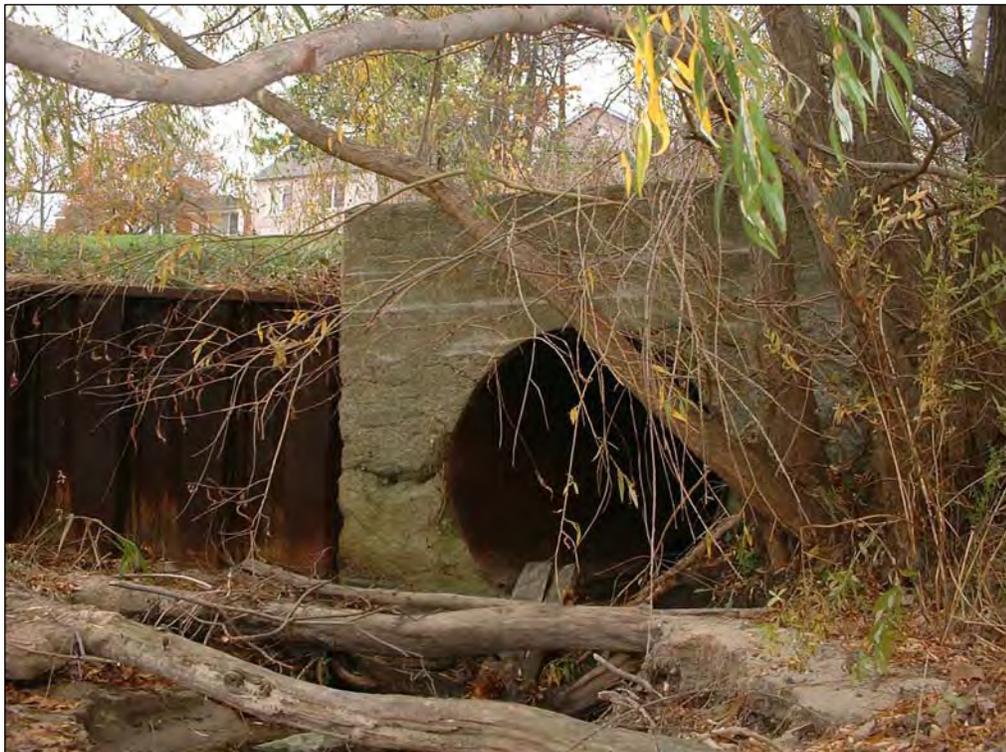
Property 21

- There are no visible problems with vertical or horizontal alignment of the wall
- Due to the lighter gauge of the wall minor dents are noticeable which are assumed to have been caused by ice
- There is a minor loss of material behind the boardwalk
- The boardwalk masks any issues occurring immediately behind the steel sheet pile wall

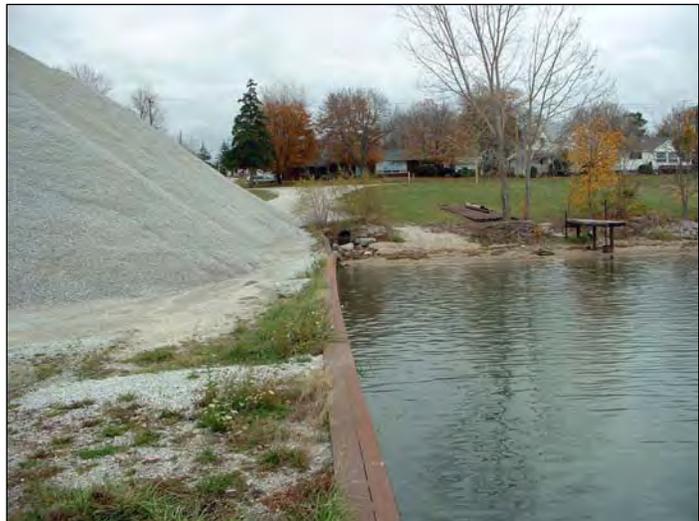
Property 24

- The northern portion of the property has very steep slopes and at one location there is evidence of bank failure
- At the toe of the slope, in a five foot section, there is the debris from the failure

- The boat slip is in good condition
- The steel wall and cap are in also in very good condition
- However, due to a flaw in the design of the sheet pile wall, massive soil loss has occurred

- At the corners of each wall section, major failure has occurred behind the walls
- Depressions greater than a metre cubed have occurred at each corner

- Some of the corners have been filled with poured concrete
- Moving south, there are large voids between the broken concrete and sections of the bank are experiencing loss of material

- Around the gravel dock, the retaining wall does not appear to be vertically straight at all locations thus indicating areas of slippage behind wall
- The top of the wall appears to be leaning toward the water
- A possible explanation for this slippage may be attributed to the significant amount of weight that is being placed on the underlying substrate from the gravel storage
- The cap of this wall is cracked
- This is further evidence of stress on the wall and of movement

- At the north end of the site it is recommended that the existing wall be replaced with a wall that is anchored into the bed of the river so that no undercutting behind the wall is possible
- An armourstone wall / revetment would provide the necessary support as well as provide a significantly more friendly environment
- The option does exist to contour the wall to provide further opportunities
- The discarded concrete rip rap should be replaced with suitable erosion control in the form of rock rip rap or armourstone
- In the longer term, the wall around the gravel docks could be replaced with a armourstone wall

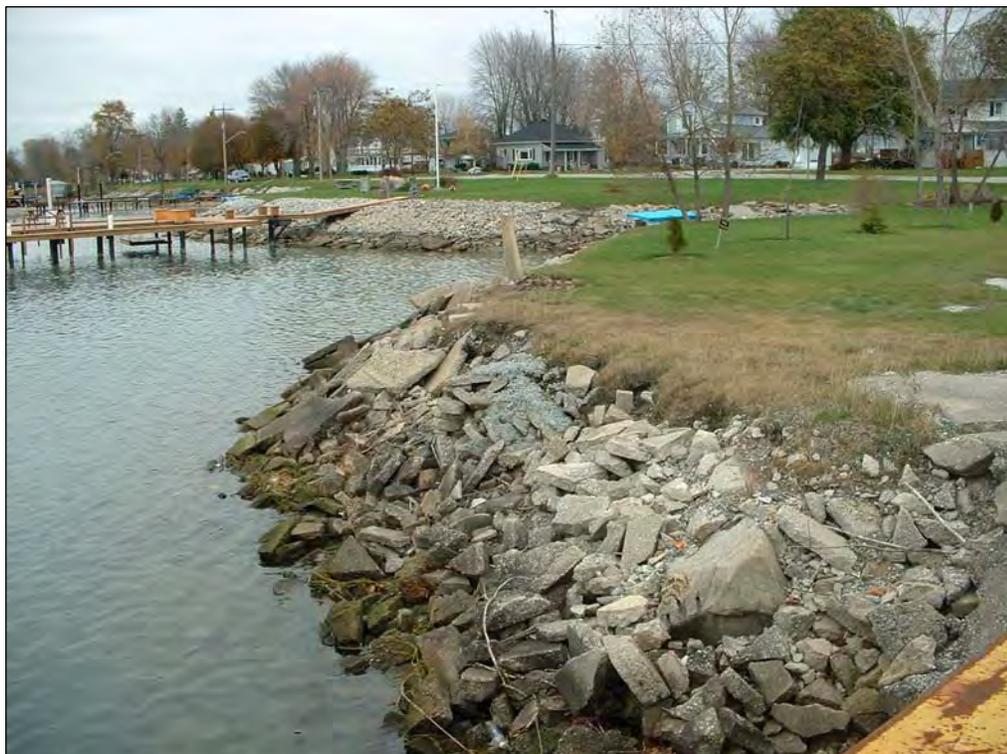
Property 27

- The shoreline of the property is approximately 6 metres in length extending north from the seawall which protects the gravel docks
- Protection on site is discarded concrete and broken sidewalk

- Due to the lack of design and sporadic placement there are several large voids in the protection
- The large voids indicate existing erosion and foreshadow major failures in addition to being a safety concern

- Due to the current status of the site and the resulting short lifespan of the existing protection this site is a candidate for habitat enhancement activities
- However, the site is quite short in length and is bounded to the north and south by areas of greater activity (gravel docks to the south requiring deeper water access and a recreational dock to the north) which will have to be taken into consideration

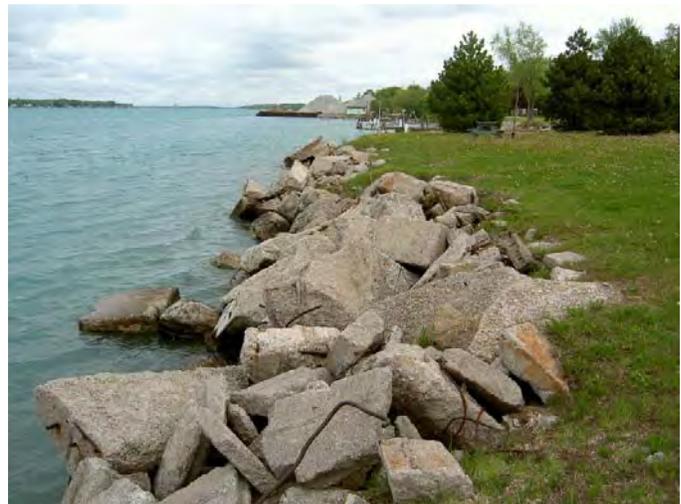
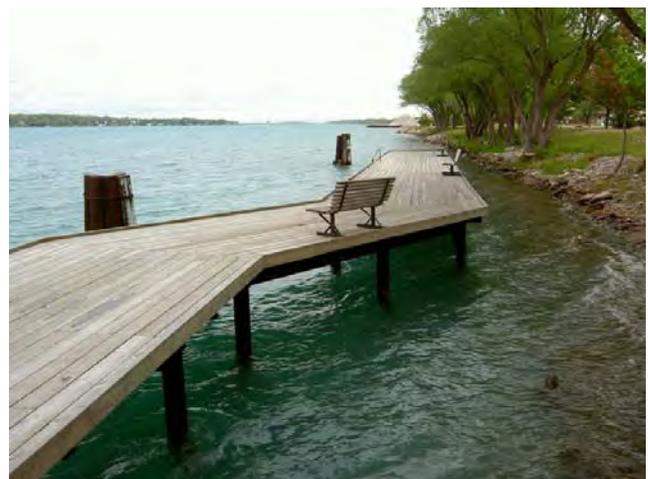
Property 28

- This reach is approximately 210 metres in length
- The northern third of the property is protected with concrete rubble
- The central third of the site has rip rap and armourstone providing some protection to the shoreline
- The southern third has small rip rap and cobble as protection
- The park has been filled out into the channel by approximately 12 metres relative to the adjacent shoreline
- A large dock supported on piles extends out from and north along the shoreline in the near the centre of the site

- The rubble in the north end although providing some protection also contains a sizeable amount of rebar and other steel and has several voids
- Other protection is quite marginal, especially at higher water levels

- Increased water levels will increased the issues present at this site
- Safety concerns are quite serious at the northern end
- This is a sizeable site and would provide significant opportunities for enhancement however, without higher water levels the incentive will not be there in the short term

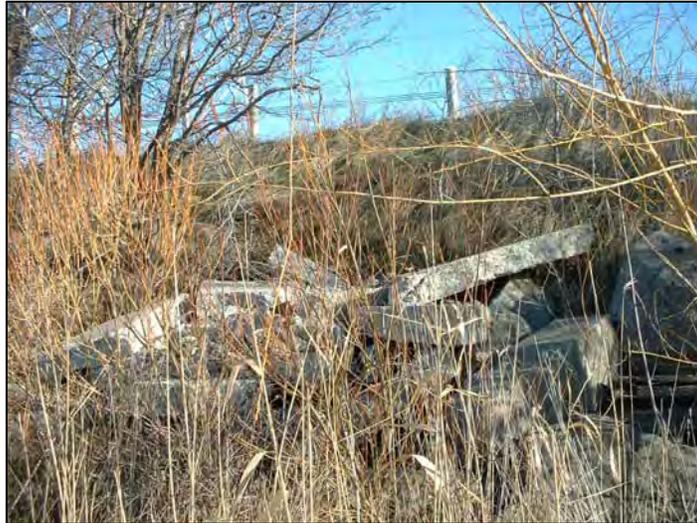
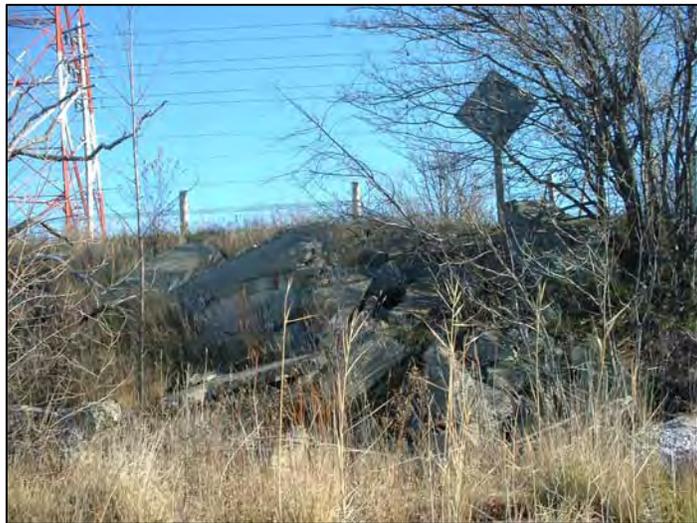
Property 30

- The bank is quite significant at this location in excess of 5 metres in height
- No designed protection is in place at this location
- Large slabs of concrete have been deposited at this location and although they have added a significant amount of weight to the slope it does not appear to be having a significant impact
- Some erosion on the upper portion of the slope is evident, possibly as a result of overland flow
- Woody vegetation is also prevalent on the slope

- Despite the lack of protection, erosion appears to be in check

- Again although this is a potential site for enhancement without the need for protection it will certainly be a lower priority
- The steep bank at this location will also limit the options available

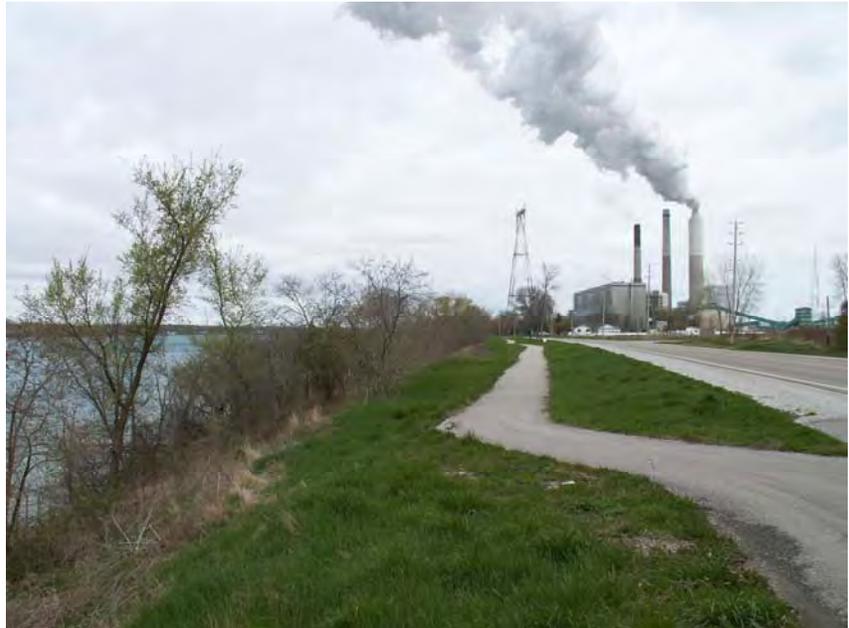
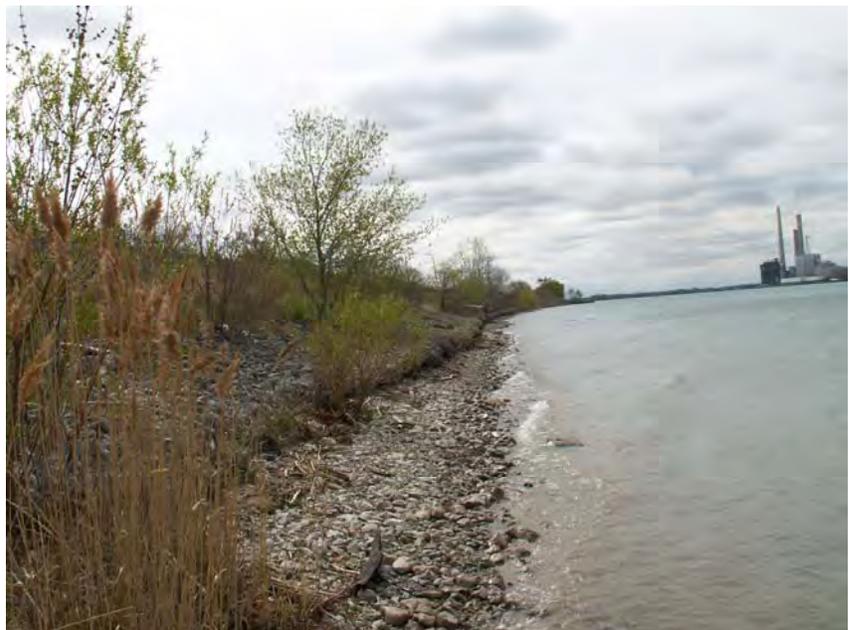
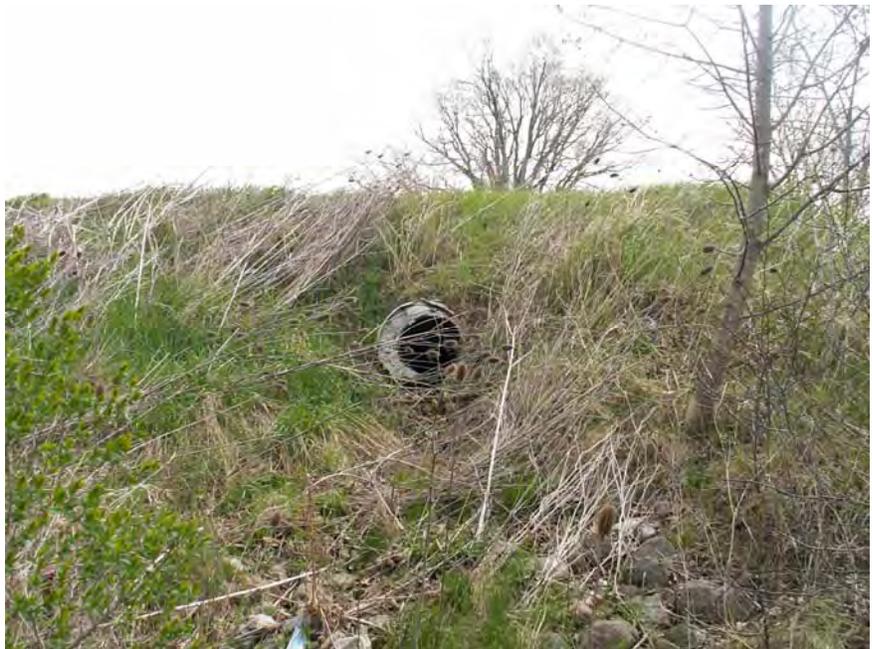
Property 31

- Shore protection varies greatly along this reach
- The northern portion of the site is protected with a row of gabion baskets
- A cobble beach fronts the gabions at current water levels
- Proceeding south on the site, the gabions end and no protection replaces it
- A very narrow sand beach with sporadic rip rap and wood debris provide the remainder of the site with protection
- Several outfalls are present throughout the site some of which have erosion protection measures

- The gabion baskets at the north end of the site are breaking down and are rolling toward the river
- Cobble beach is providing some added protection at lower water levels
- Further south erosion is more obvious as a narrow sand beach fronts the toe of an eroding slope
- The degree of toe erosion varies from section to section
- In addition some erosion has been caused by overland drainage and still further erosion is evident at some of the multiple outlets within the reach

- The site is a good candidate for habitat enhancement works
- Alternatives that permit the existing uses (footpath) and provide protection to the road at the top of the slope could be proposed but will have to be supported by the landowner

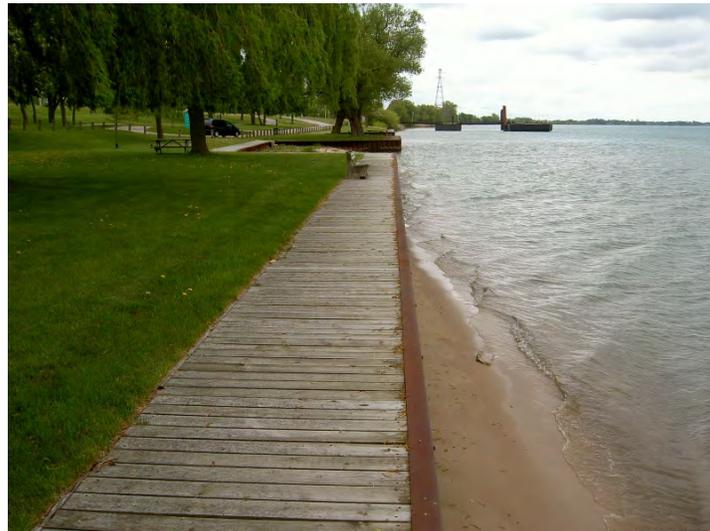
Property 32

- The property is protected by a steel sheet pile wall with two pocket beach cells
- The wall has a steel cap and in some areas has a boardwalk on the inland side
- At the south end, cobble has been placed in front of the steel sheet pile wall for additional protection

- In the beach cell areas there are signs of minor misalignment, however on the whole the wall is in good condition
- Minor backfill losses behind the wall and boardwalk in some locations
- Some of the boardwalk timbers are broken

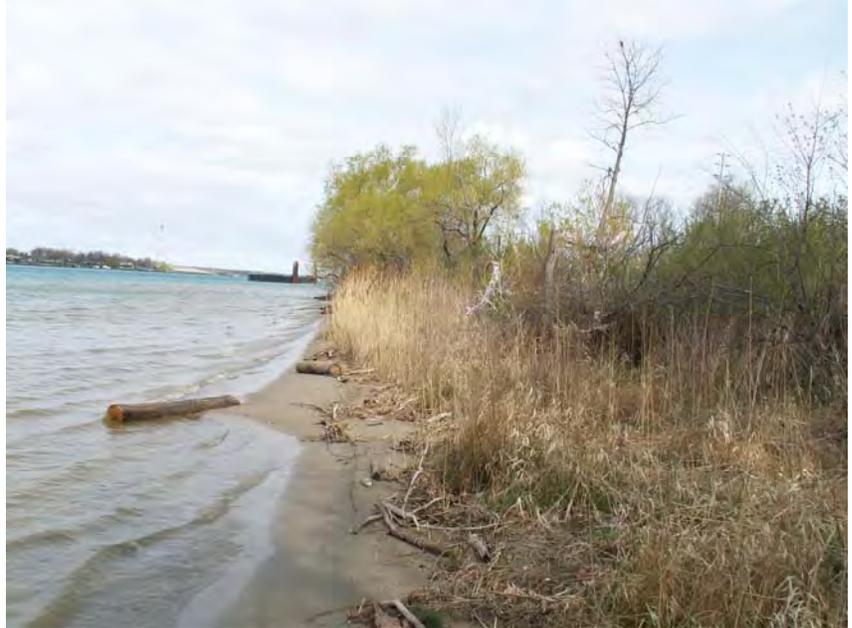
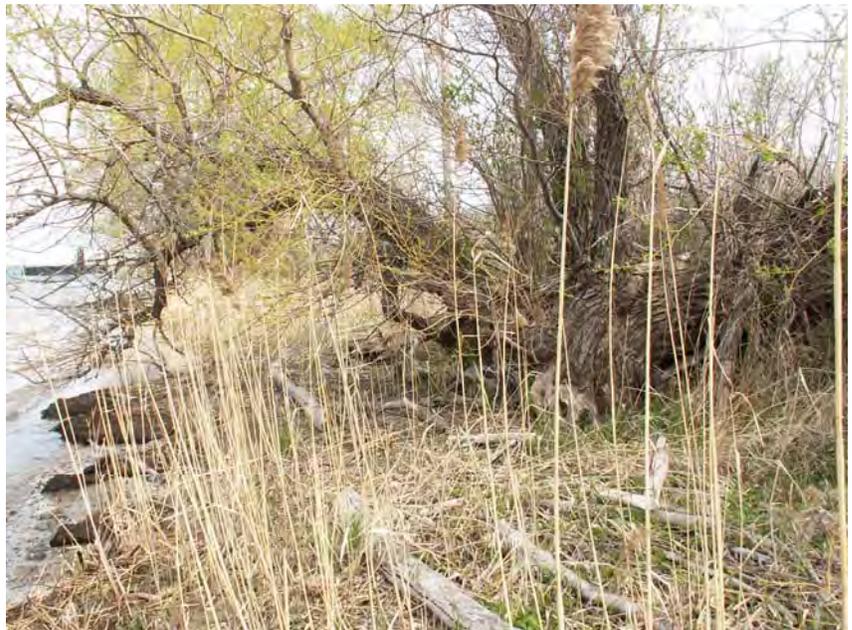
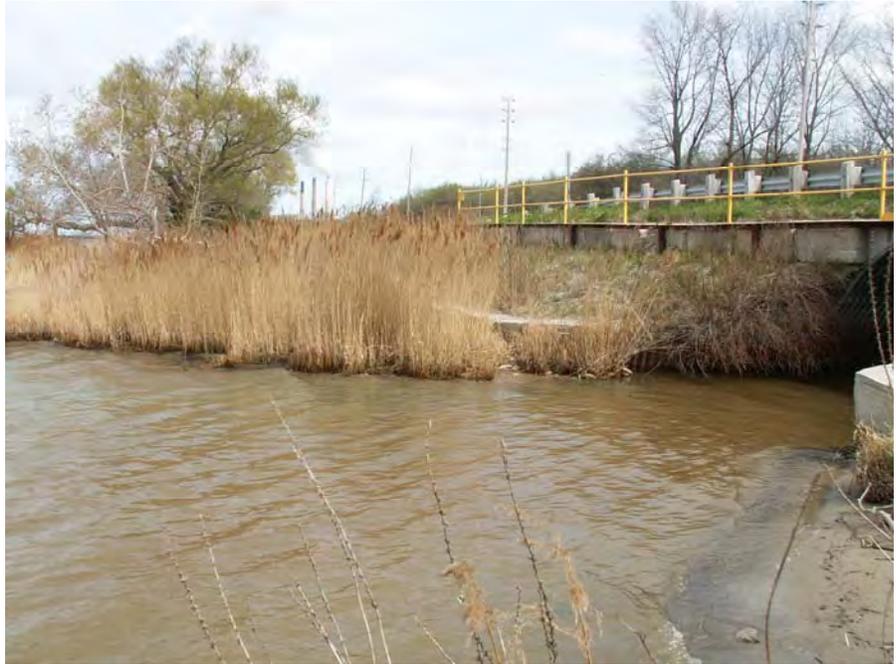
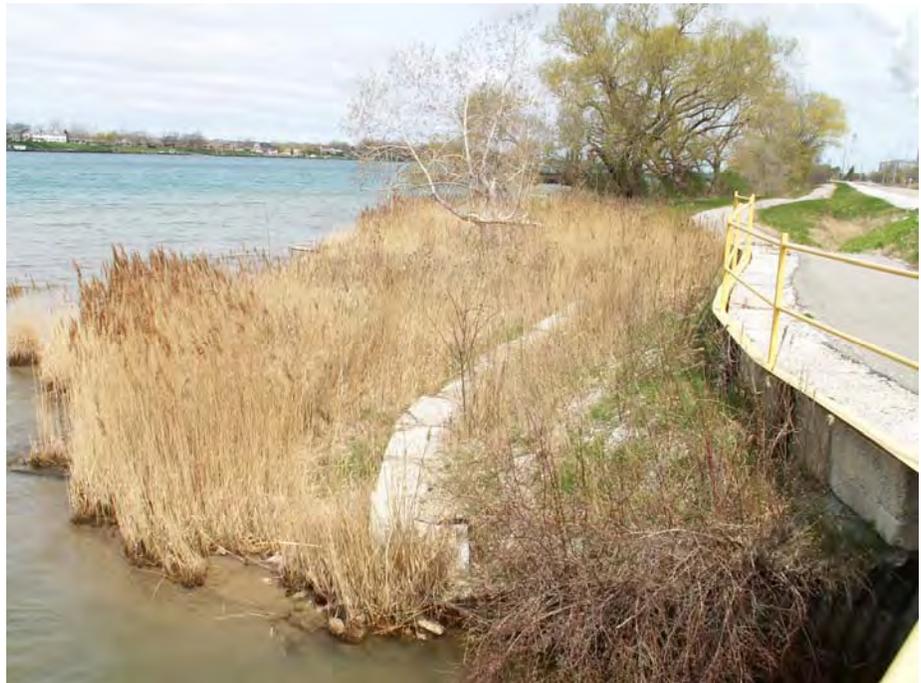
- Two types of shore protection are present at this site
- The area around the outlet of Bowen's Creek is protected by large concrete blocks which are also incorporated into the construction of a bridge over the creek for the walkway
- A very narrow sand beach with sporadic rip rap and wood debris provide the remainder of the site with protection
- The bank is heavily vegetated but does show some signs of previous slumps
- Several outfalls are present throughout the site some of which have erosion protection measures

- The concrete blocks are in good condition and are supporting the bank, walkway and bridge
- In other areas north and south of the outlet, erosion is more obvious as a narrow sand beach fronts the toe of an eroding slope
- Other areas are protected to some degree by dense wetland vegetation
- The degree of toe erosion varies from section to section
- In addition some erosion has been caused by overland drainage and still further erosion is evident at some of the multiple outlets within the reach

- The site is a good candidate for habitat enhancement works
- Alternatives that permit the existing uses (footpath) and provide protection to the road at the top of the slope could be proposed but will have to be supported by the landowner

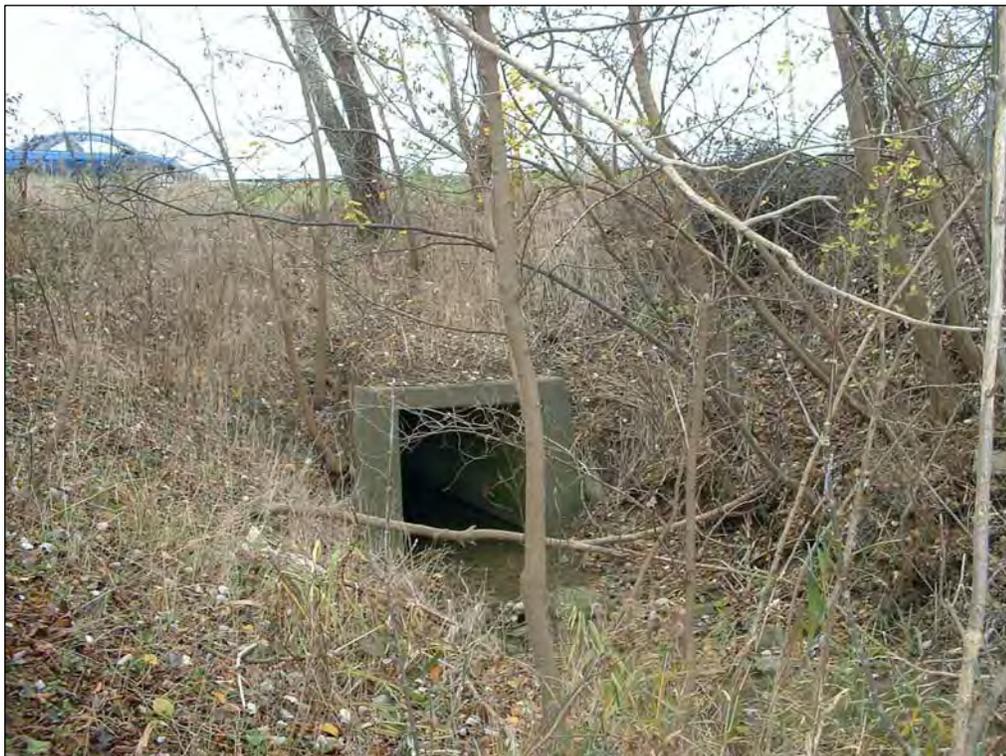
Property 34

- The banks appear to be in stable condition
- Based on the angle of growth of some of the larger woody vegetation it appears that there has been some form of slippage in previous years
- The outfall is functional and in good condition

- No anticipated improvement is protection at this time
- Some of the large vegetation should be removed to reduce weight on the bank
- There may be an opportunity to improve the channel from the St. Clair River up to the concrete culvert which should be investigated further

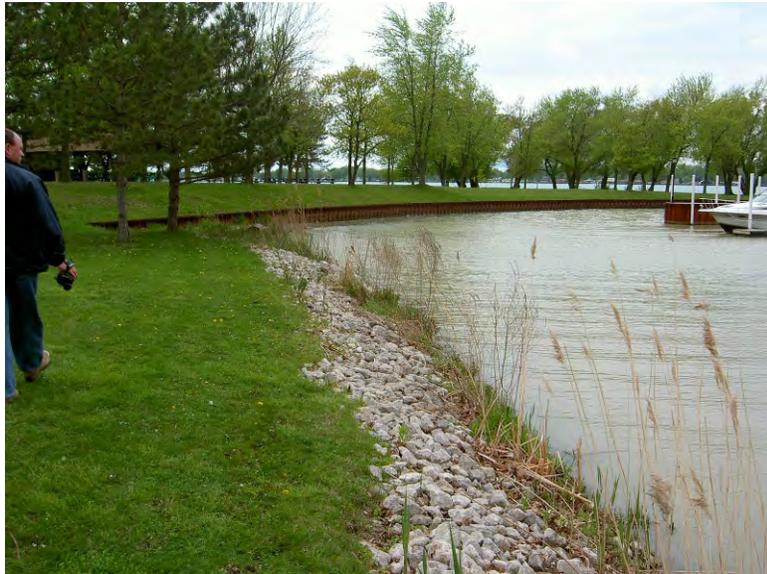
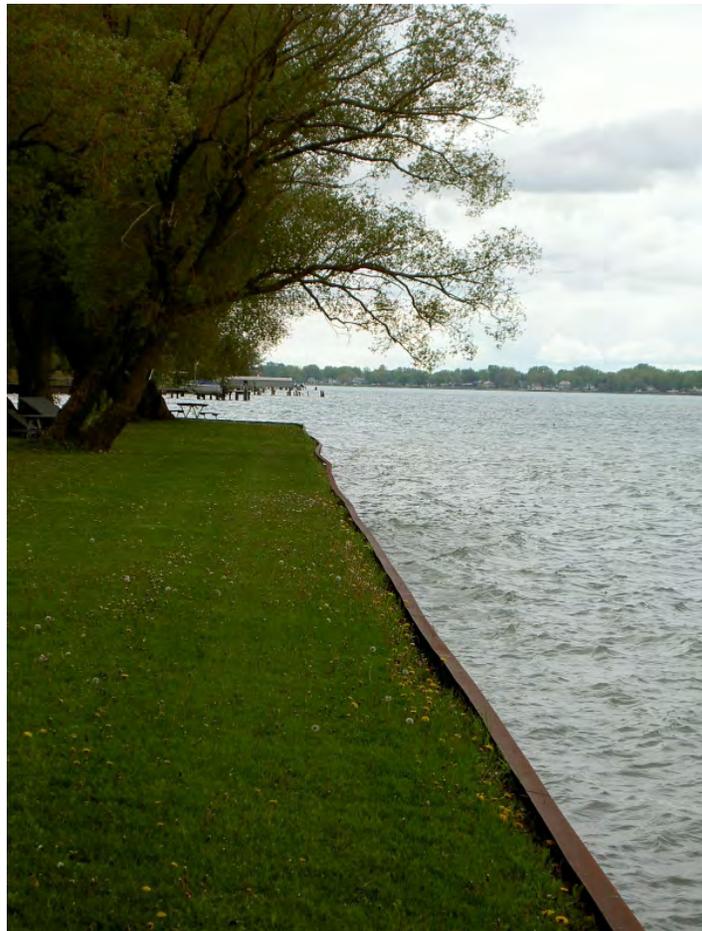
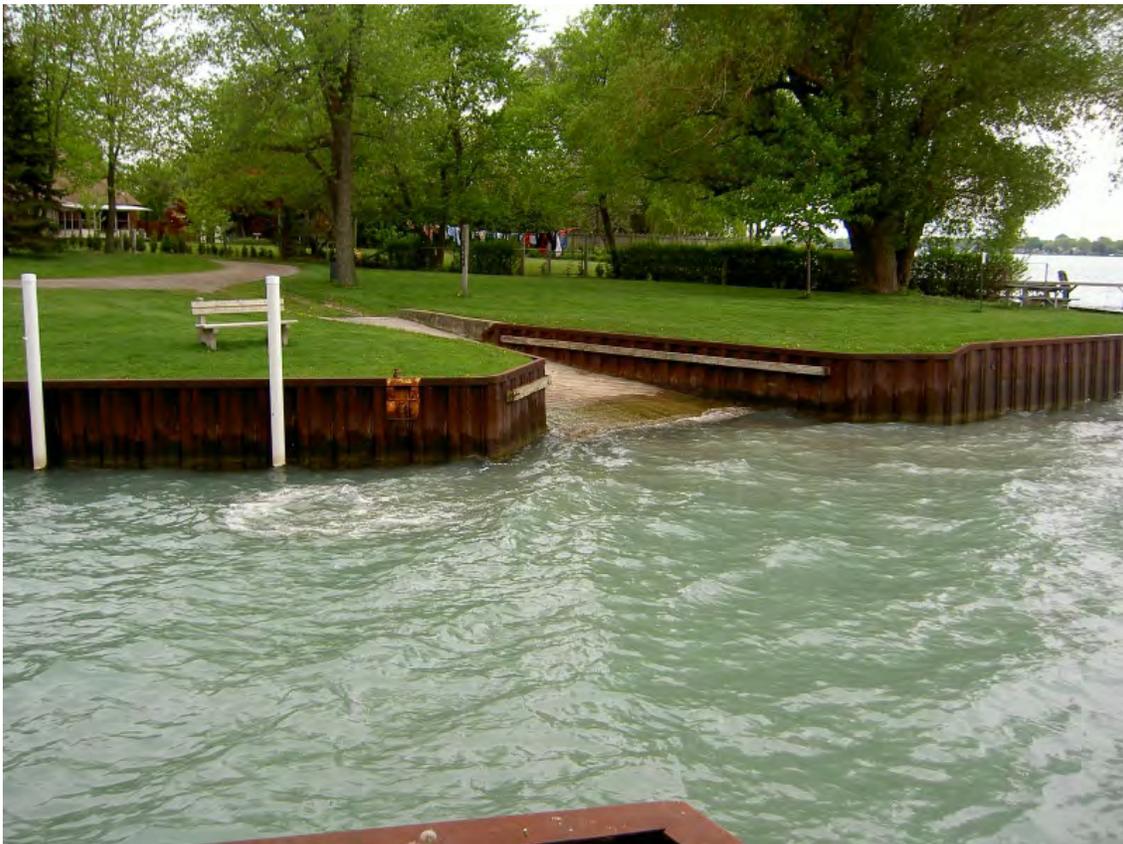
Property 35

- Steel sheet pile wall line all but 75 metres of the over 1300 metres of shore protection on site
- Along Clay Creek moving toward the mouth from the St. Clair Parkway, a rip rap revetment protects the banks
- Continuing out to the mouth of Clay Creek along the St. Clair River and along both sides of the internal channel (around an island) are steel sheet pile walls which extend 1 – 2 metres above water level
- The boat launch walls are constructed of

- The rip rap in the revetment is undersized but no significant erosion is apparent
- Repairs to the walls of the internal channel have occurred recently
- Walls along the St. Clair River are misaligned both vertically and horizontally
- Some denting of the wall is evident, likely from ice
- Use of launch ramp hampered by reflecting waves from surrounding steel sheet pile walls
- Walls also reflect waves notably into internal channel docking area
- Walls along the creek and on the internal channel appear to be in satisfactory condition

- The exposed steel sheet pile wall have a very limited lifespan (under 5 years) and may afford an opportunity to change the type of protection
- An armourstone revetment with rip rap ramp at the toe would provide improved significantly improved
- Limited opportunities will exist to vary direction of the shore protection but these opportunities should be researched
- A reduction in the amount of steel sheet pile walls will improve boat launch and dock safety as well

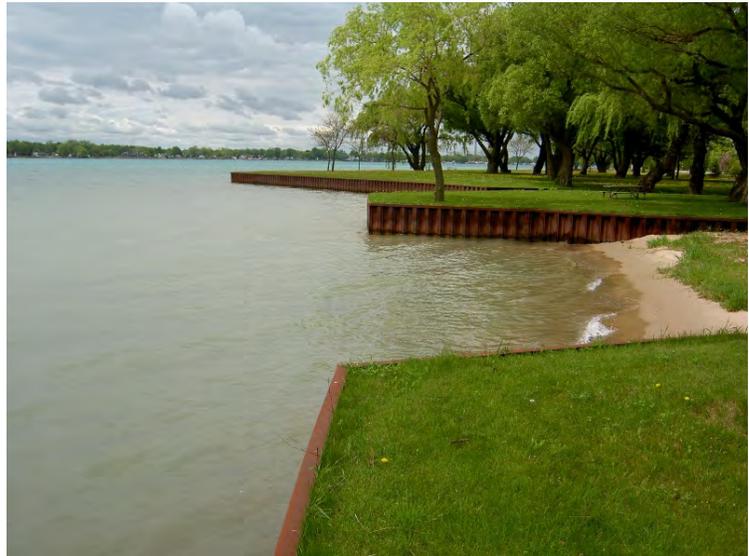
Property 36

- Light gauge steel sheet pile walls protected most of the shoreline
- 3 pocketed beaches are incorporated into the structures
- The north end of the site is partially protected with rubble and partially unprotected
- The boat launch wall are constructed on steel sheet pile with a concrete floor

- Steel sheet pile walls in the north end of the site and south of the ramp exhibit signs of moderate instability (horizontal and vertical misalignment)
- North wall of boat launch appears stable
- Unprotected extreme north end of the site is experiencing erosion
- A minor indent from ice observed at several locations

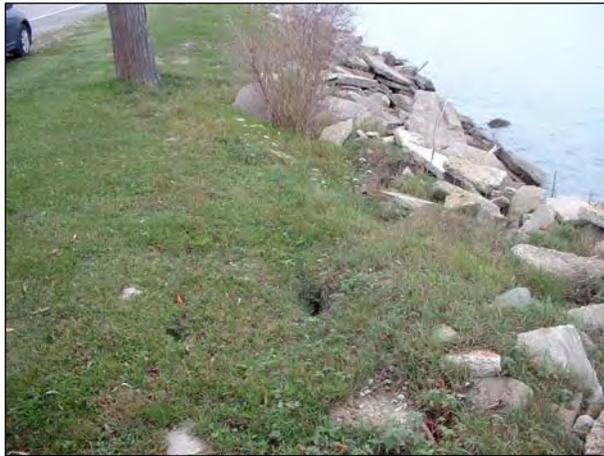
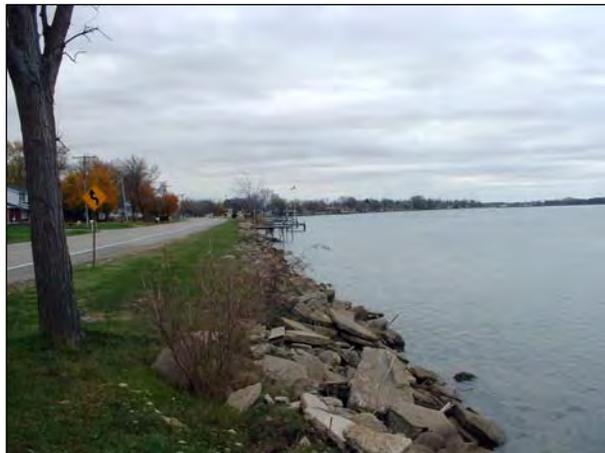
- Protection varies greatly along the length of this site from discarded concrete, broken sidewalk, cinder blocks, crushed quarry stone and no protection in several areas
- None of the existing appears to have been designed
- Some areas have a fifteen foot buffer of green space between the top of bank and the road while others have no green space and just a guard rail
- Therefore it is imperative that erosion protection is in place to prevent any loss of roadway or road bed
- Along this section of riverfront there are several private docks

- Erosion is evident in several areas ranging from minor toe erosion to significant voids around large blocks of misplaced concrete

- Good candidate for enhancement
- Two issues will have to be taken into consideration
- Protection of the road and road bed will be a priority for any improvement works
- With little land available in some areas the project will have few contours and will likely require some infilling

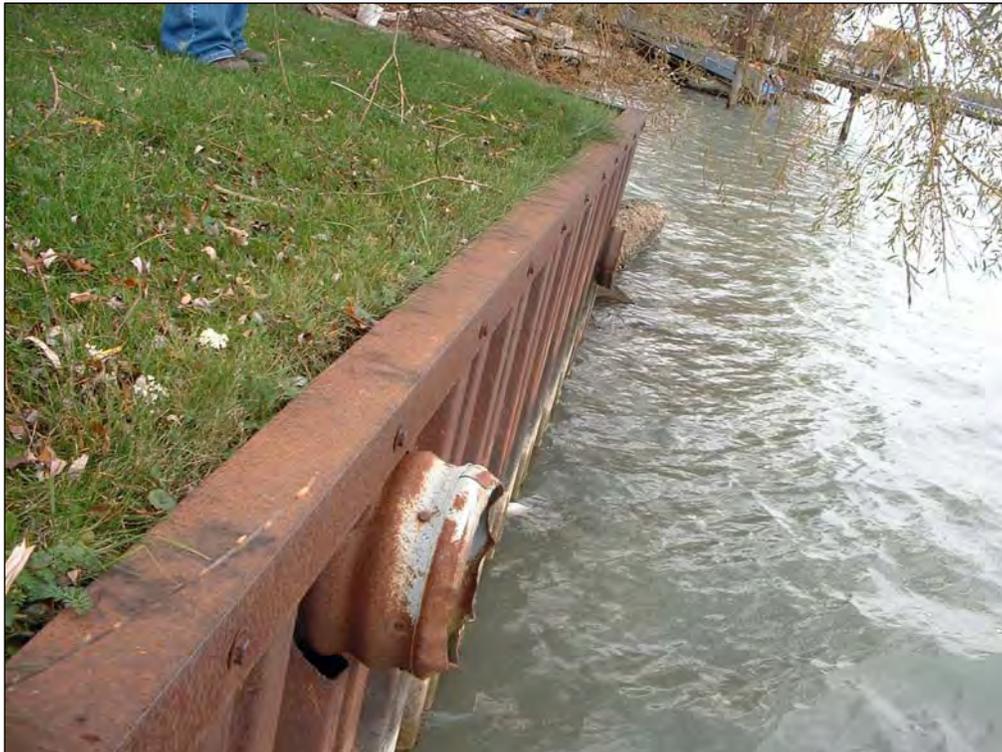
Property 38

- The wall is in good condition
- The wall is vertical and shows few signs of pitting
- Outlet is in fair condition with some deterioration

- Due to the estimated lifespan of the existing protection of 15 to 20 years, this is not seen as a good candidate site
- However, there may be an opportunity to research this site further to determine if there is an opportunity to place rip rap at the toe of the wall to provide some additional habitat
