St. Clair River Shoreline Restoration Assessment and Design of Restorative Works

Report to Great Lakes Sustainability Fund and Project Partners

St. Clair Region Conservation Authority
April 2006

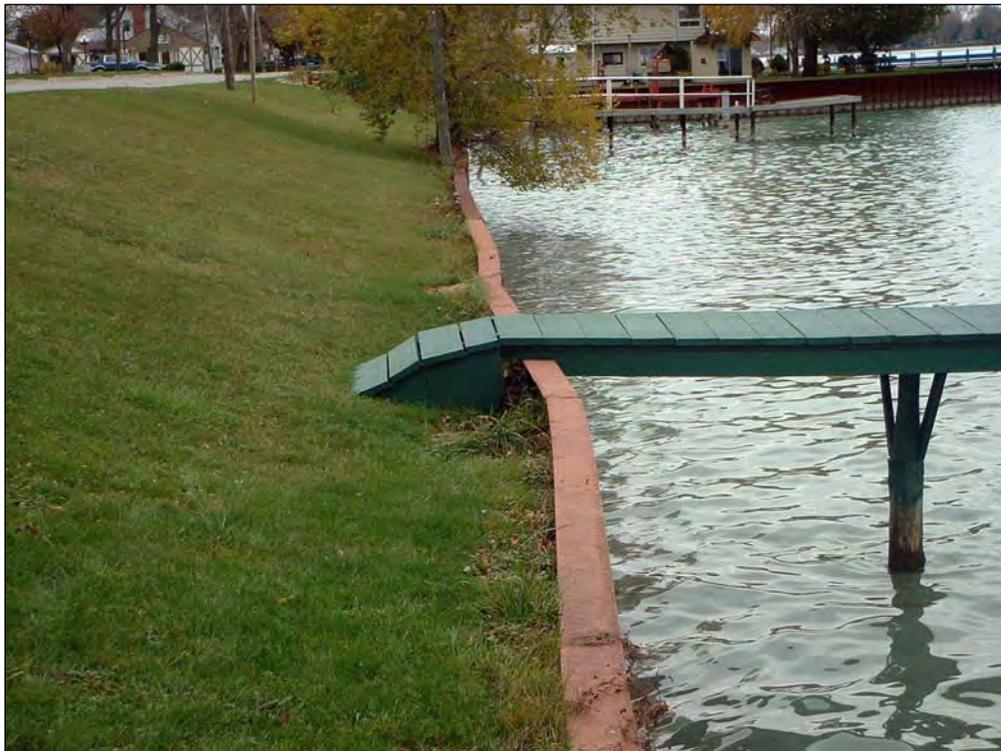
Property 39

- The retaining wall is experiencing some movement
- This is evident in the vertical variability in the wall
- At several locations the wall is bowed and at these locations there is a significant loss of material from behind the wall
- The loss of material has exposed tie-backs at some locations
- Another concern at this location is a break in the weld along the steel cap
- The outfalls are in good condition

- The anticipated lifespan of these walls, 10 years, and the size of each site makes these properties lesser candidates

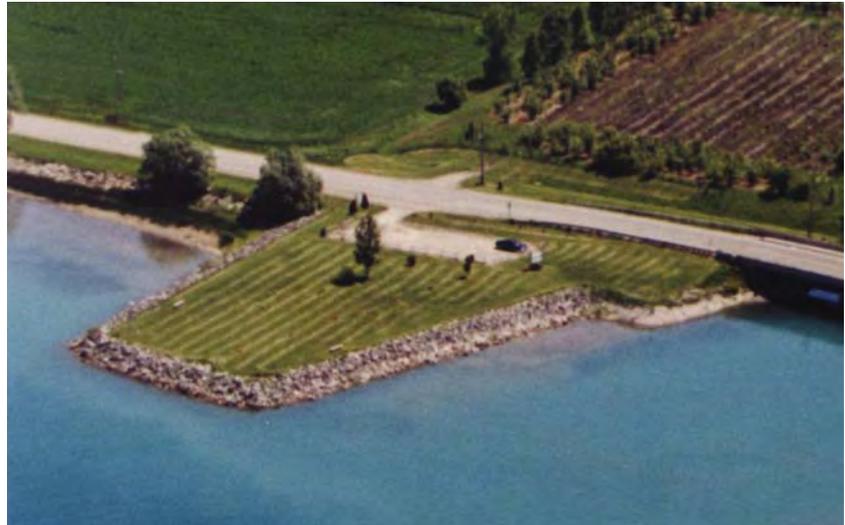
Property 41

- The shoreline protected by a large rip rap / small armourstone revetment along both the river shoreline and the floodway outlet shoreline
- The total shoreline length of the property is almost 300 metres

- Existing shore protection is in good conditions
- Protection appears to be over designed for the site which may be the result of the capping of core material under the park

- The condition of the existing protection and the requirement to maintain the existing cap on the site will not permit any significant changes to the protection

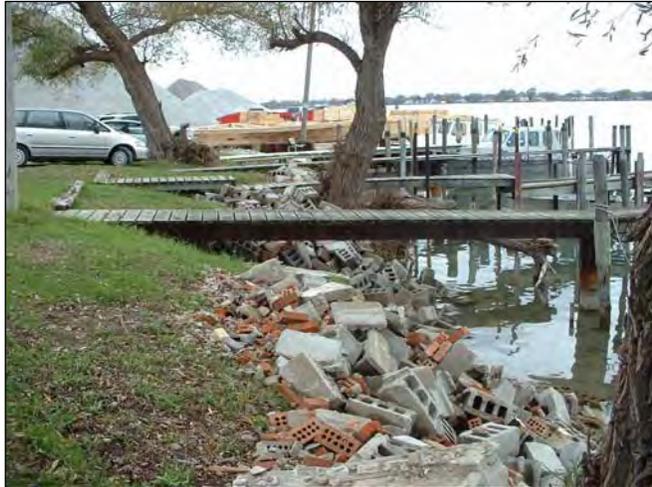
- The northern portion of this location there is erosion control in the form of discarded concrete slab and broken cinder block rubble
- Running south, the erosion control makes a transition into a steel sheet pile wall with a steel cap, within this section there is a boat launch
- Further south the structure makes the transition back into dumped concrete

- In the areas of discarded concrete and blocks erosion is ongoing and several large voids have developed
- There is some large stock woody vegetation which may pose a threat to the erosion control protection and the stability of the bank
- The area of the steel sheet pile wall appears to be in good condition having only warped slightly and with minimal erosion present

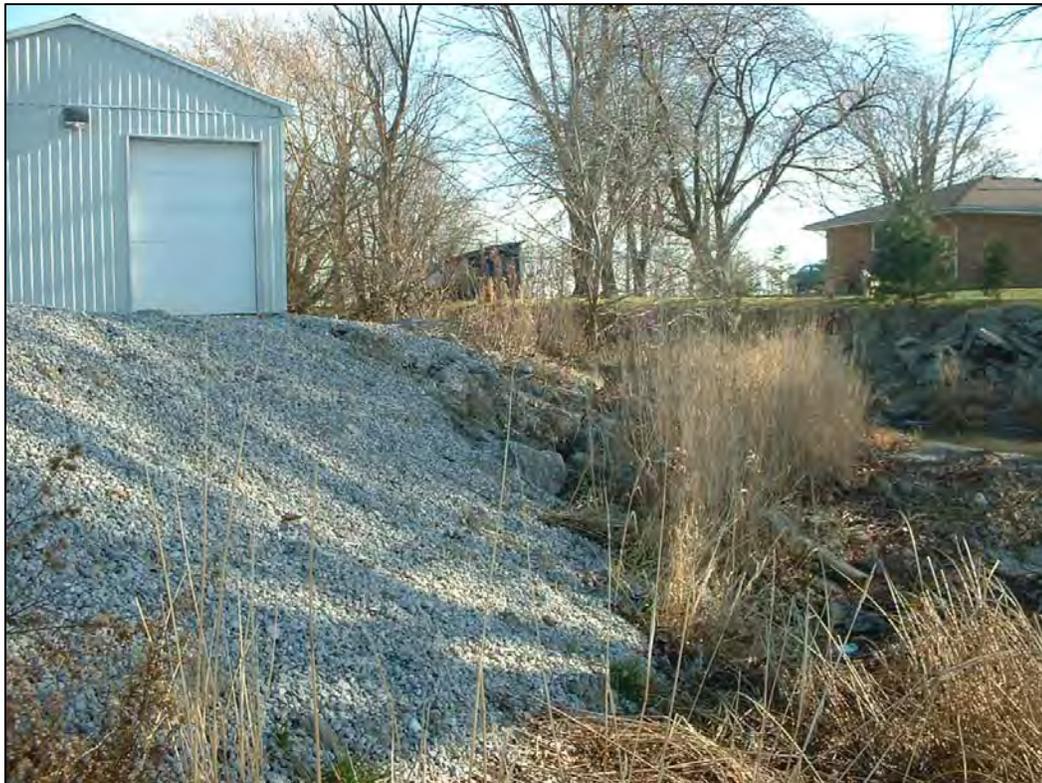
- The erosion protection appears to be in good condition with no evidence of ongoing erosion being visible
- There is some large woody vegetation which is adding weight to the bank at several locations

- Large woody vegetation although providing some shade is of concern due to the potential for significant failure
- Although not created of preferred material, the existing material is performing its required duty and therefore this site is not seen as a lesser candidate

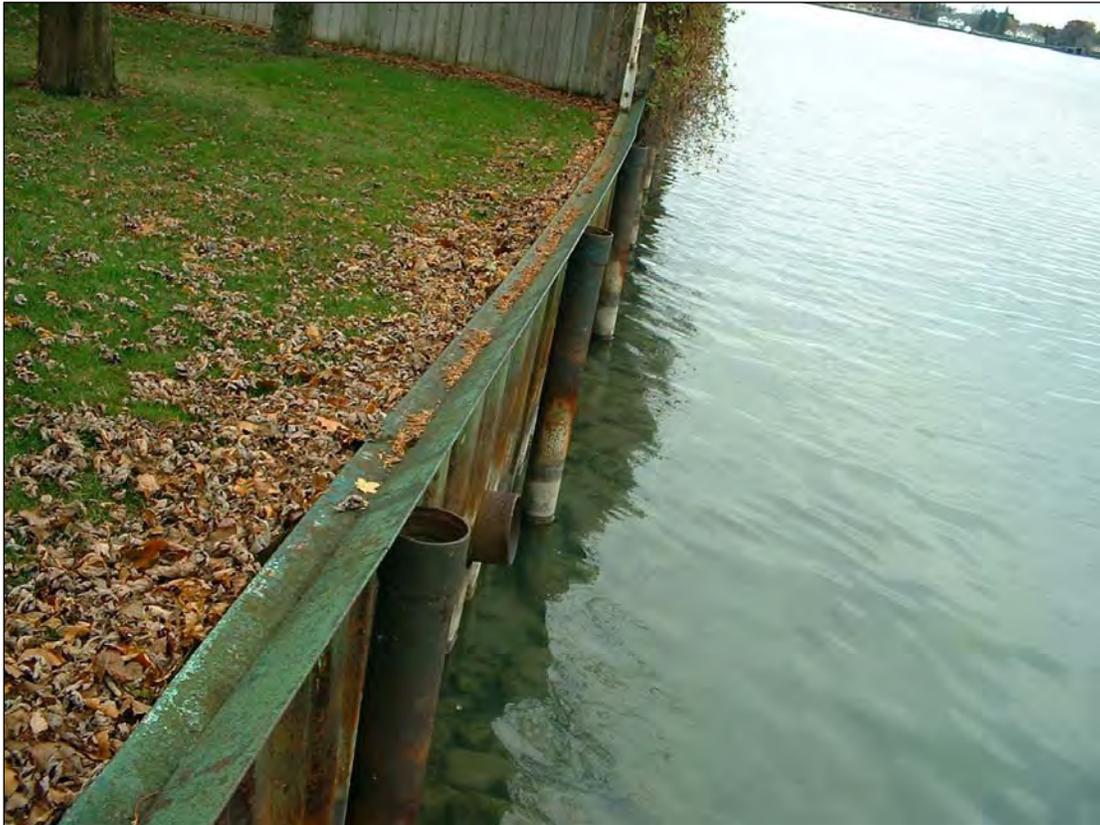
- The wall is in very good condition with minimal rusting and only the slightest misalignment

- Due to the size and condition of the site, enhancement activities are not expected to be supported

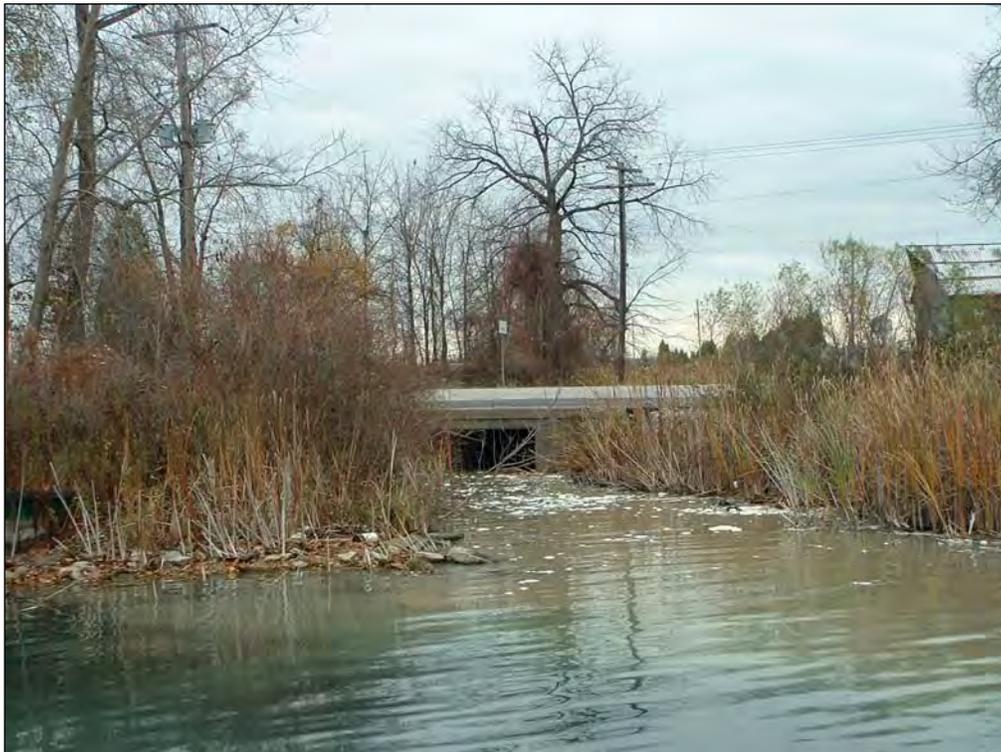
- The extent of the erosion, if any, is difficult to quantify due to the large amount of vegetation present on the bank
- Overall, the site appears to be in good condition with minimal erosion taking place

- Although a portion of the protection is an unnatural product (broken concrete) this site has naturalized itself and therefore this is not seen as a candidate site
- However, the refuse being removed from the site would be a significant improvement

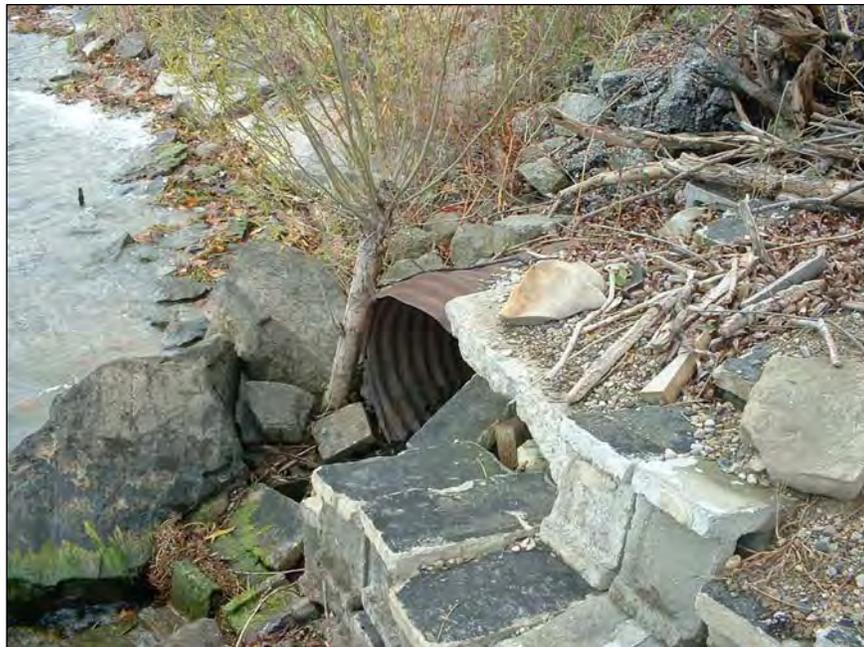
- Although some of the cinder blocks have been placed, the greatest portion of the rubble protection was not
- As a result there are quite a few large voids within the existing erosion control structure
- These large voids not only increase the threat of erosion and decrease the marginal effectiveness of the existing protection it also can pose safety issues due to the instability
- The outfall is in good condition

- With very little value in the existing protection, this site is a good candidate for enhancement especially with an opportunity to remove the unwanted materials from the shore and near shore
- However, as a road allowance the reach is only approximately 20 metres in length

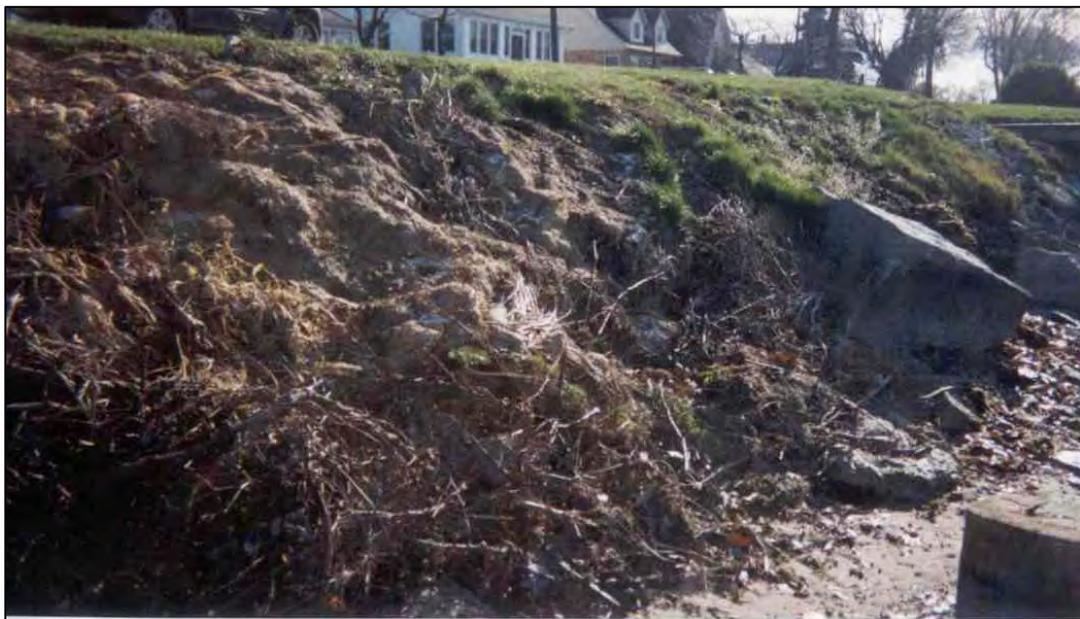
- Virtually no protection exists at this site, some broken concrete and blocks are present
- As a residential road allowance this reach is short
- The bank at this location is approximately 1.5 metres in height

- Although protection improvements and habitat enhancement at this site would be significant improvements, due to its size this site would not rank well in comparison to other
- Education to the local residents with regards to disposal of clippings and brush would provide an immediate improvement

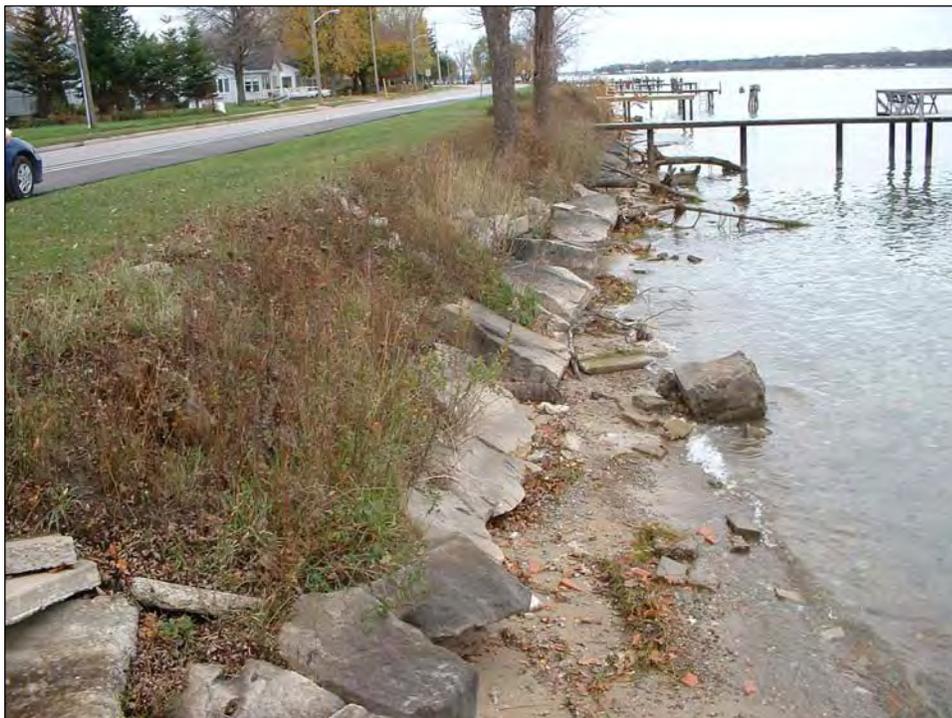
- There does not appear to be any significant erosion taking place with the exception of a few areas where fill has been placed
- There is some minimal surface erosion occurring due to overland flow
- The outfall is corroded and completely blocked with sediment which may indicate that it no longer support its intended function

- Due to the stability of this site, this does not appear to be a good candidate site
- Improved protection will provide little habitat enhancement

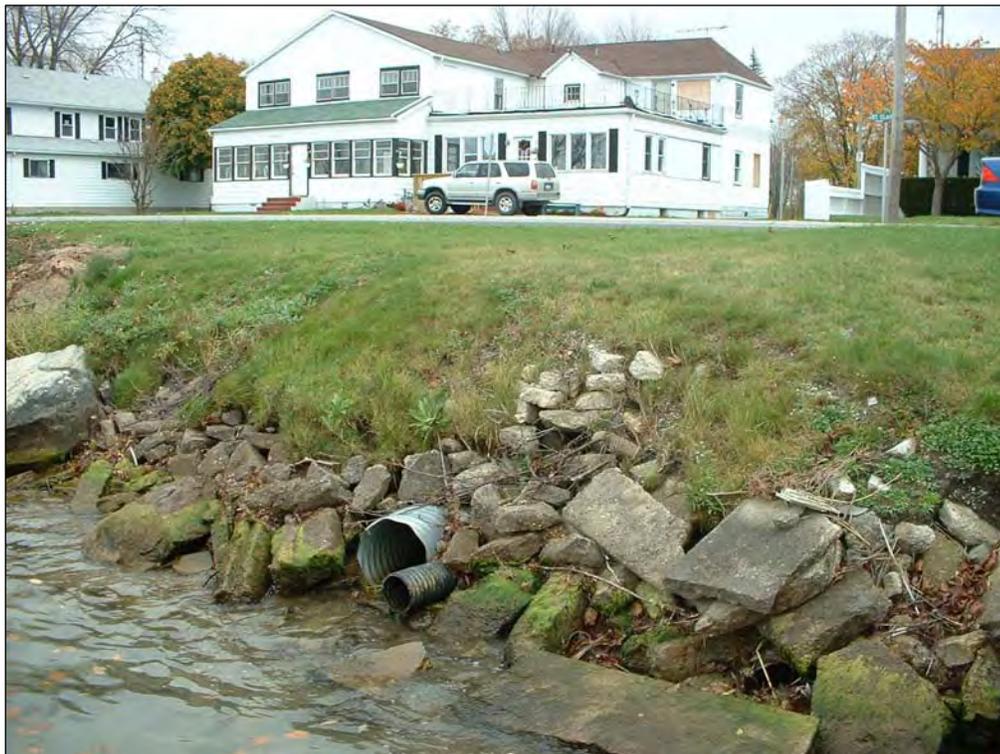
- The existing erosion protection appears to be slipping as a result of toe erosion
- This is evident by the large crescent shaped depression that appears to be forming just above the erosion protection
- The two outfalls are in good condition

- Once again, due to the length of the site this is not a strong candidate for habitat enhancement

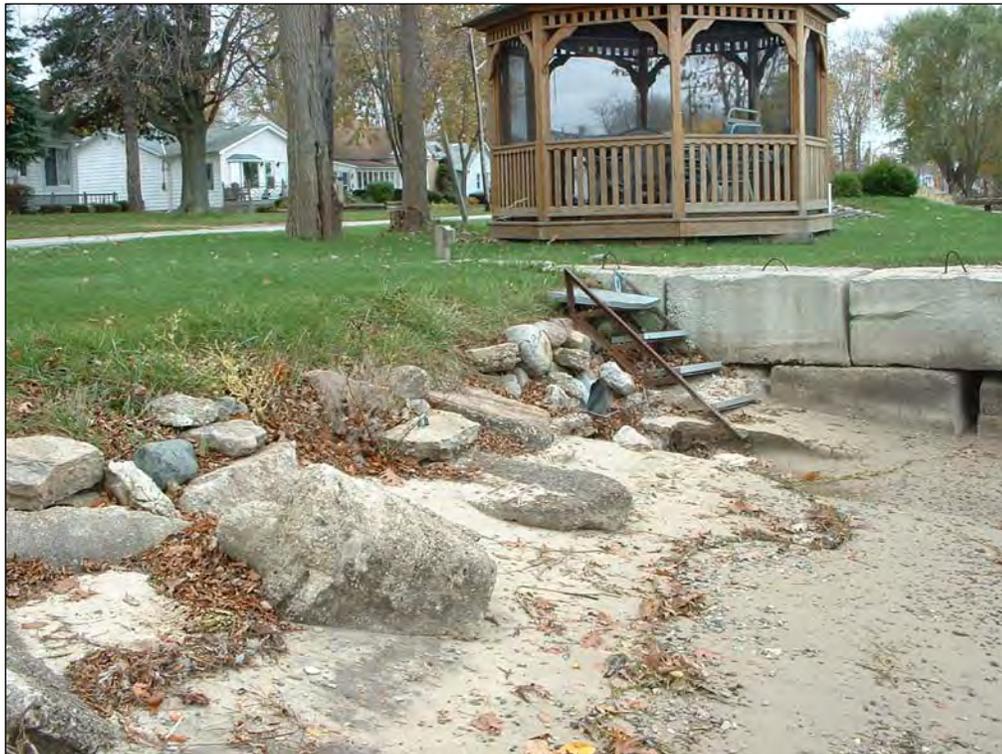
- There are some large voids within the structure but based on the height and gentle gradient of the slope, bank erosion is not of concern
- There is no surface loss observable at the top of the erosion protection and the outfall is in good condition

- A sizeable beach fronts the protection, as a results habitat enhancements opportunities at this location are limited

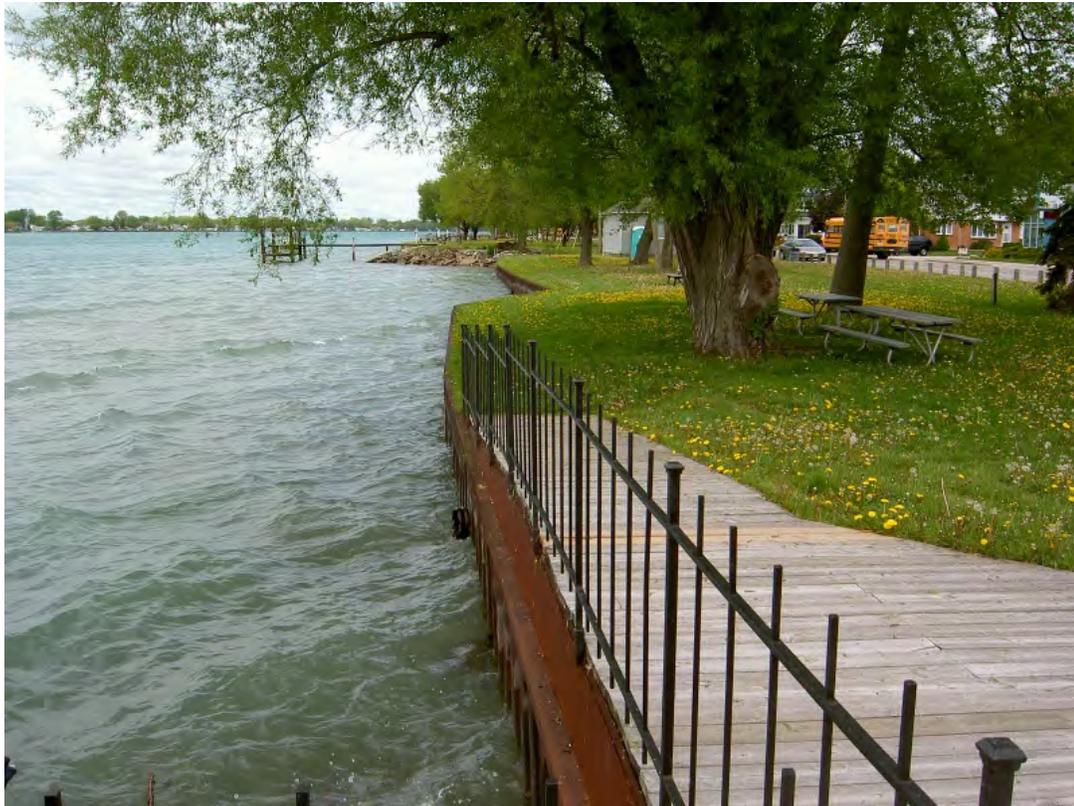
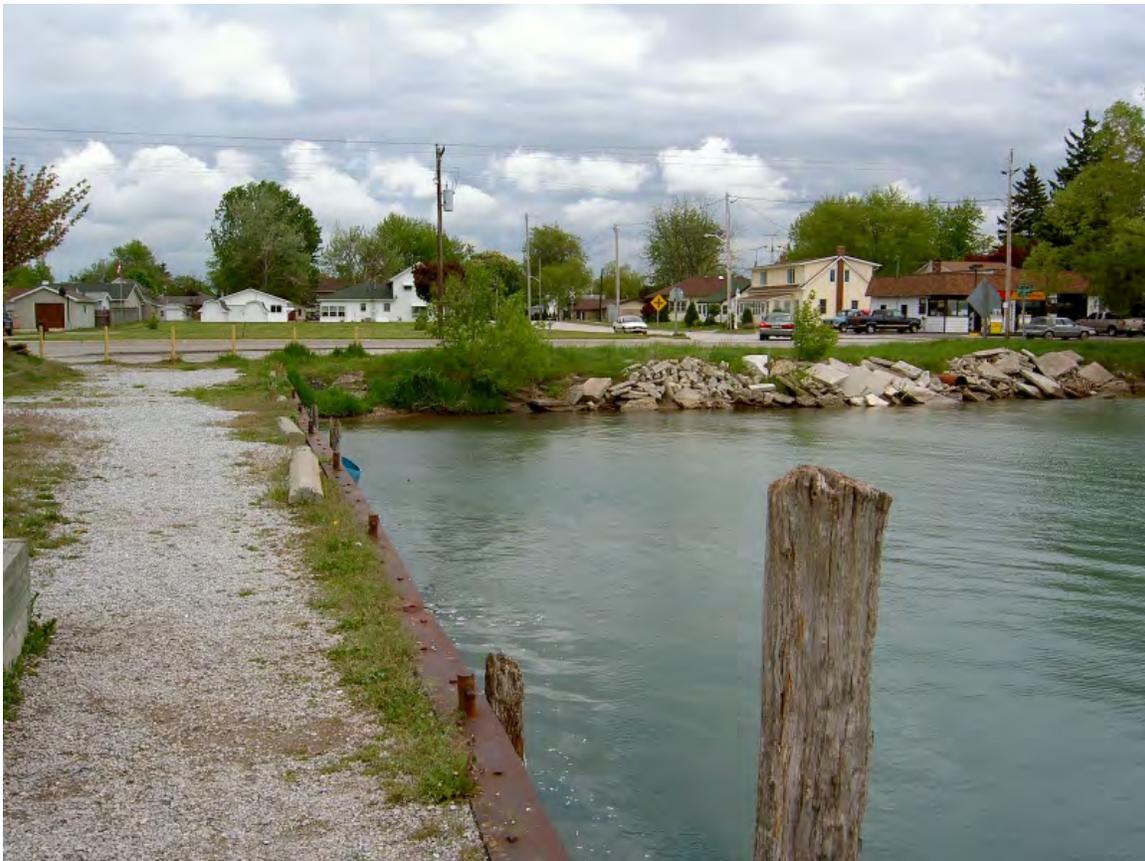
- The light steel sheet pile wall in the northern area shows slight misalignment and minor losses of material
- The rubble protection immediately north and to the south of the Public Works Canada / Transport Canada Rescue Station is providing some protection however, each area is experiencing some erosion and these losses become exaggerated at higher water levels

- This site and the adjacent Public Works Canada / Transport Canada Rescue Station site provide opportunities for significant improvements in the quality of protection and could provide significant habitat improvement opportunities
- The area south of the Rescue station is also adjacent the end of a road allowance providing an additional reach for an enhancement project

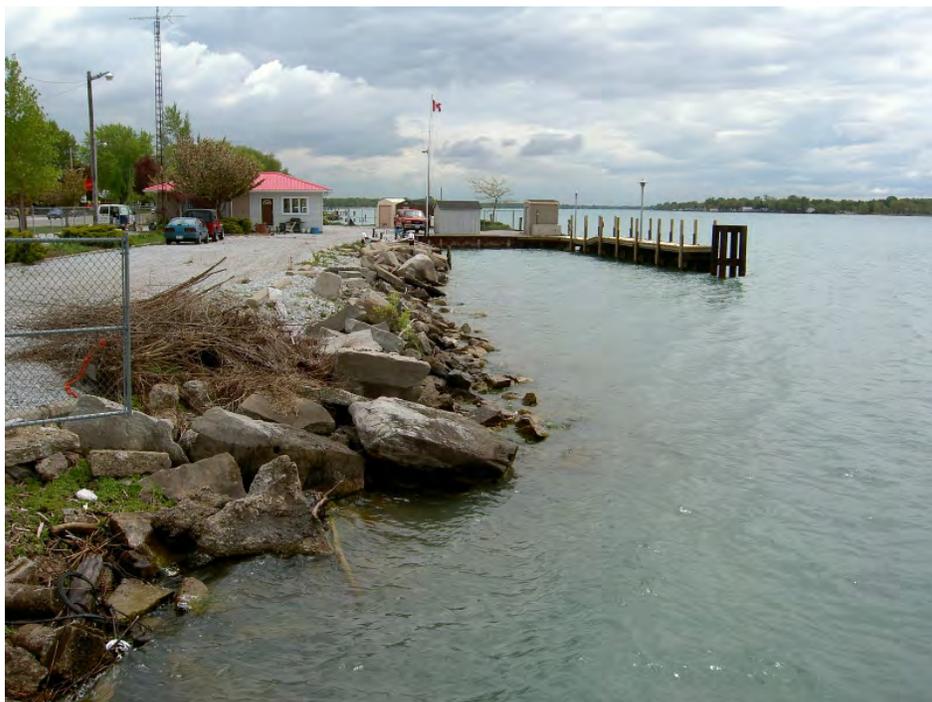
- The steel sheet pile wall is in fair condition with some misalignment but no apparent loss material
- The interior basin protection is in fair condition with what appears to be minor erosion occurring along at least the northern portion of the protection

- This site and the adjacent Port Lambton Park site provide opportunities for significant improvements in the quality of protection and could provide significant habitat improvement opportunities
- The area south of the Rescue station is also adjacent the end of a road allowance providing an additional reach for an enhancement project

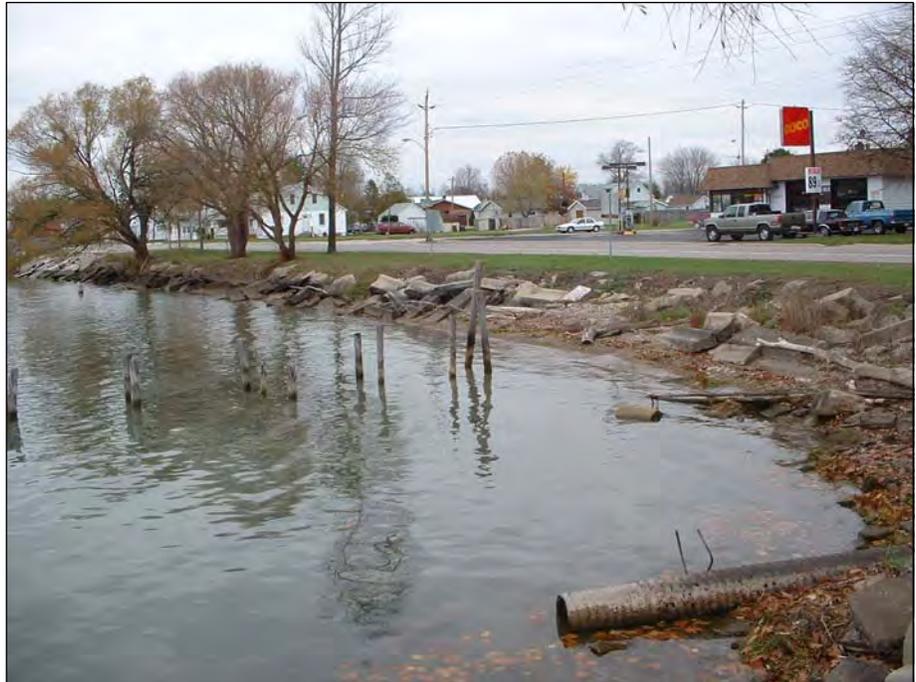
- The steel sheet pile wall is in fair condition
- There is both vertical and horizontal misalignment as well as a minor loss of material
- There are numerous large voids in the rubble protection where material continues to be lost due to overland flow
- Due to the proximity to the road these pose a safety hazard
- The outfalls are corroded

- The misaligned wall, ongoing erosion and corroded outfall make this site a reasonable candidate on its own
- However, when combined with the adjacent areas to the north, opportunities for significant improvements in the quality of protection and could provide significant habitat improvement opportunities

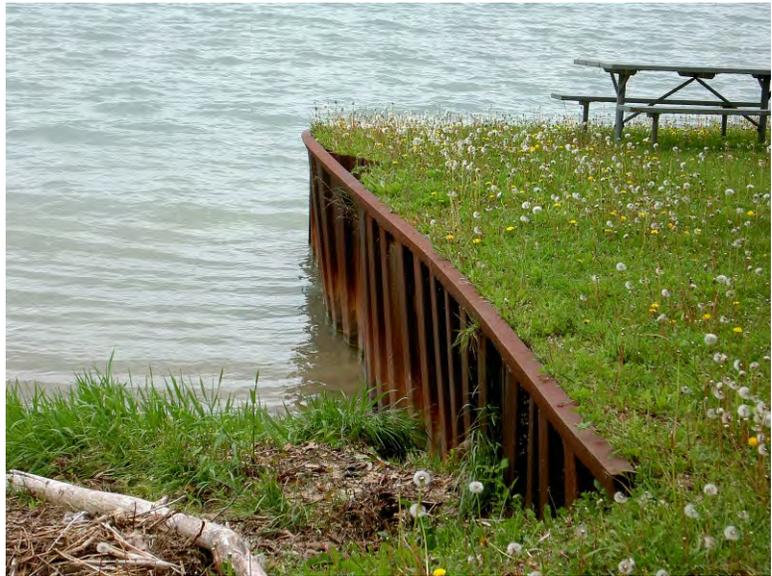
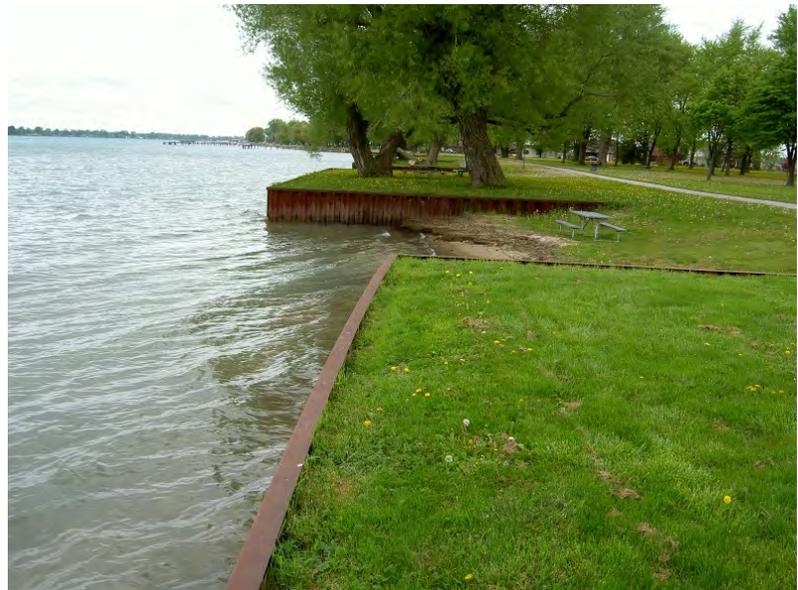
- Minor to moderate vertical and horizontal misalignment is noted along the protection
- The steel cap has been damaged at several locations
- The sand beaches appear to be stable

- Although the estimated lifespan of the structure is 5 – 10 years, this site may not be a strong candidate due to its other functions

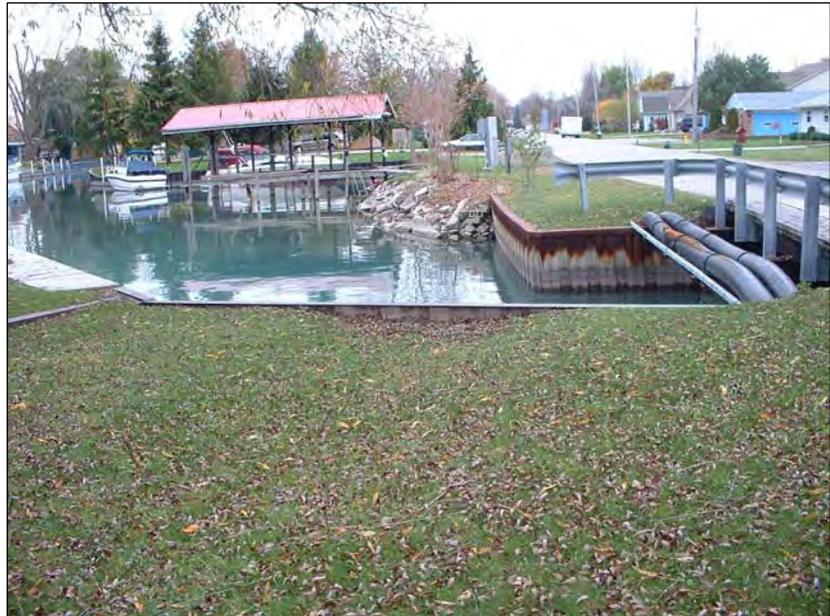
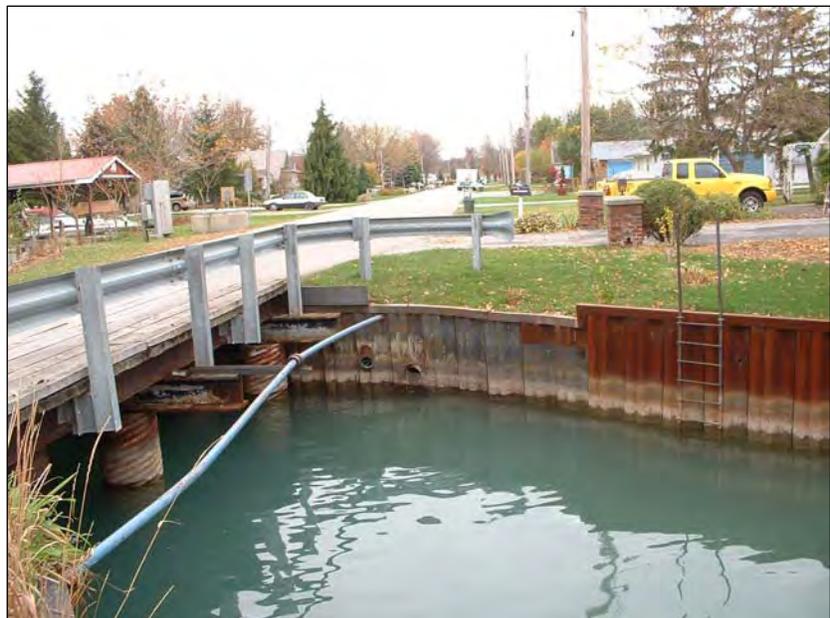
- The wall and outfalls appear to be in good condition
- The only area of concern is the northeast corner of the bridge abutment
- At this location there is significant loss of material behind the wall
- The loss of material is occurring where the tie backs are located

- Despite a concern at one specific point, as the remainder of the protection remains in very good condition, this is not a good candidate site for habitat enhancement works

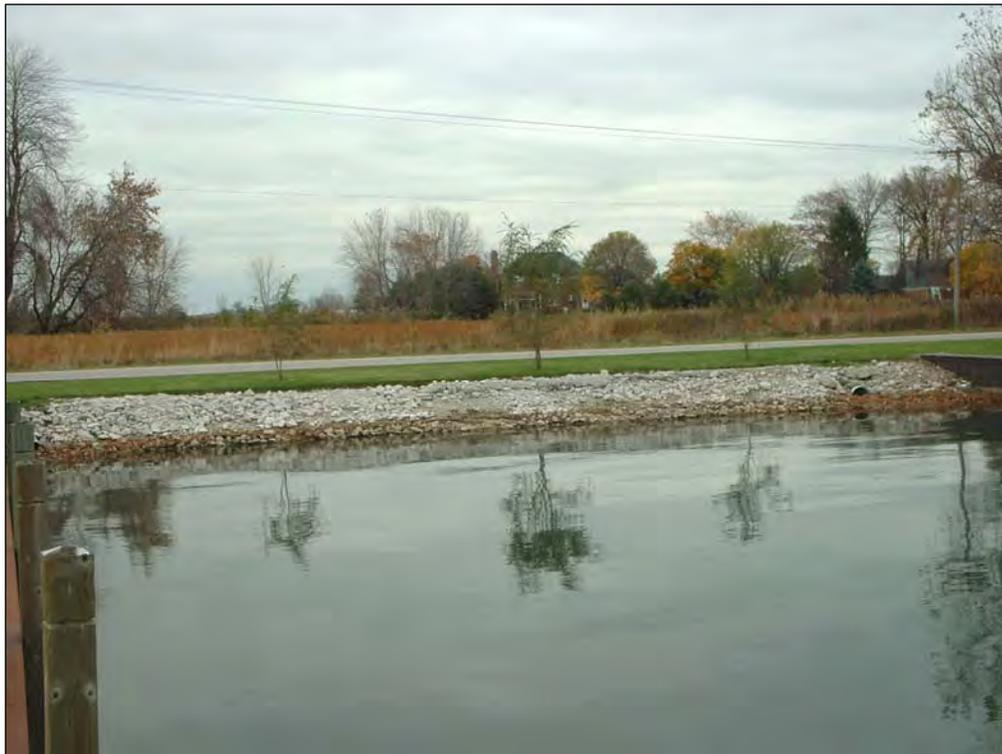
- Erosion does not appear to be occurring at this site
- The rip rap erosion control structure is in good condition as are the flanking steel sheet pile walls
- The outlet is also in good condition

- The existing protection is in good condition and afford reasonable habitat
- Therefore this is not considered to be a good candidate site

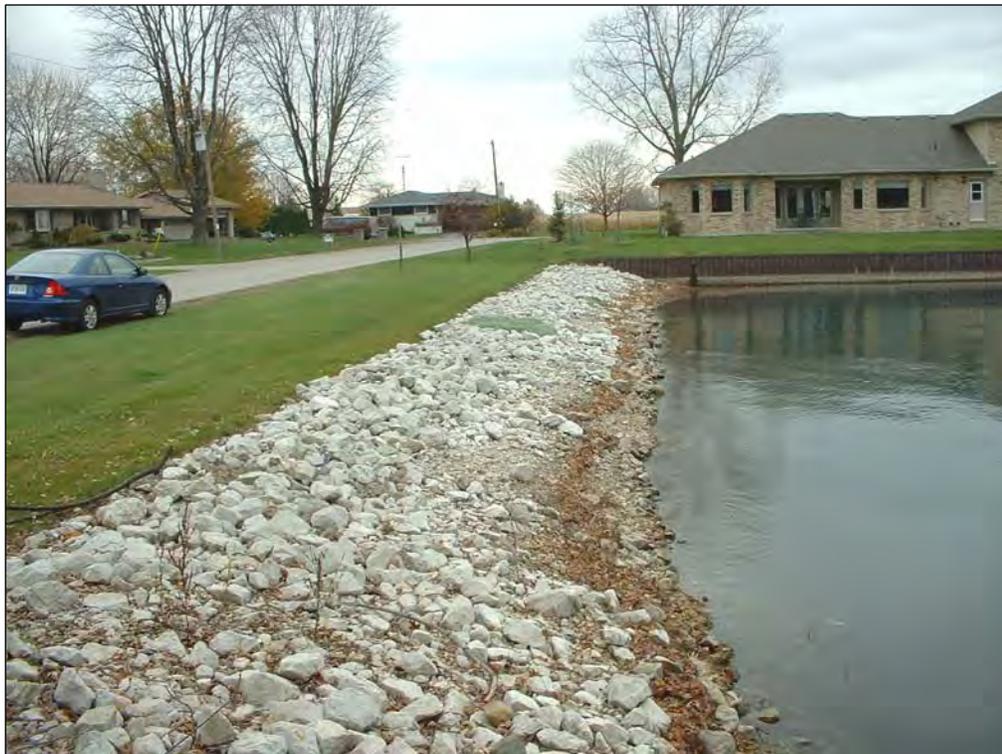
- Erosion is not evident at this site
- The rip rap erosion control structure is in good condition as are the flanking steel sheet pile walls
- The outlet is also in good condition

- The existing protection is in good condition and afford reasonable habitat
Therefore this is not considered to be a good candidate site

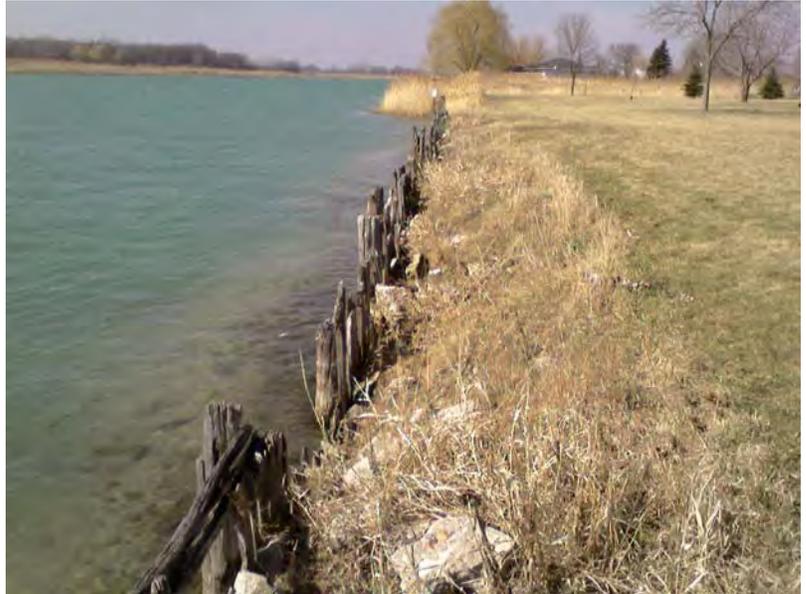
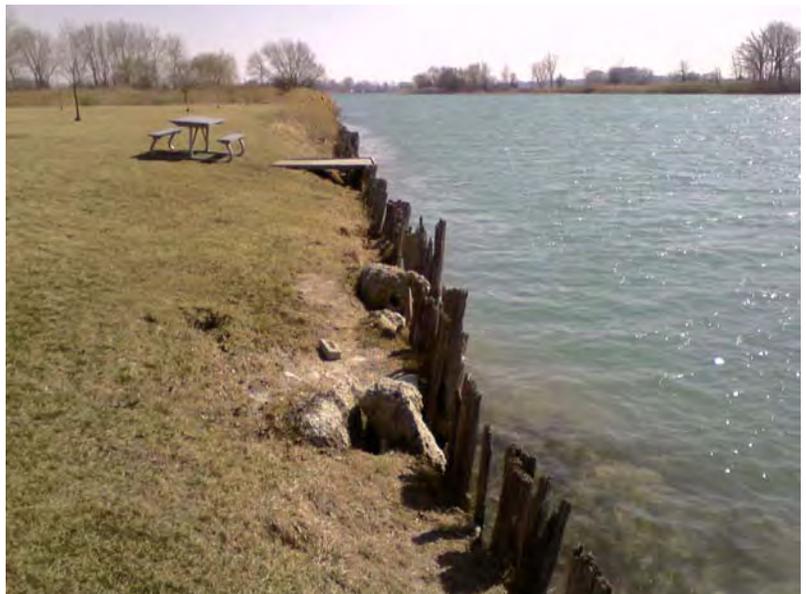
- The wooden pile wall is severely deteriorated
- The rubble is providing little support to the shoreline

- With virtually no protection in place, this site is an excellent candidate for enhancement activities

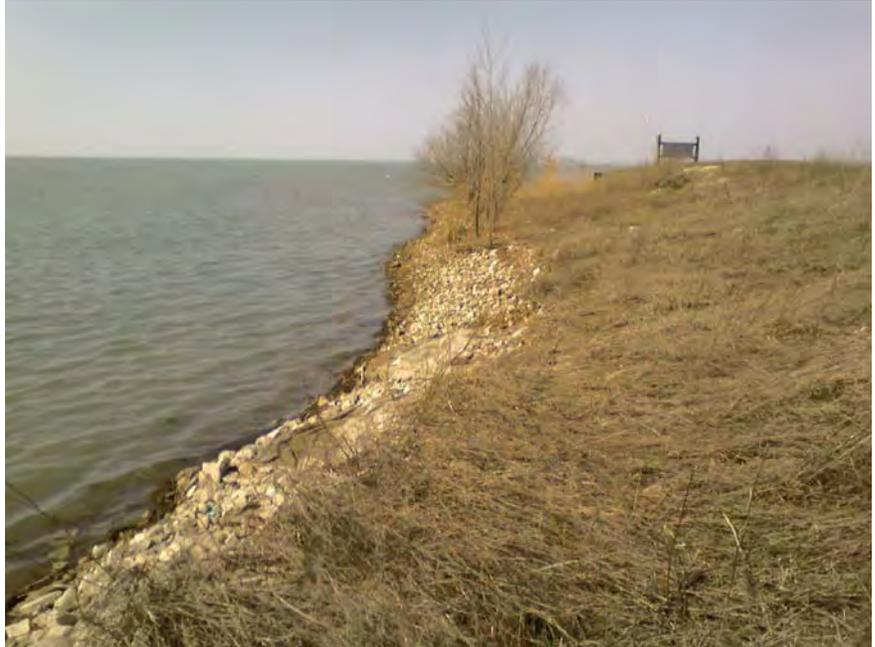
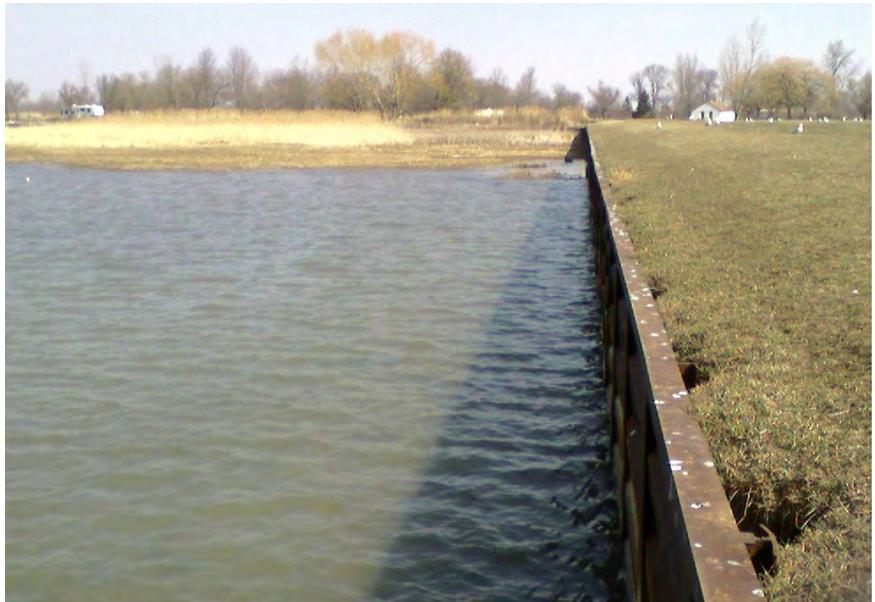
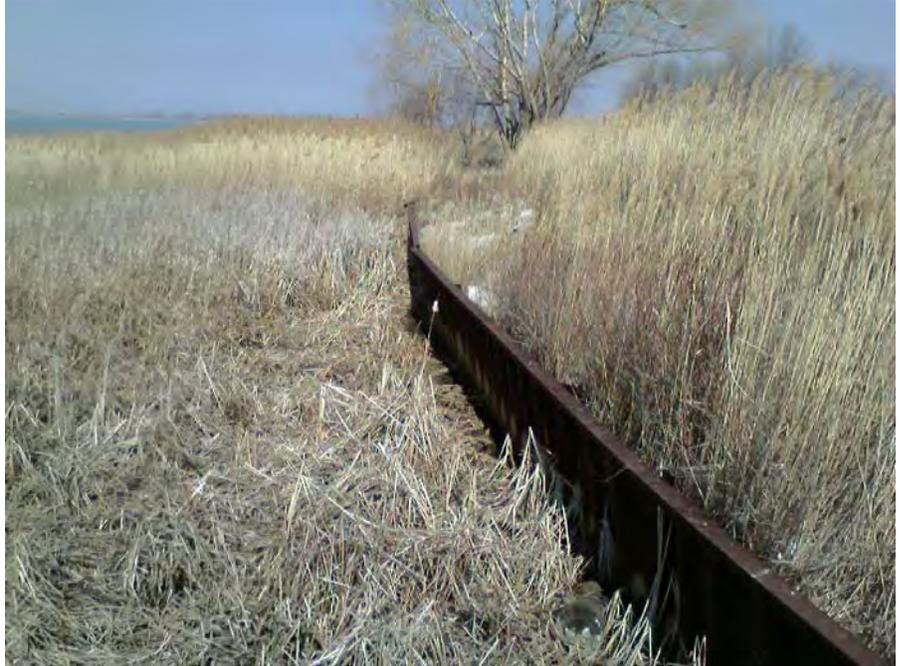
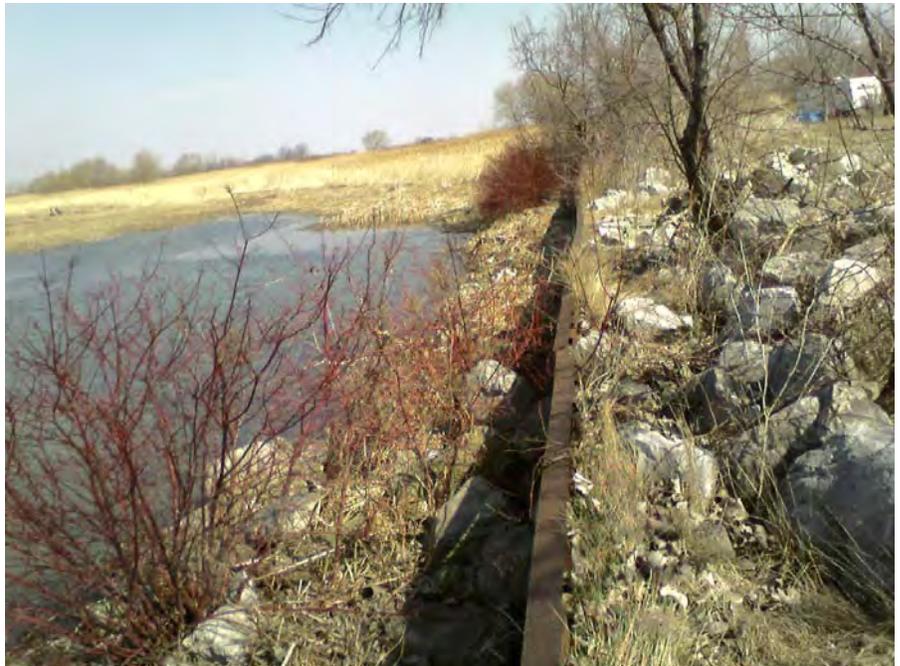
- The rip rap revetment was constructed from significantly undersized material
- In some areas the rip rap has been removed completely leaving the install filter cloth exposed
- The sheet steel wall is properly aligned and in good condition
- However voids are obvious at most of the support piles
- It appears that the soil loss may be attributed to the type of wall constructed and the quality of the assembly
- The lighter gauge wall is misaligned vertically at several locations and the steel cap welds have been broken and the cap displaced

- This is would be an excellent candidate for enhancement improvements
- The light gauge wall, despite its rip rap toe, is providing little habitat and has a lifespan of possibly 5 years
- Replacement of the existing protection would provide a virtually blank slate, however, current and forecasted water levels must be taken into account

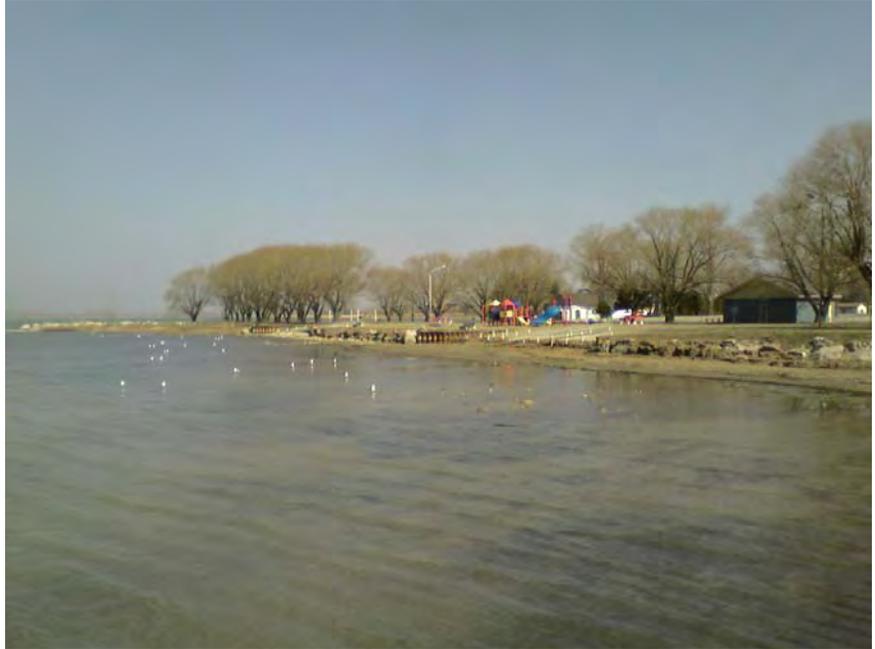
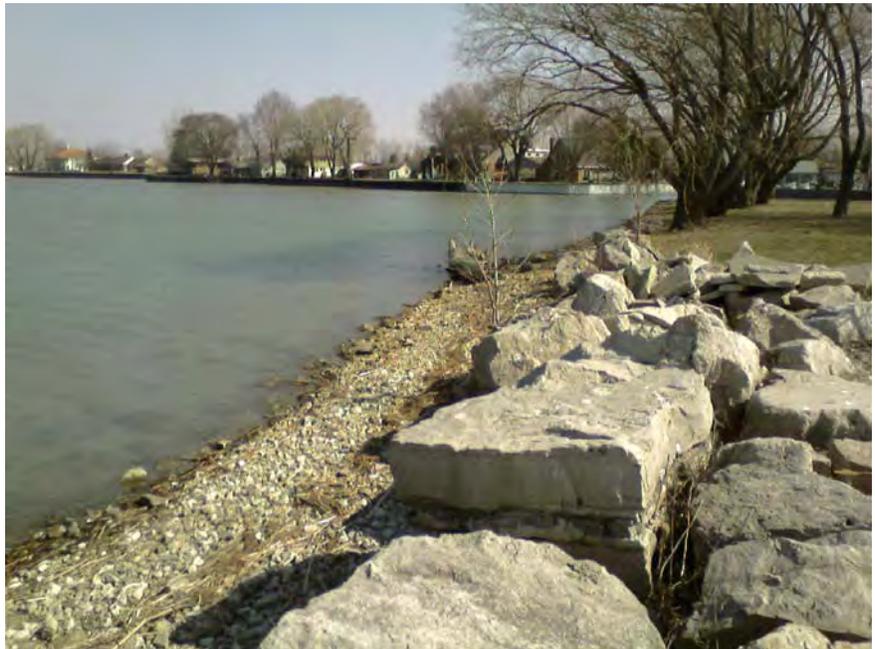
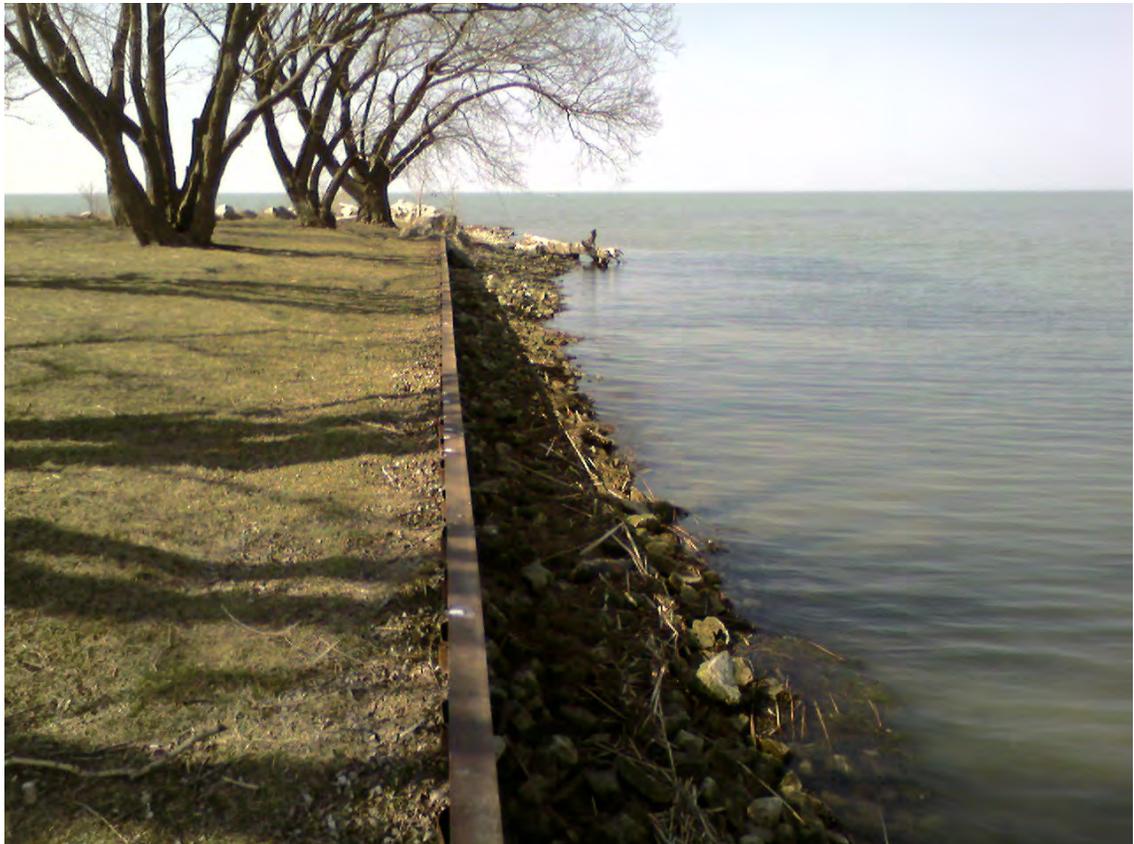
- The near shore is very shallow in front of the rip rap and the bank being protected by the rip rap is just over a half metre in height
- The rip rap is quite large but placement is very rough
- The boat launches are in good condition, however low water levels find them use little in spring
- The armourstone protection on the point of the property is fair protection for the site
- The steel sheet pile wall is in good condition with rip rap fronting the greatest portion of the protection

- This would have to be considered a fair to poor site for enhancement opportunities
- An obviously well used municipal park, any major changes may not be taken well
- The existing protection is maintaining the site, mostly because of low water levels but meeting needs
