St. Clair River Shoreline Restoration Assessment and Design of Restorative Works

Report to Great Lakes Sustainability Fund and Project Partners

St. Clair Region Conservation Authority
April 2006

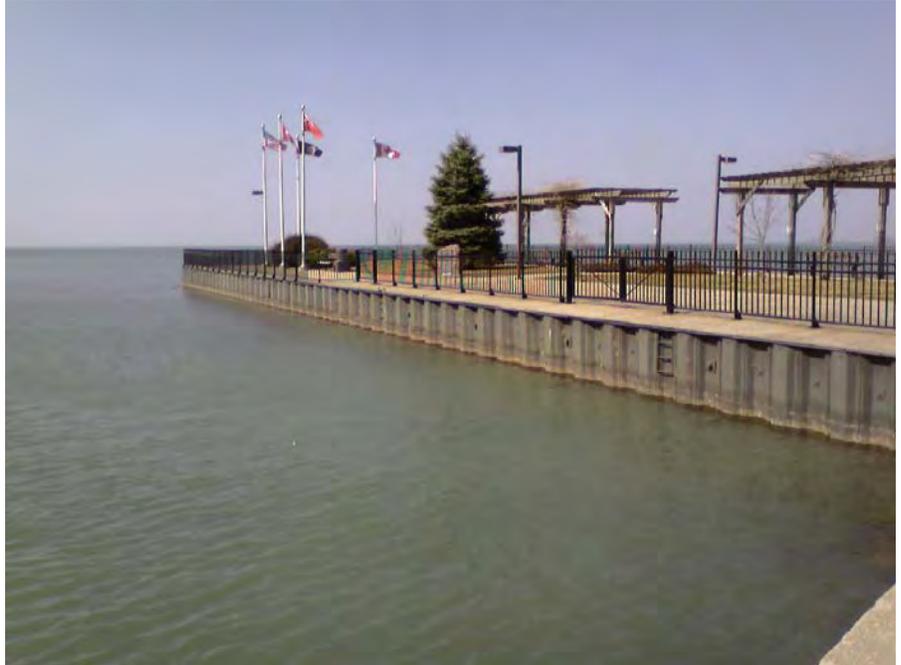
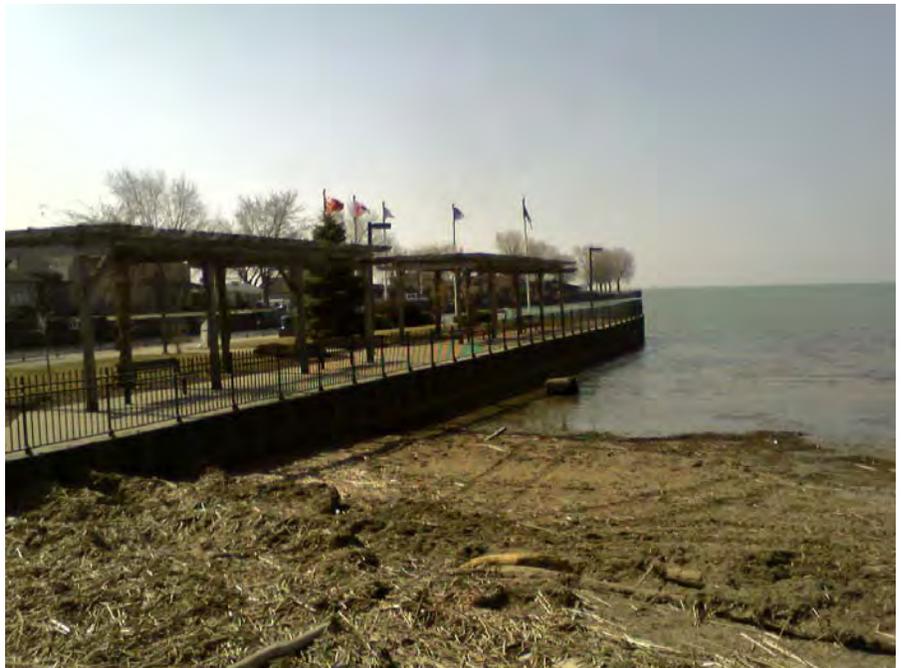
- The wall is in good condition

- Due to the use of the site, there are few habitat enhancement that would be permitted at this site
