# A GREEN INFRASTRUCTURE CASE STUDY

On-farm green infrastructure to reduce sediment  
accumulation in municipal drain

Jessica Van Zwol  
Healthy Watershed Specialist, St. Clair Conservation

## Case Study: On-farm Green Infrastructure to reduce sediment accumulation in municipal drain

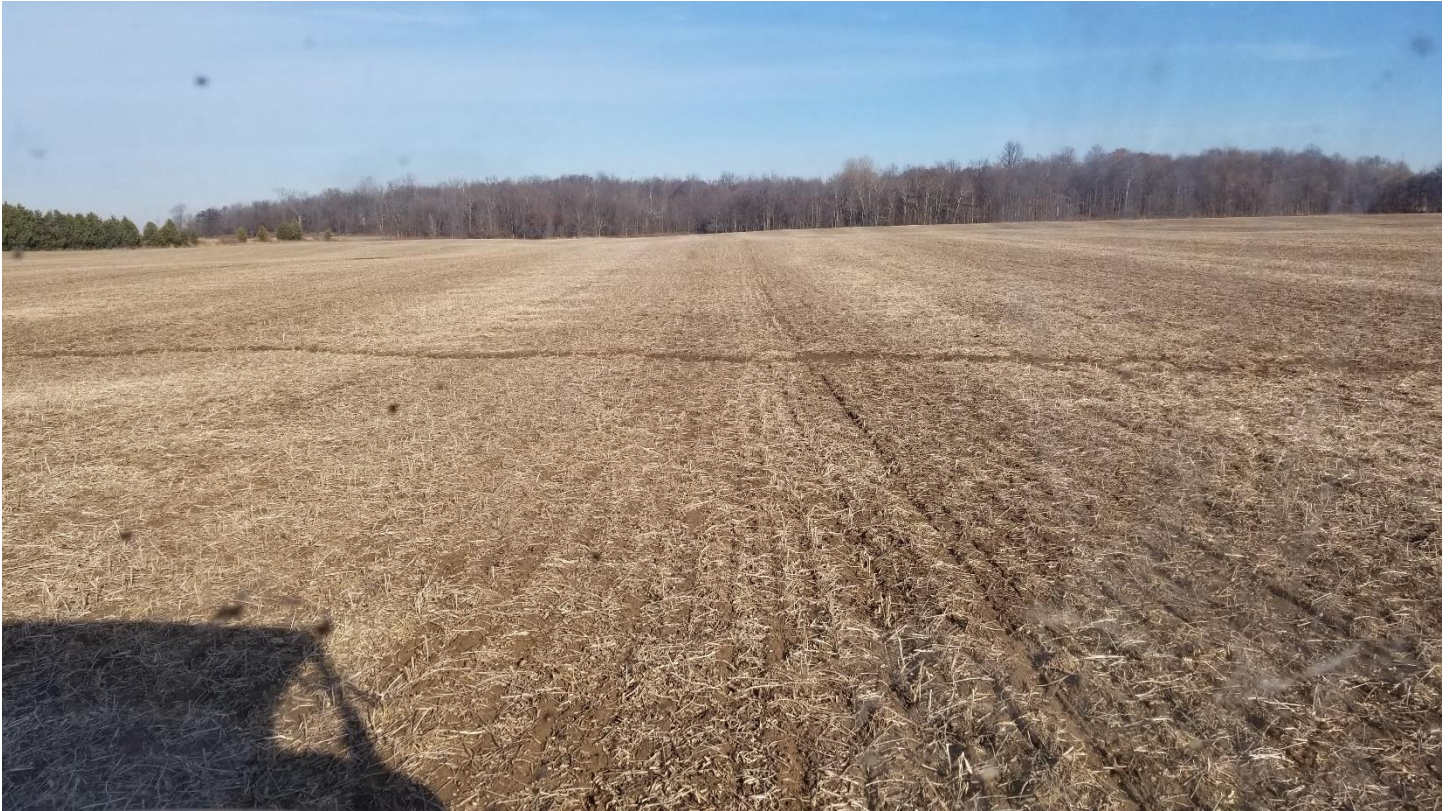
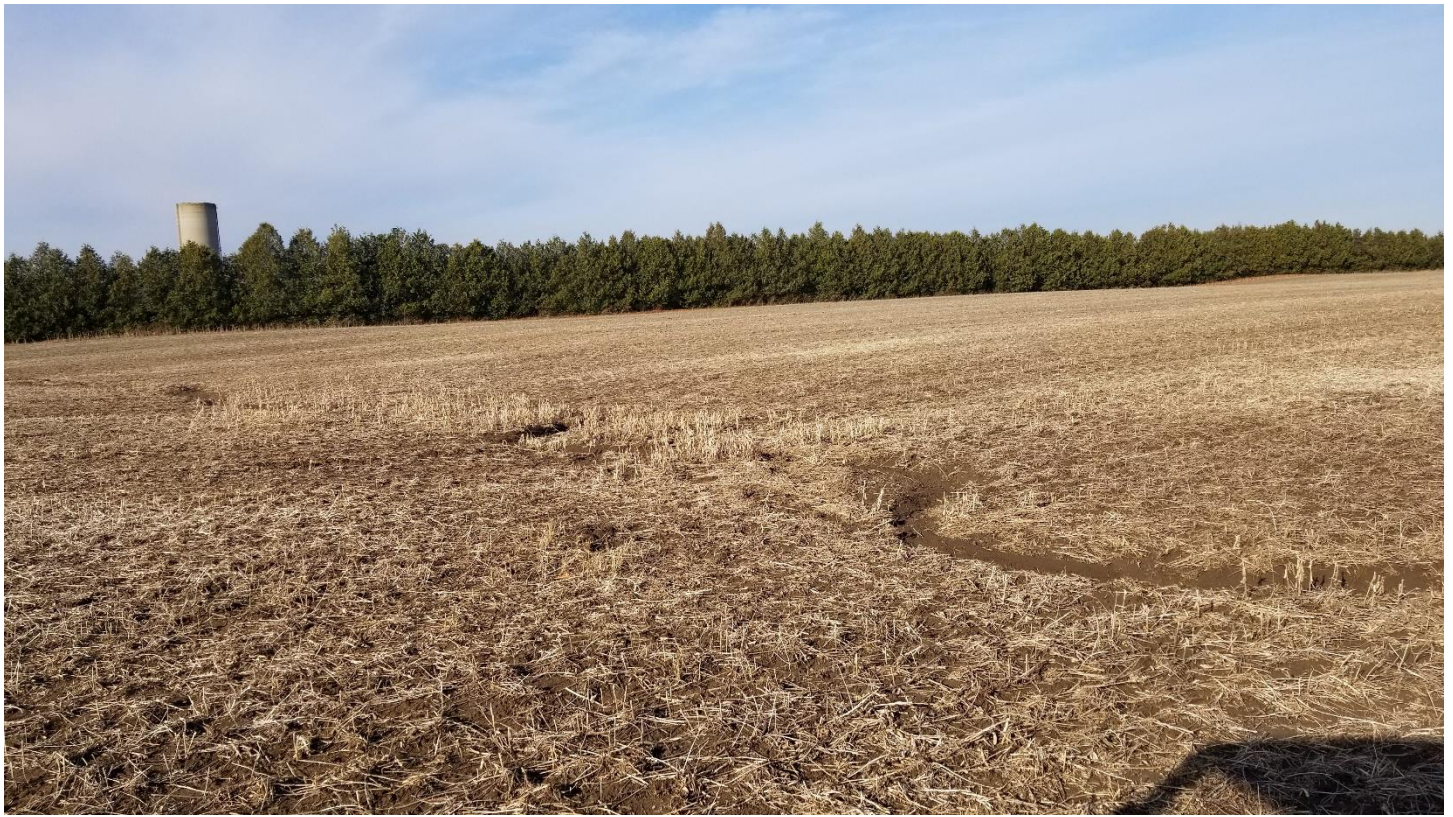
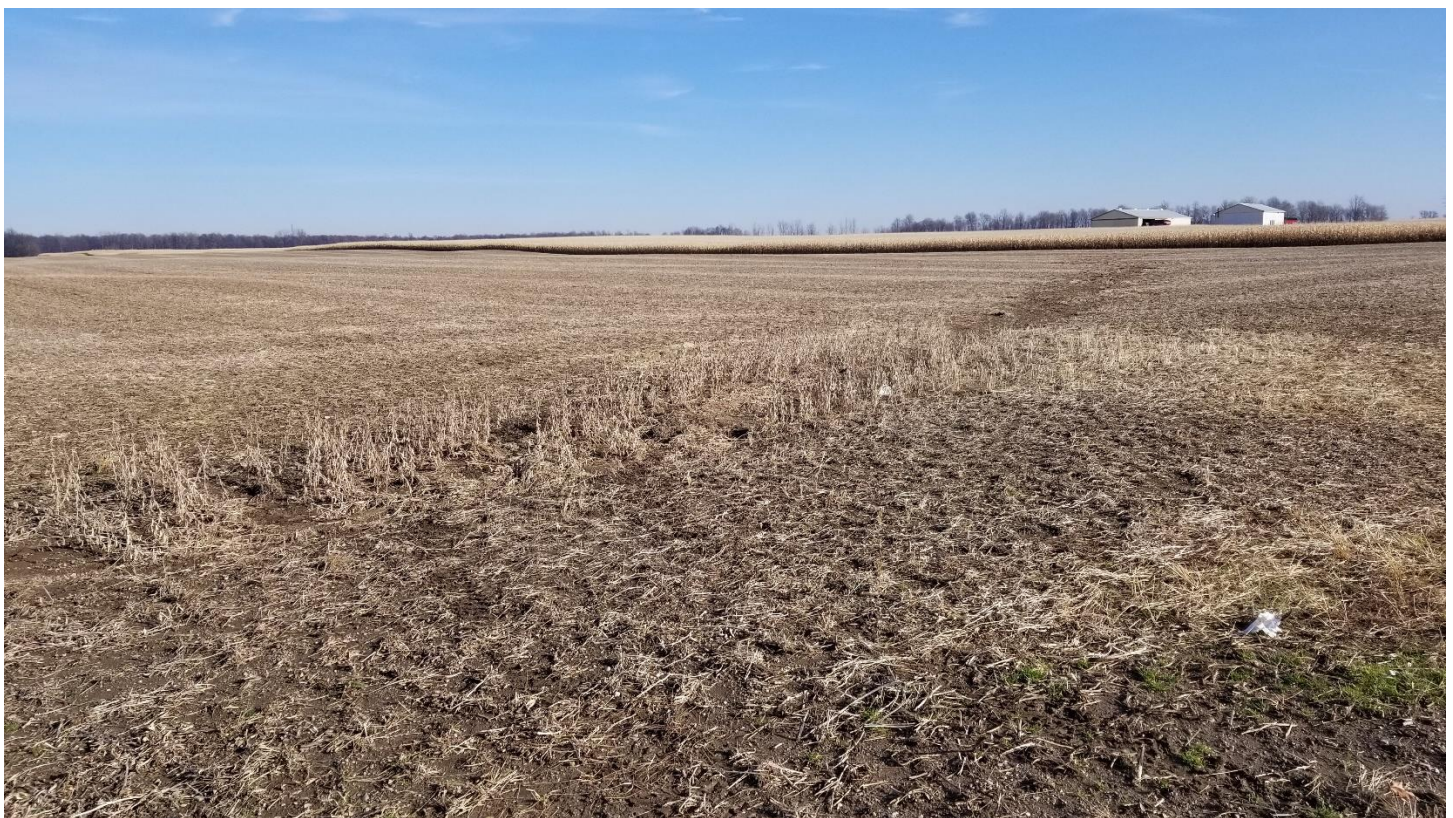
[Photos of in-field erosion:](#)

**Issue:** gullies were forming in-field perpendicular to row crops. Landowner was concerned about farm equipment traversing the gullies, but also when it rained, he was concerned with how much sediment was running off his fields into the adjacent municipal drain.

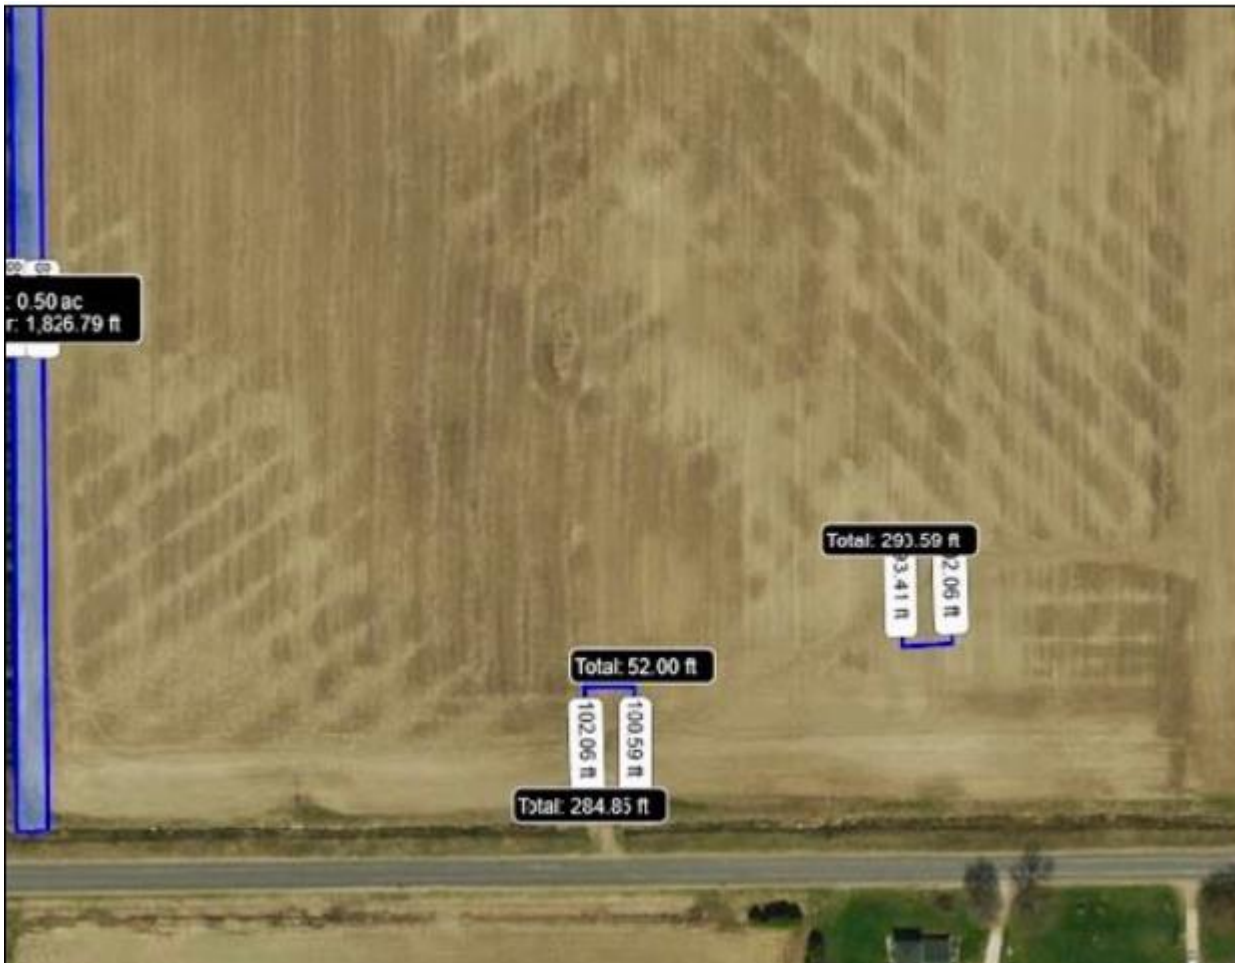
Aerial photo of Projects 1 and 2 locations.

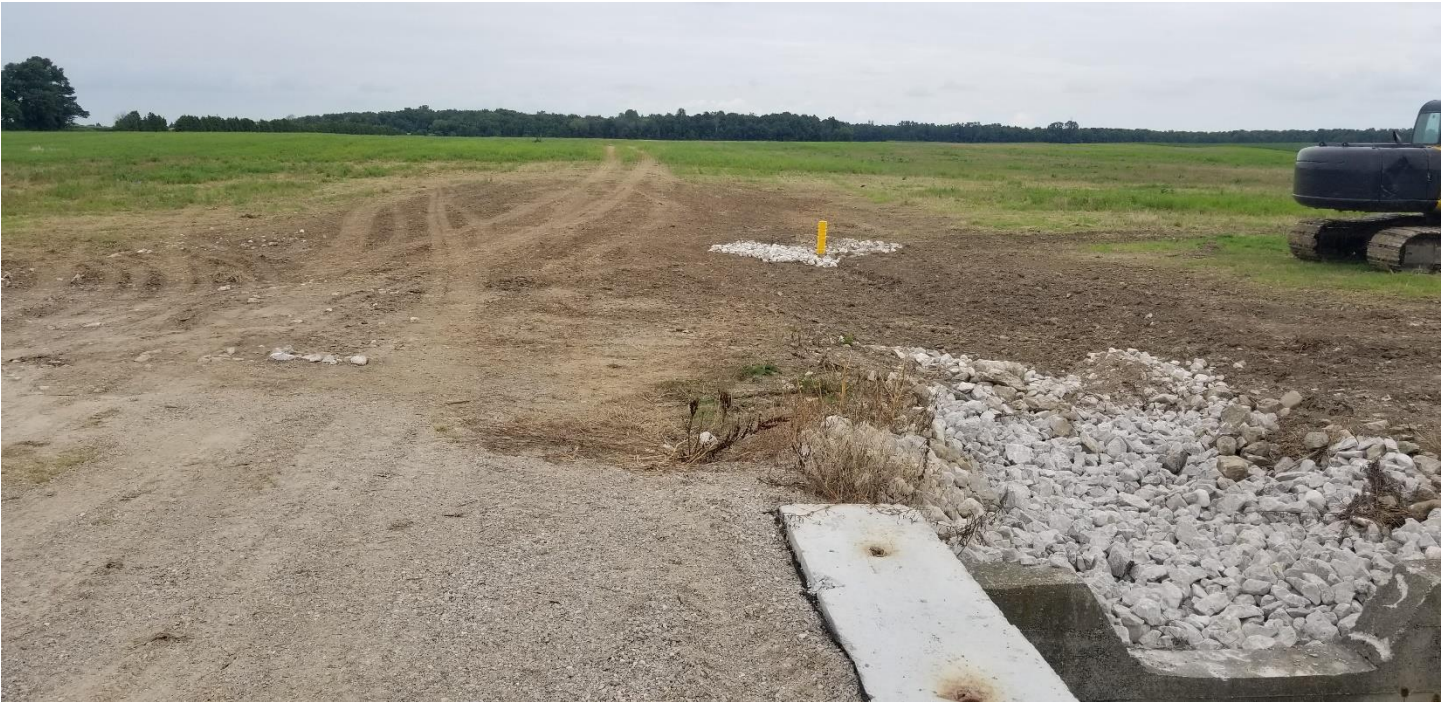
Photo of seeded low-level berm, “upstream” hickenbottom, and rock chute (looking North from Rokeby Line)

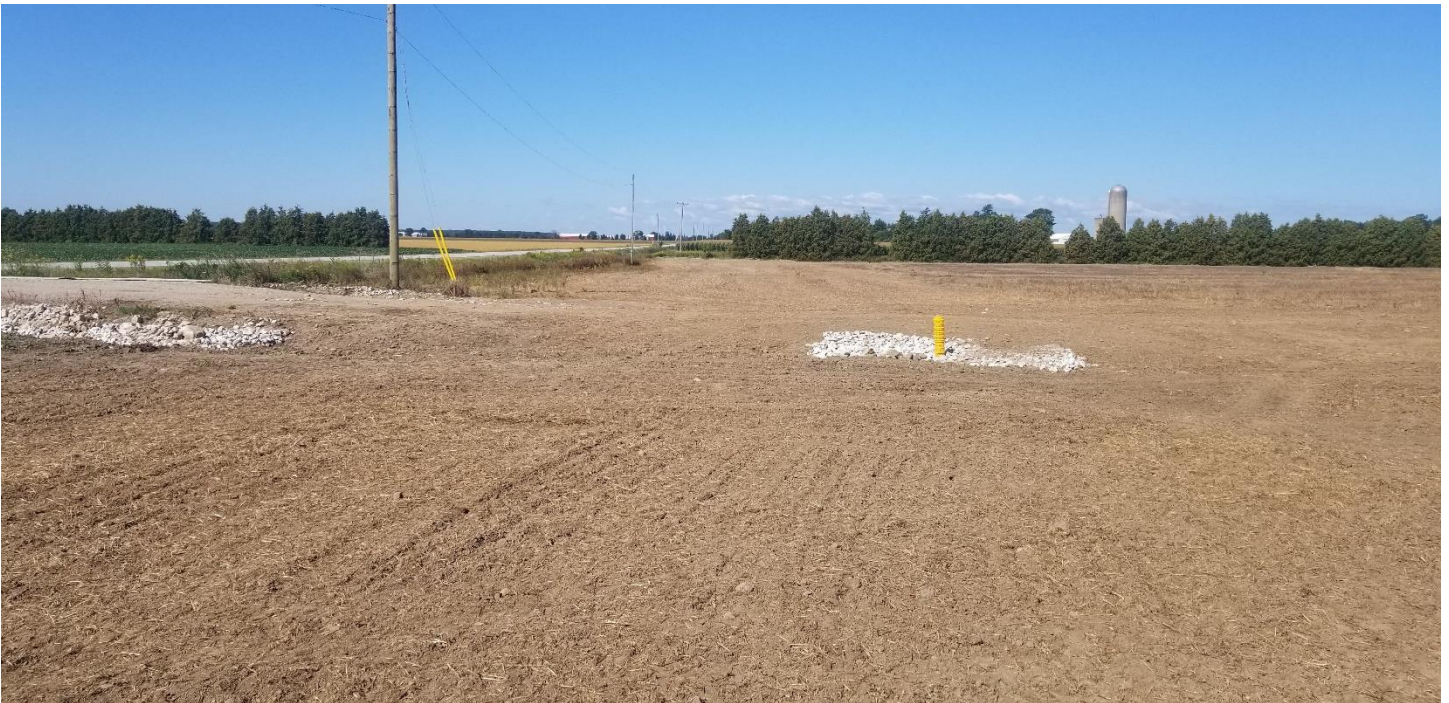
Photo of seeded low-level berm with the “upstream” hickenbottom, and rock chute (looking west)

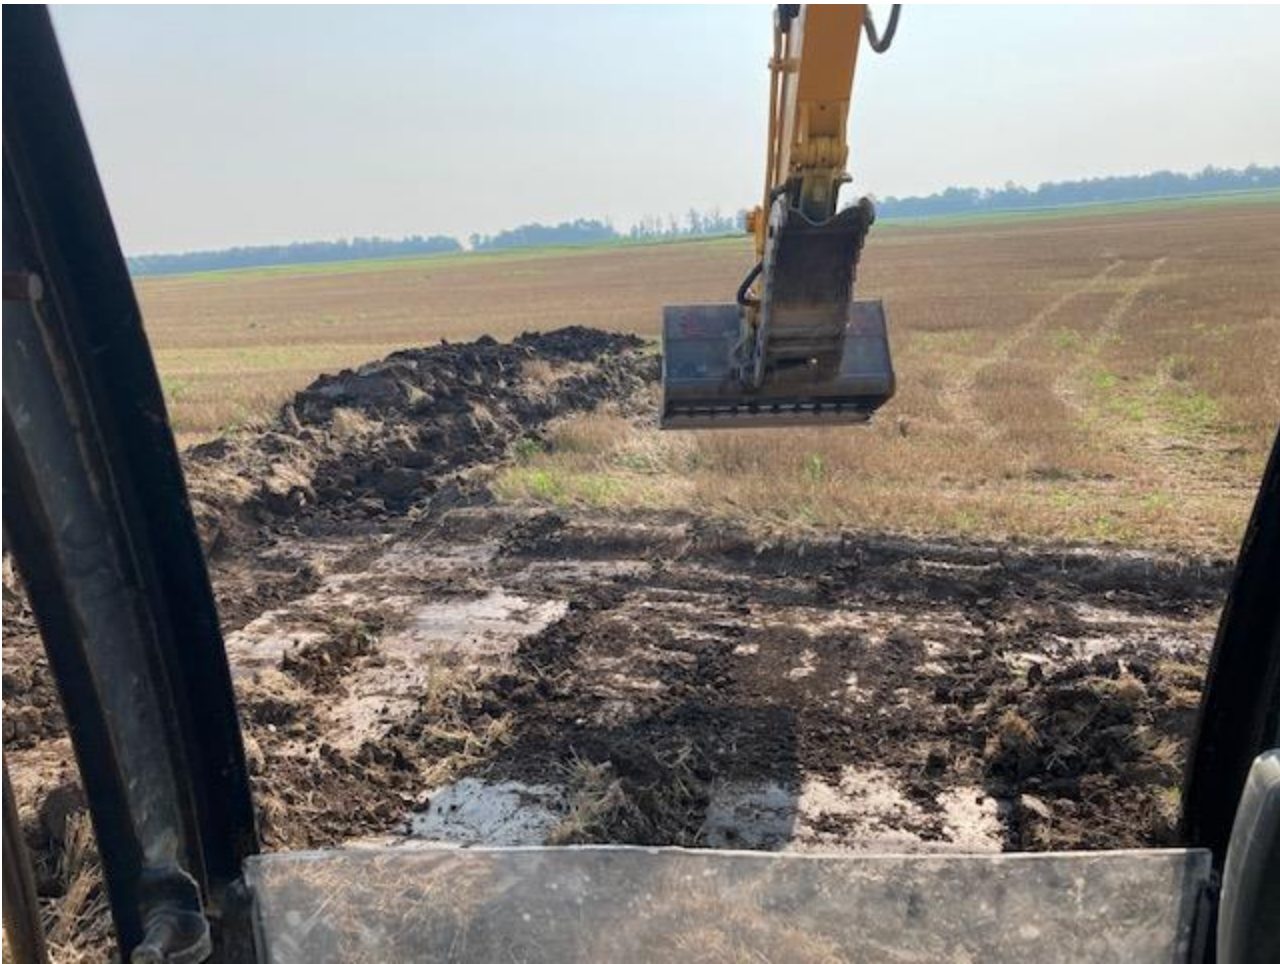
Photo of stripping topsoil prior to berm construction:

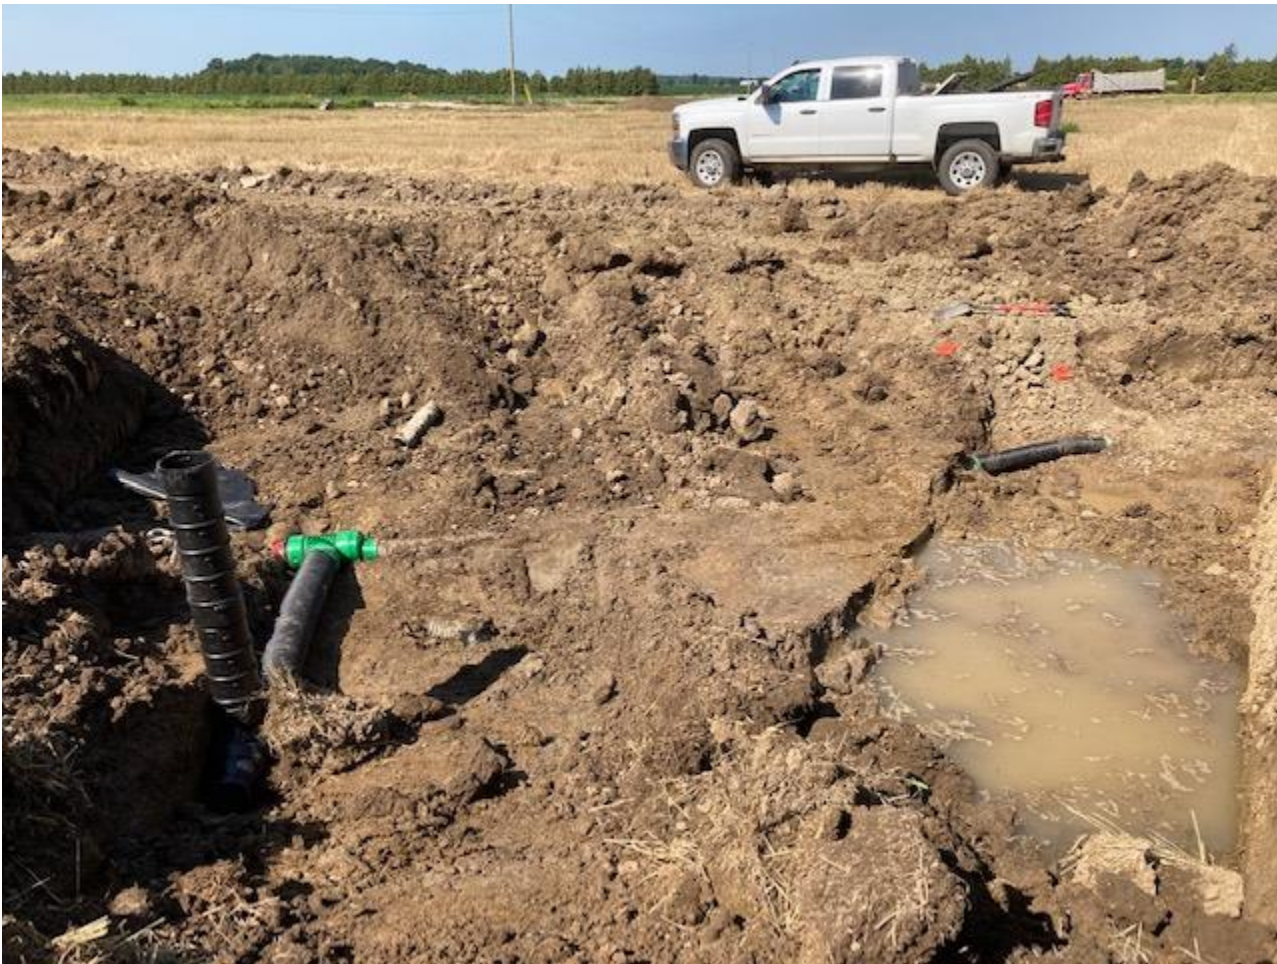
Attaching riser (hickenbottom) to existing tile

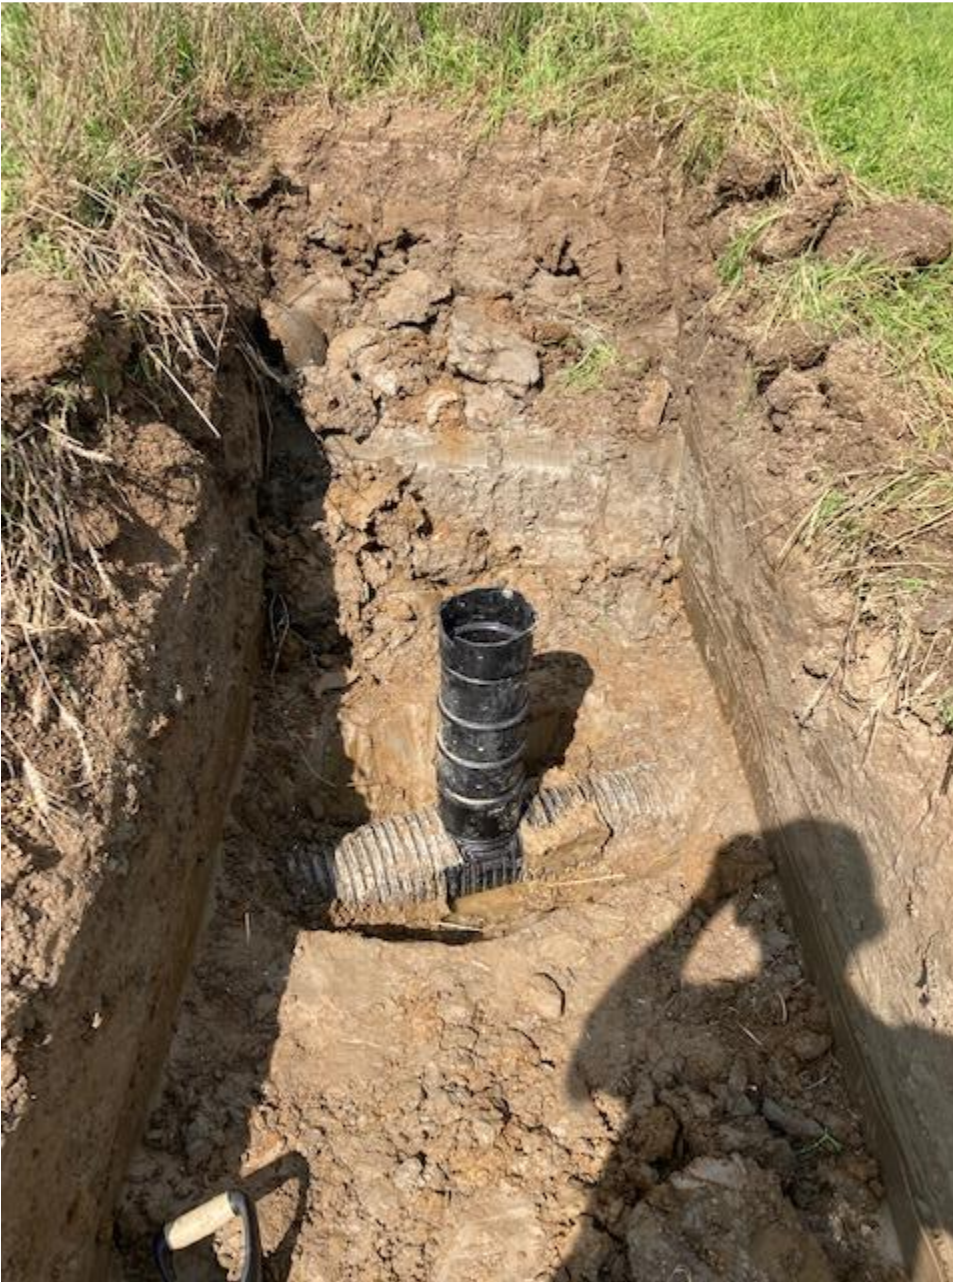
Photo of riser connection to tile

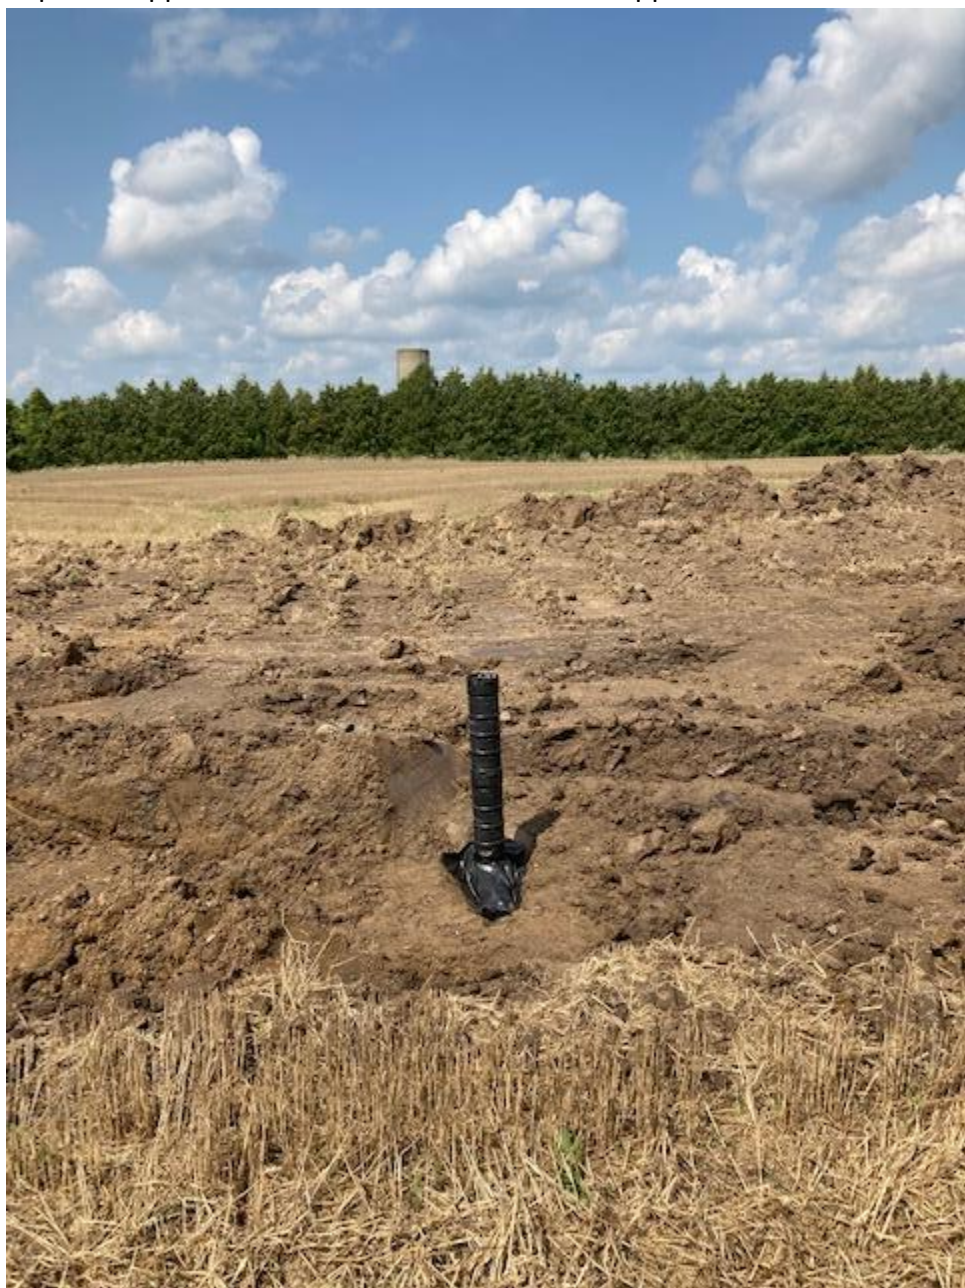
Topsoil stripped and riser connected to tile at “upper” berm.

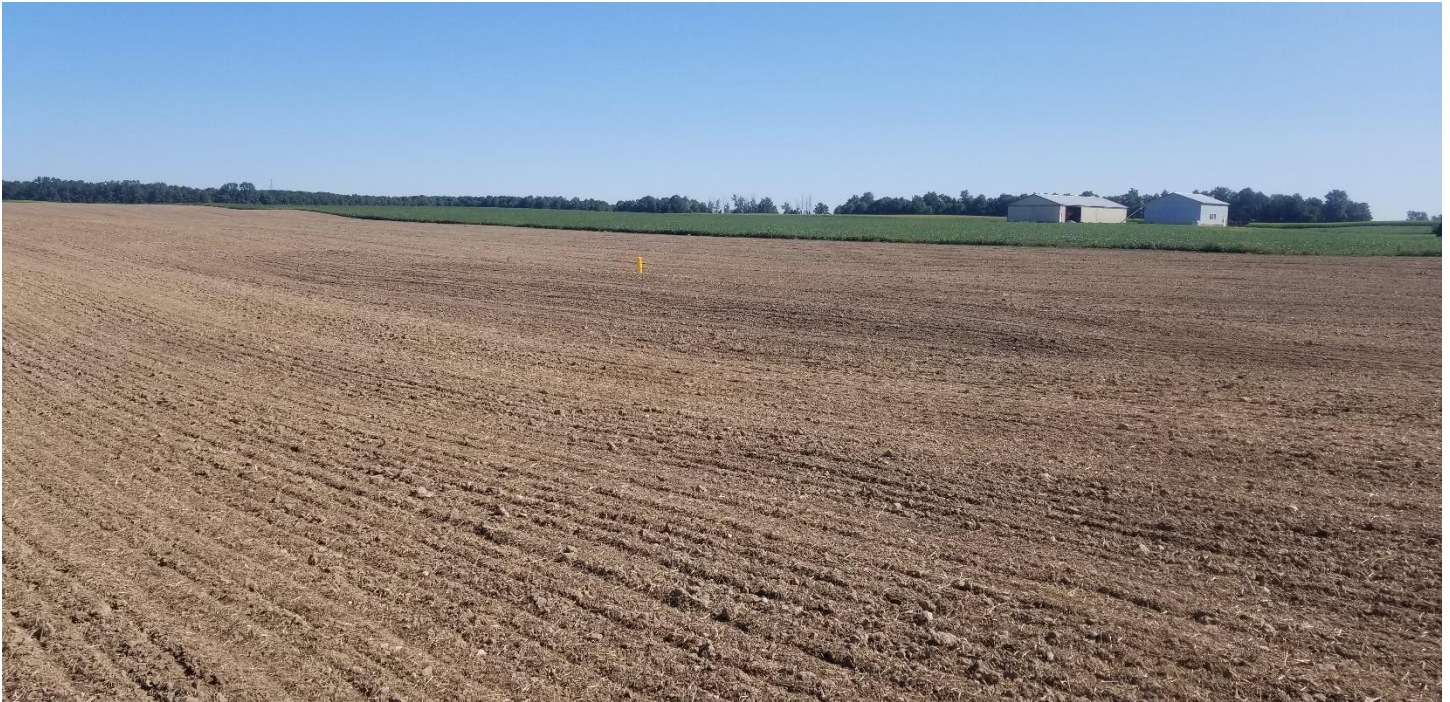
Photo of “upper” berm, looking east

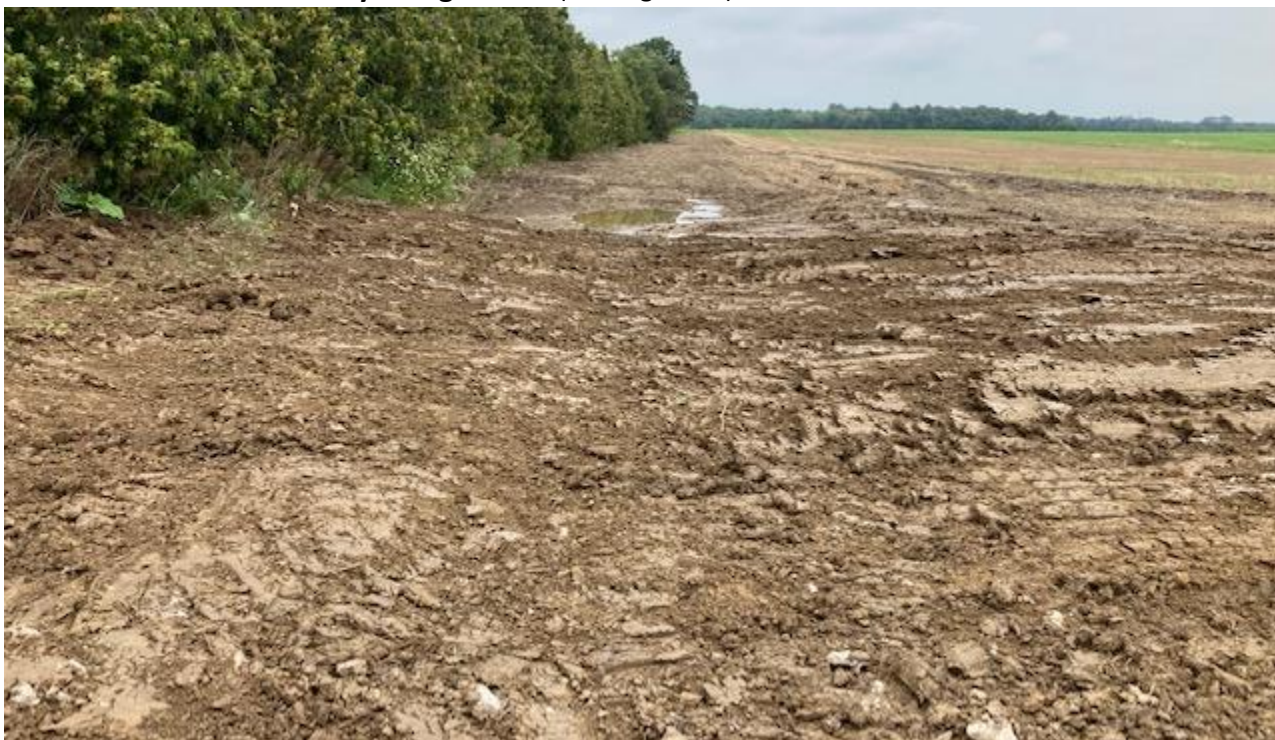
Photo of Grassed waterway “roughed in” (looking north)

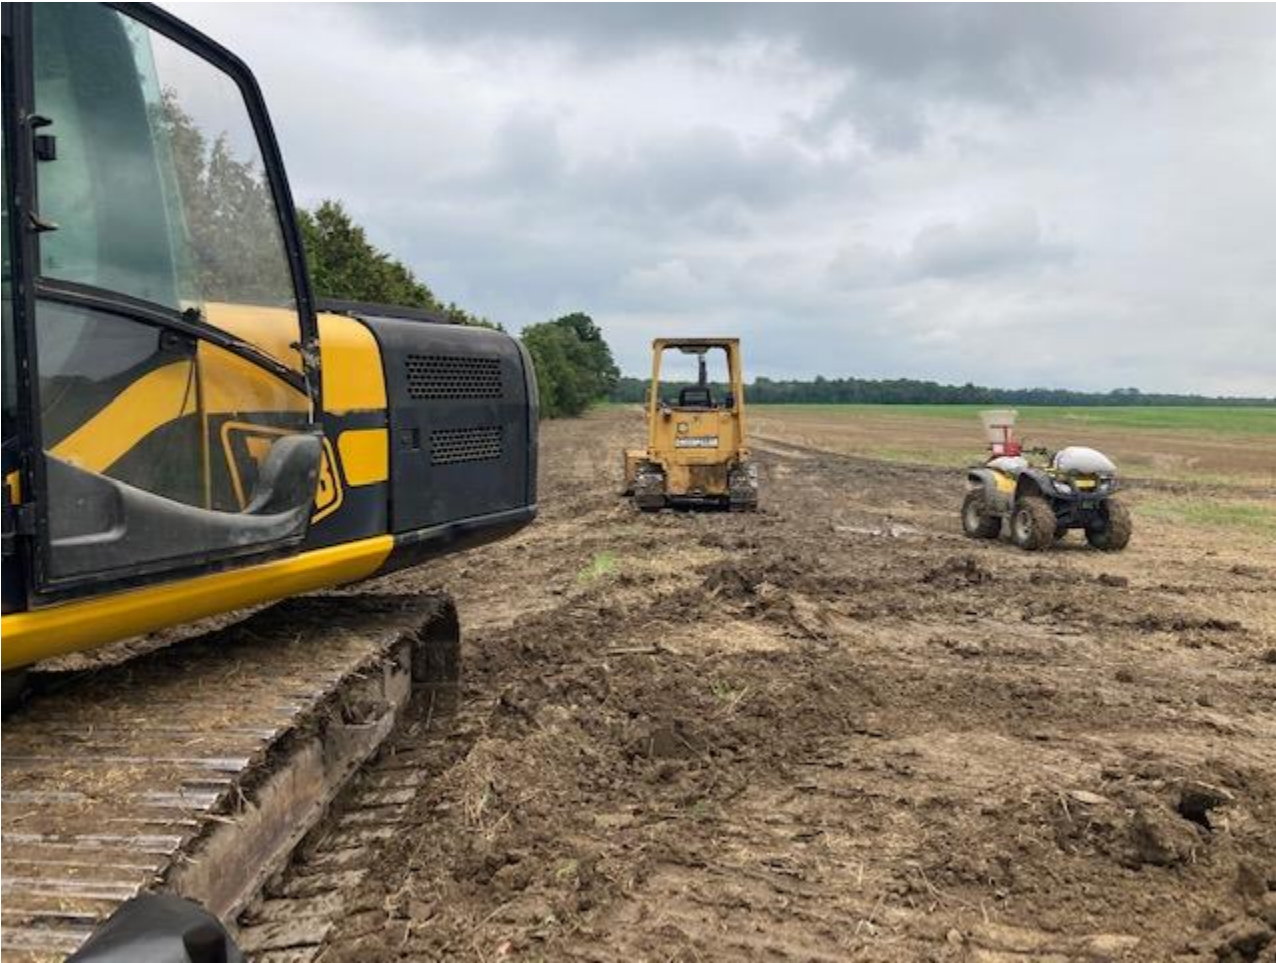
**Photo of excavator and dozer finishing grassed waterway; 4-wheeler spreading cover crop prior to harrowing**

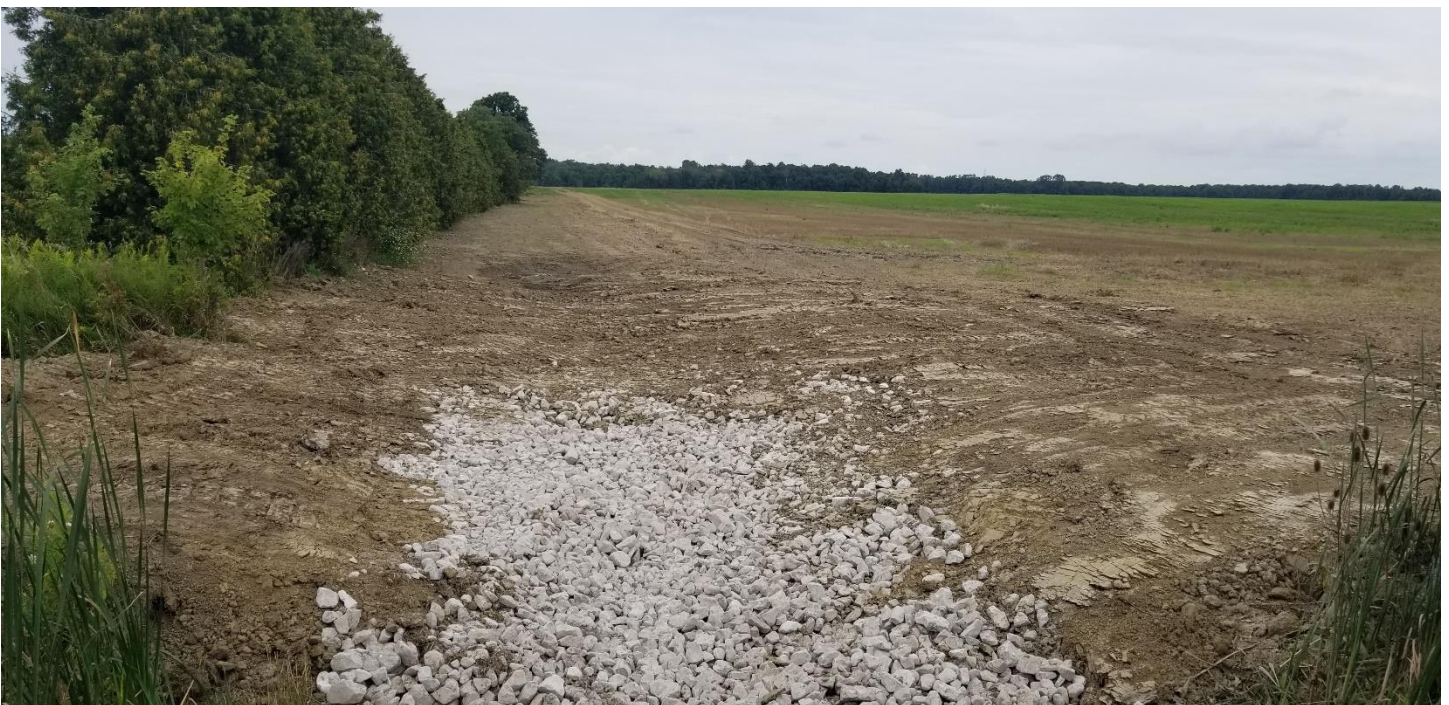
**Photo of grassed waterway after seeding and rock chute (looking north)**

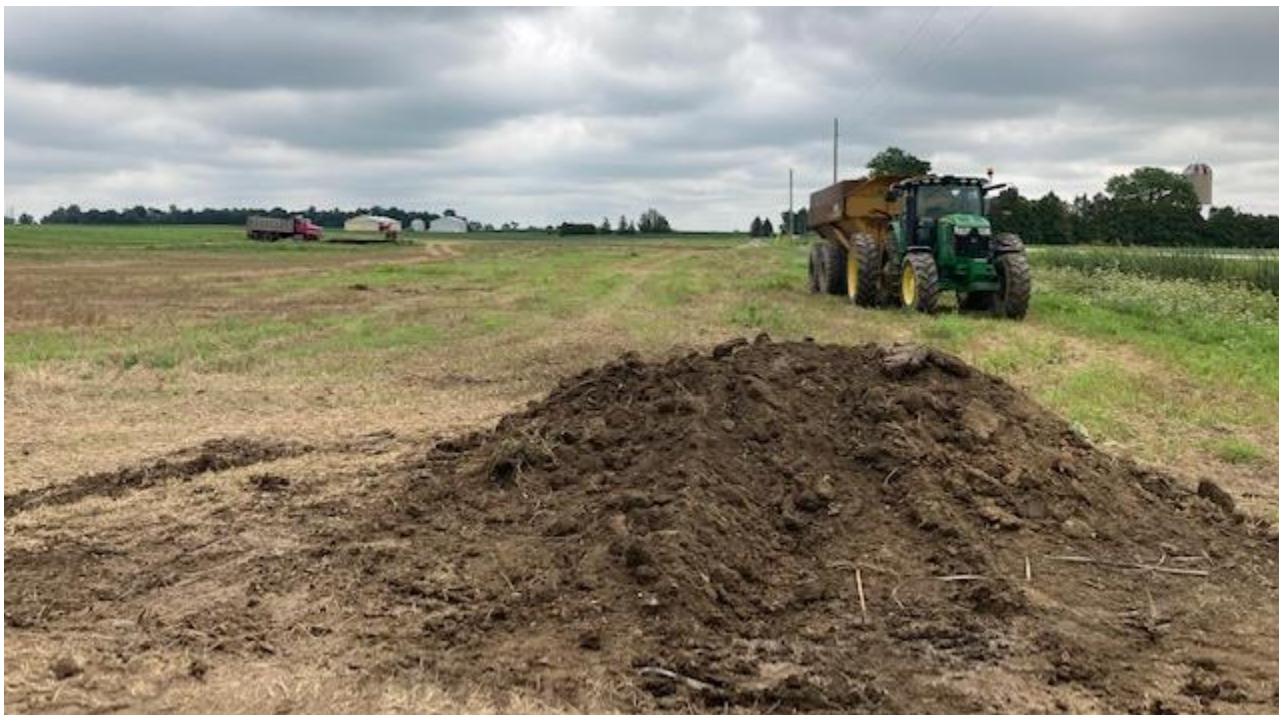
**Photo of hauling subsoil from grassed waterway spoils to berms**

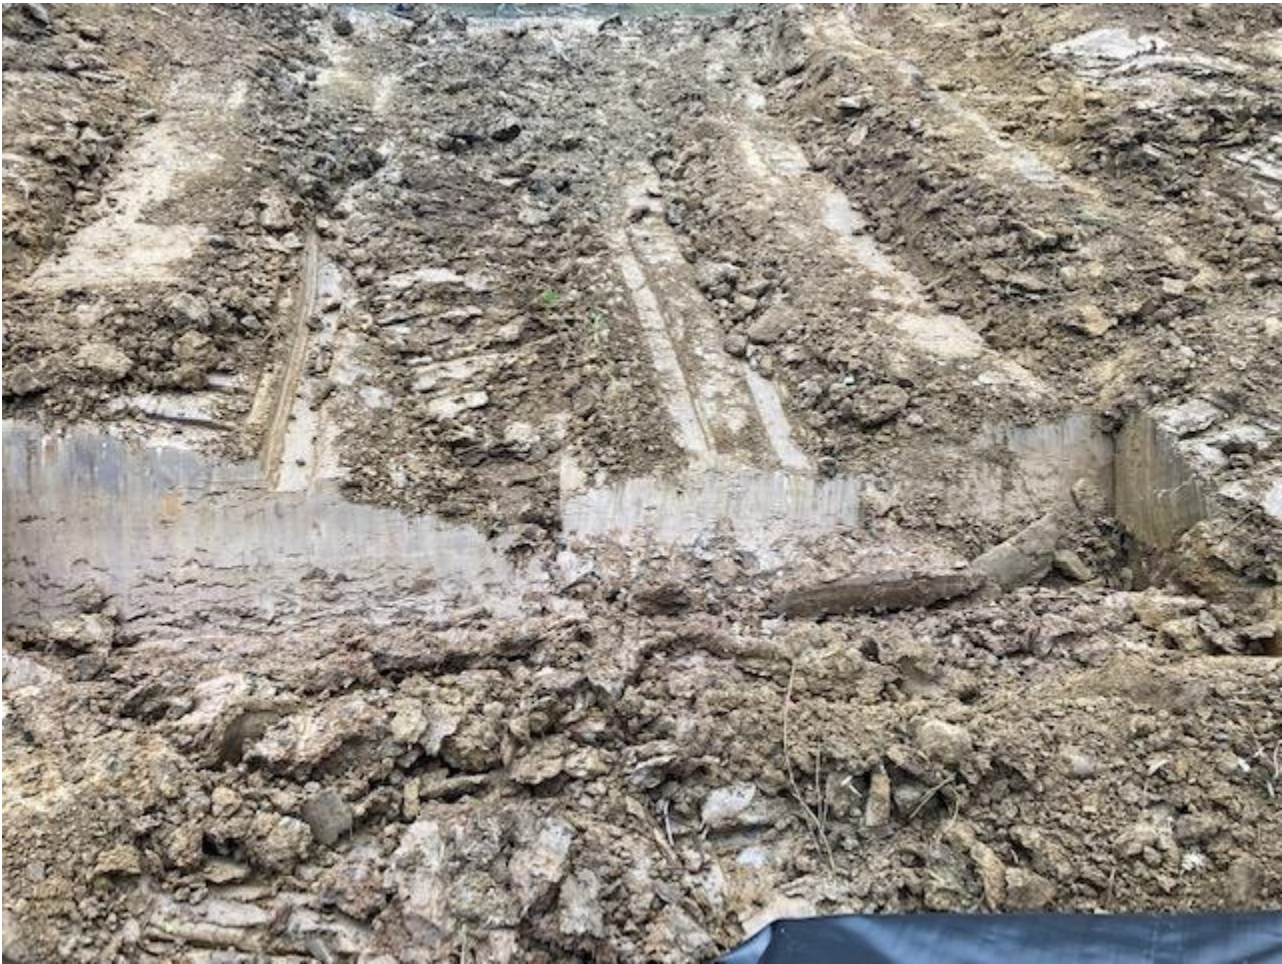
**Notch at rock chute to hold riprap and geotextile fabric**

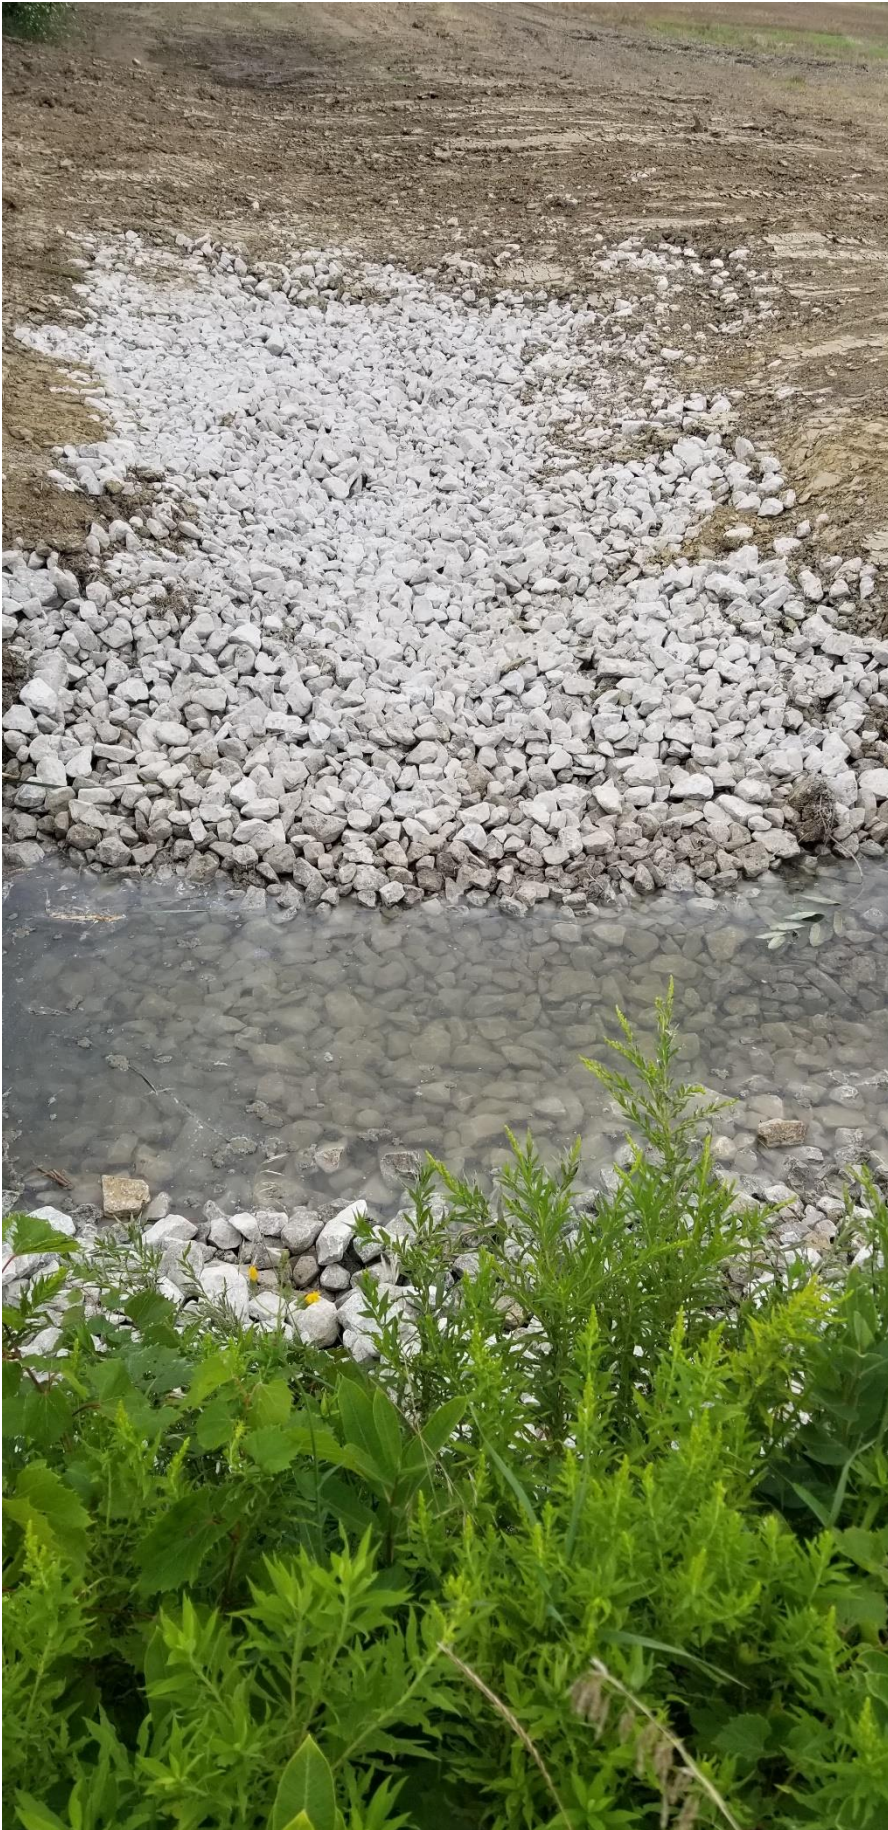
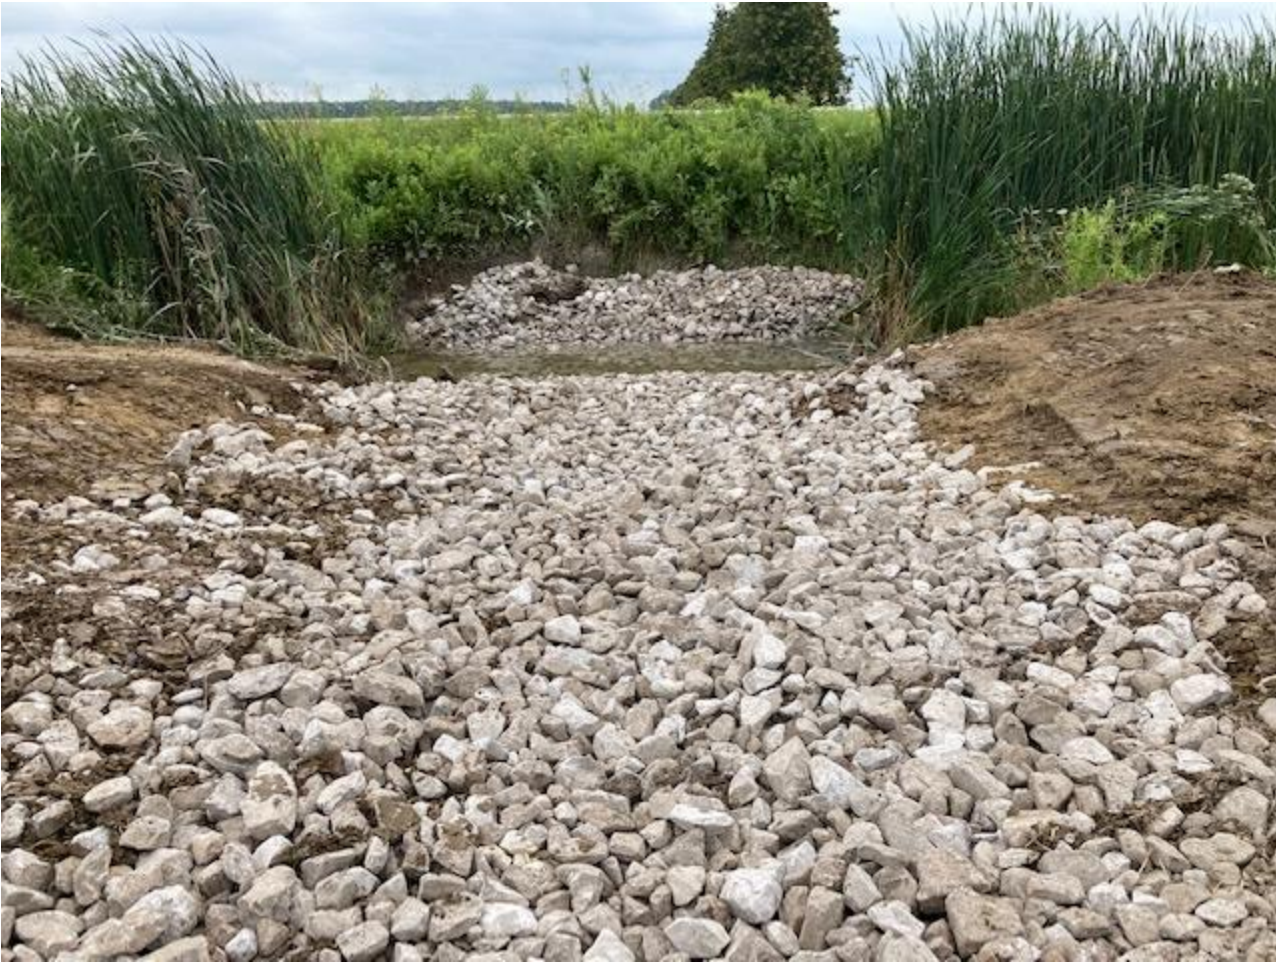
**Photos of rock chute completed to specifications with apron into municipal drain**

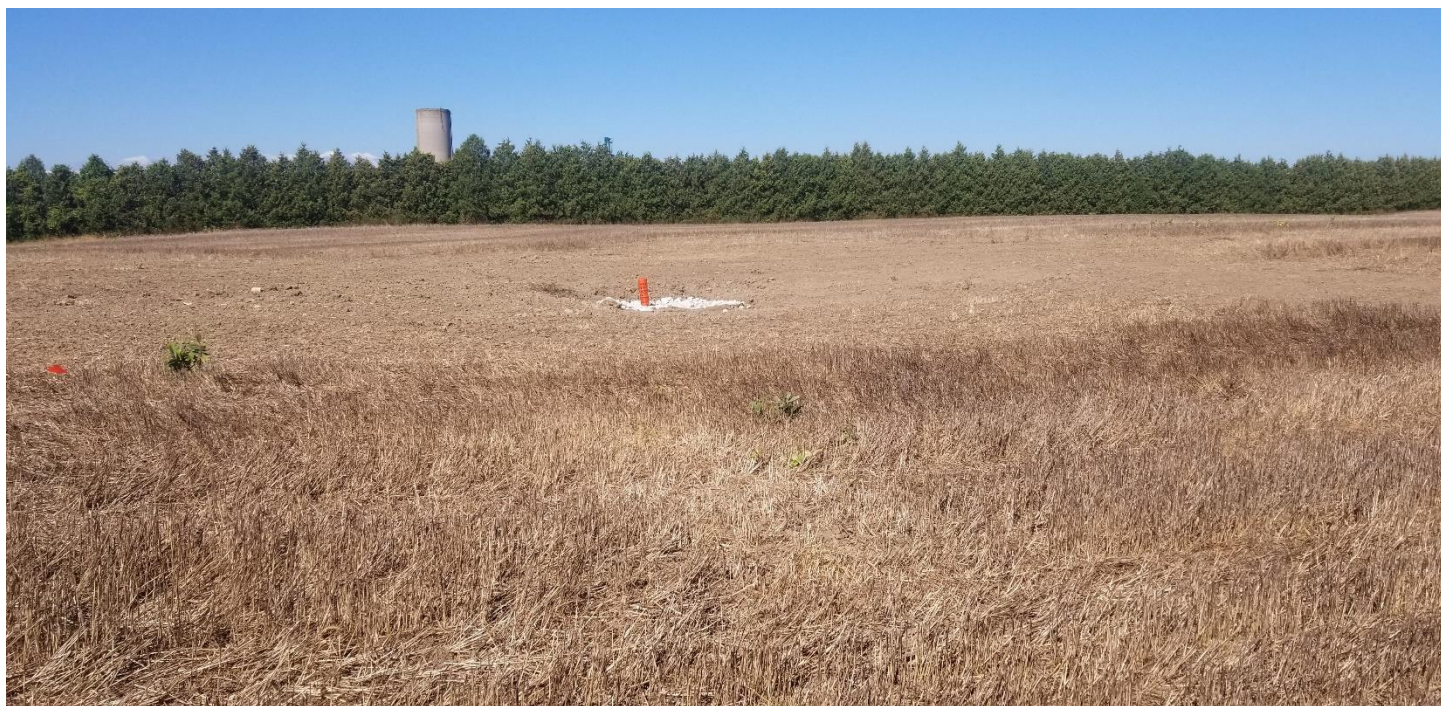
\*should be less because hickenbottom was tied into a 6" header, when the specifications called for a 3" horizontal

Photo of completed berm, looking west
